Thames Towpath Closure - Barnes West: Essential Tree Safety Works Nov 2021

The following works have been identified by the Arboriculturists of the London Borough of Richmond upon Thames as essential to maintain the safety of the public.

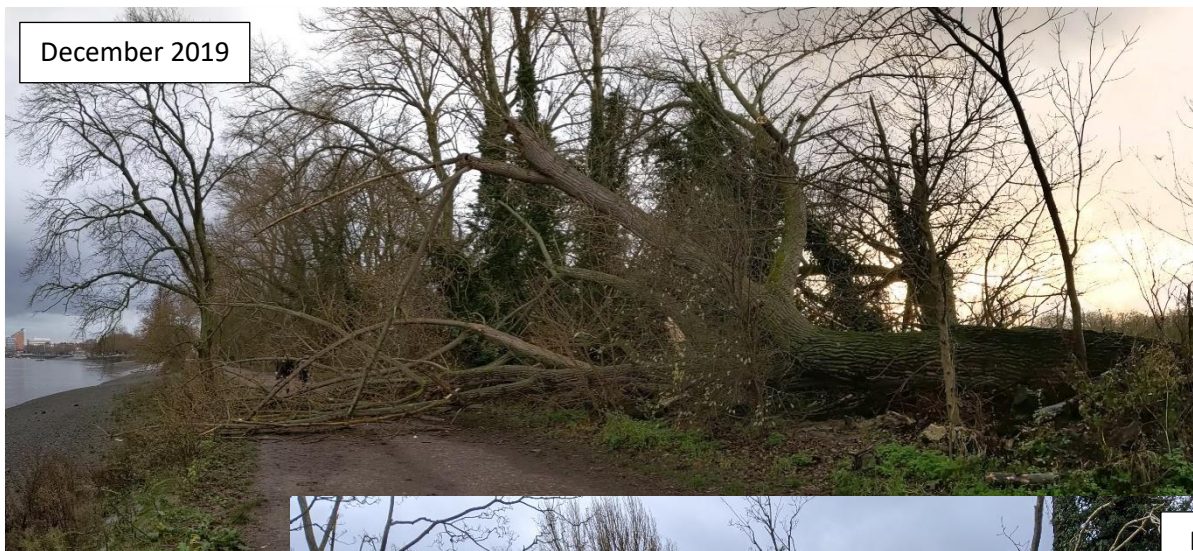
December 2019

There have been several major tree failures on and across the Thames Towpath over the last 3 years

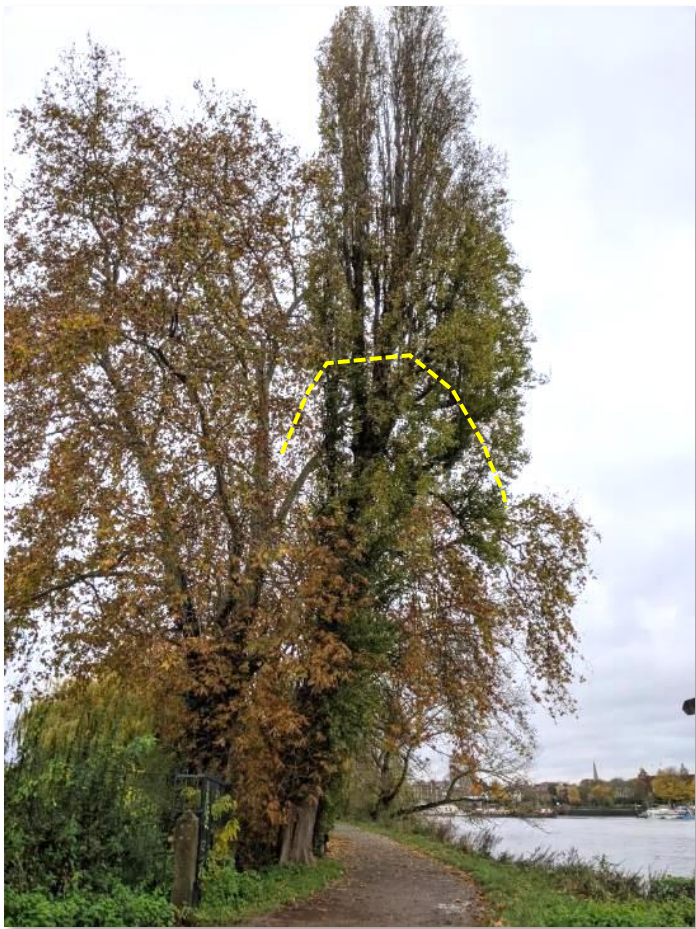
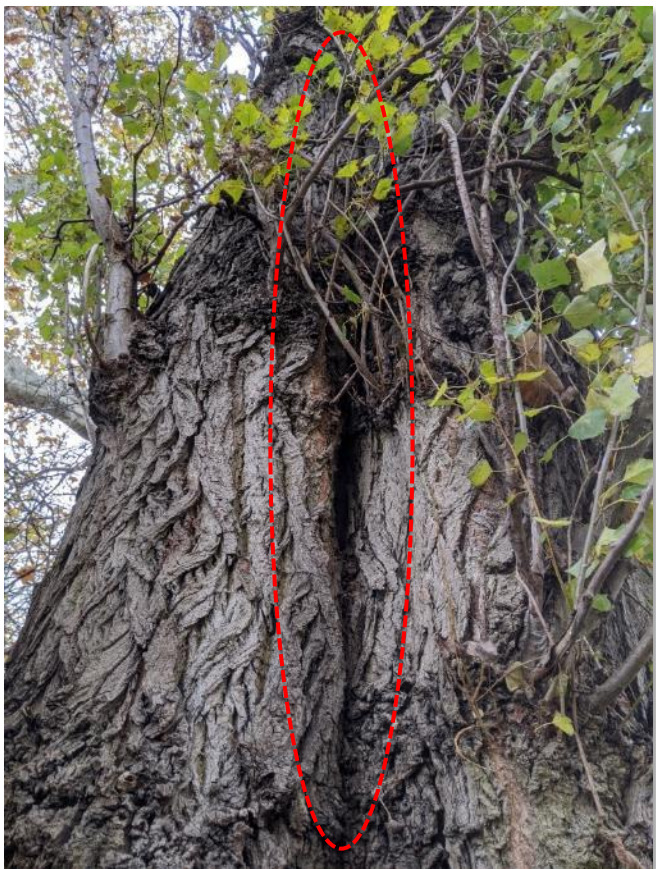
Tree number	T002 (Tag 0626)	Species	Populus nigra 'Italica'
Observations	There is a column of decay from the base of the tree (Image 2.) extending up the eastern side of the trunk. This tree has been reduced in height in the past (Indicated in image 1.) with decay evident at old reduction points. This re-growth is now subject to higher wind loading which leaves it susceptible to failure and falling from height over the footpath.		
Works Specification	Crown reduce to sound wood, 5m below last reduction points, thereby minimising the wind profile of this tree and removing decay from old wounds. This will also reduce mechanical stresses to the decayed main stem, reducing the risk of whole and partial tree failure, thereby extending its beneficial & safe life-expectancy.		
Google link	https://goo.gl/maps/dk2eSWLTgkTdrPXb7		
Image 1		Image 2

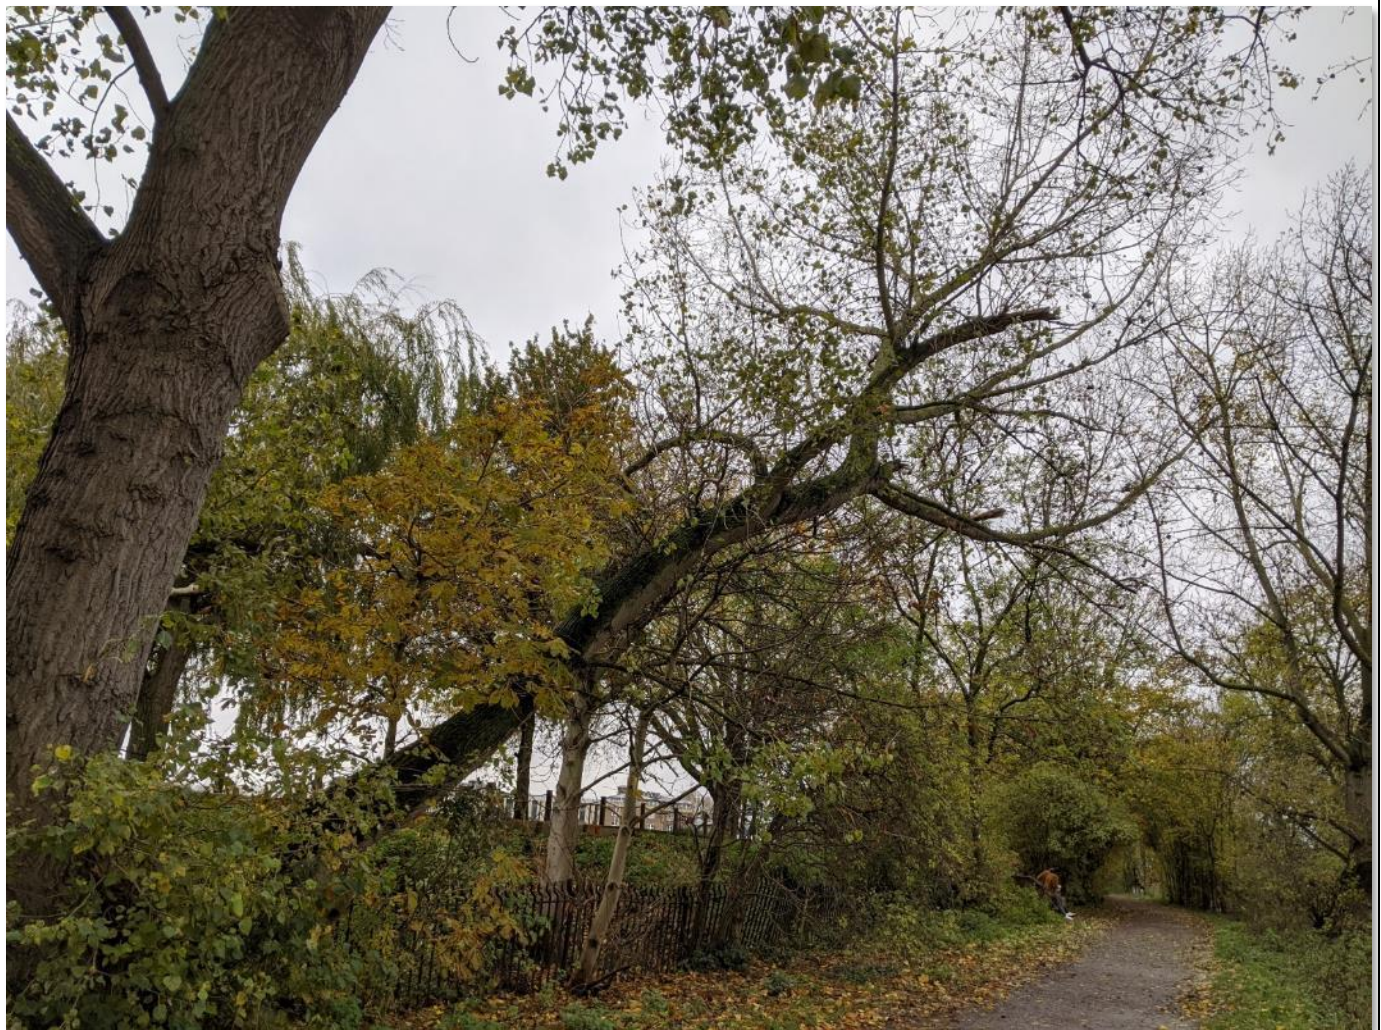
Tree number	T005	Species	Populus x canadensis
Observations	This tree has a progressive lean due to being subordinate to the larger adjacent tree and is resting on and being supported by a private Horse Chestnut tree on the adjacent land. Remedial pruning works will be beneficial to reduce the loading on the adjacent tree, reducing the risk of whole tree failure, thereby extending its beneficial & safe life-expectancy.		
Works Specification	Coppice to 1m stump and allow for future regenerative regrowth from retained stump and rootstock as per historic riverside coppice management.		
Google link	https://goo.gl/maps/v25yUL7gVUKLZDBs9		
Image 1

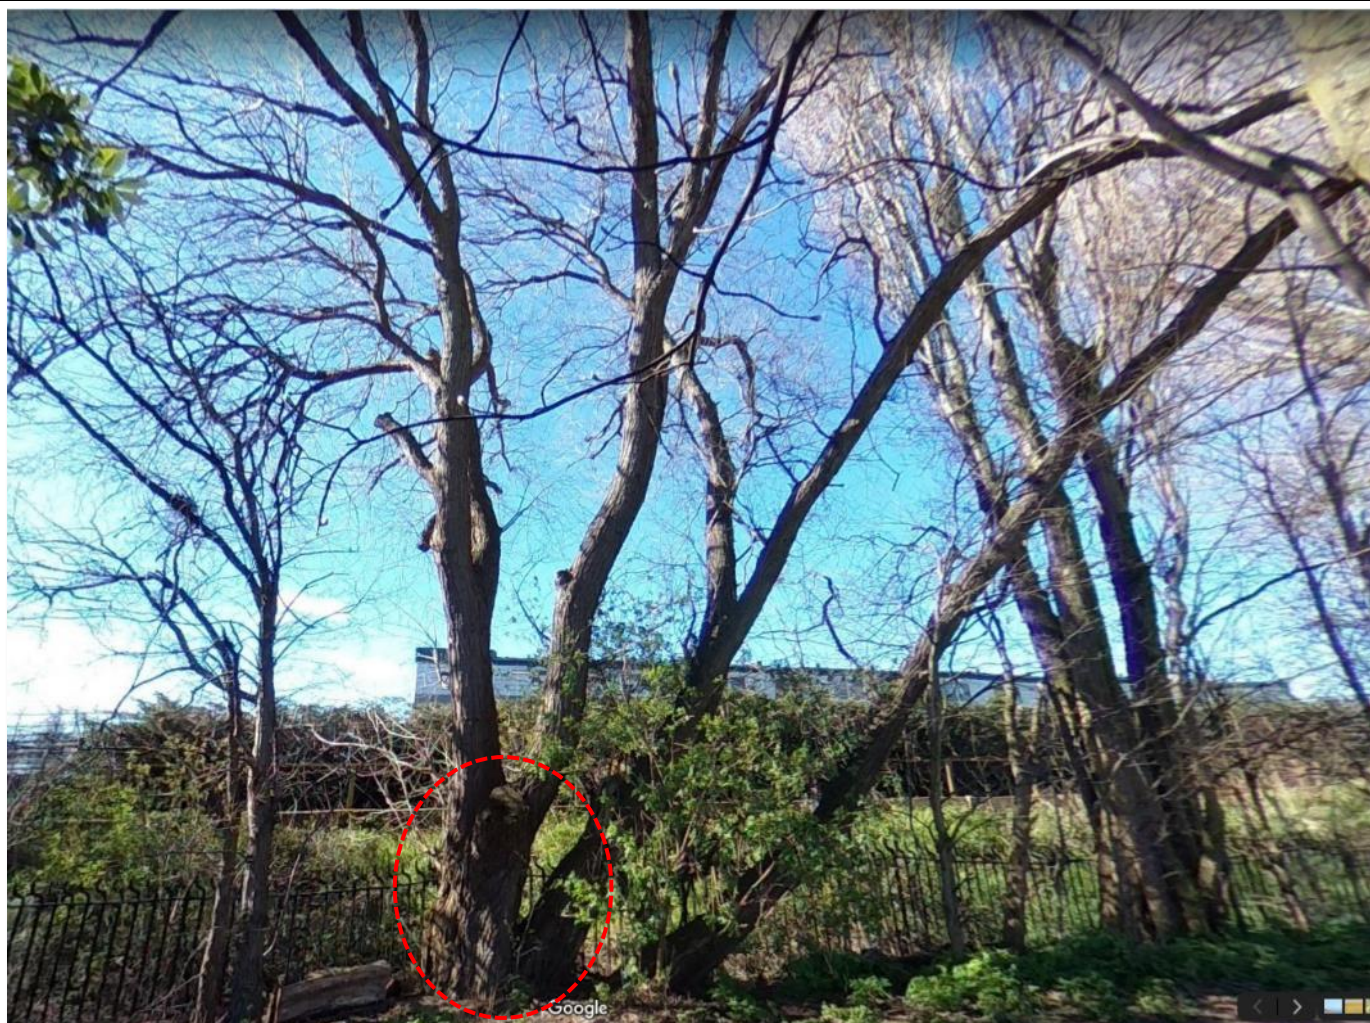
Image 1

Tree number	T012 (Tag 0610)	Species	Salix alba
Observations	<p>Fungus & decay; Bark wounds; Cracked / included bark; Leaning; old pruning wound.</p> <p>Two heavily leaning limbs over footpath.</p> <p>Signs of honey fungus at base of tree with decay, also a weak union at base between stems (Indicated image 1). Weak forks & minor cavities.</p> <p>The presence of decay fungi and cavities coupled with the weak unions near the base of the main stems presents a very real risk of failure which Willow has a propensity for, even when healthy.</p>		
Works Specification	Coppice to 1m stumps (But just above main fork on main stem retaining split fork) and allow for future regenerative regrowth from retained stumps and rootstock as per historic riverside coppice management.		
Google link	https://goo.gl/maps/jVcrZ8MWD3x8PqkN8

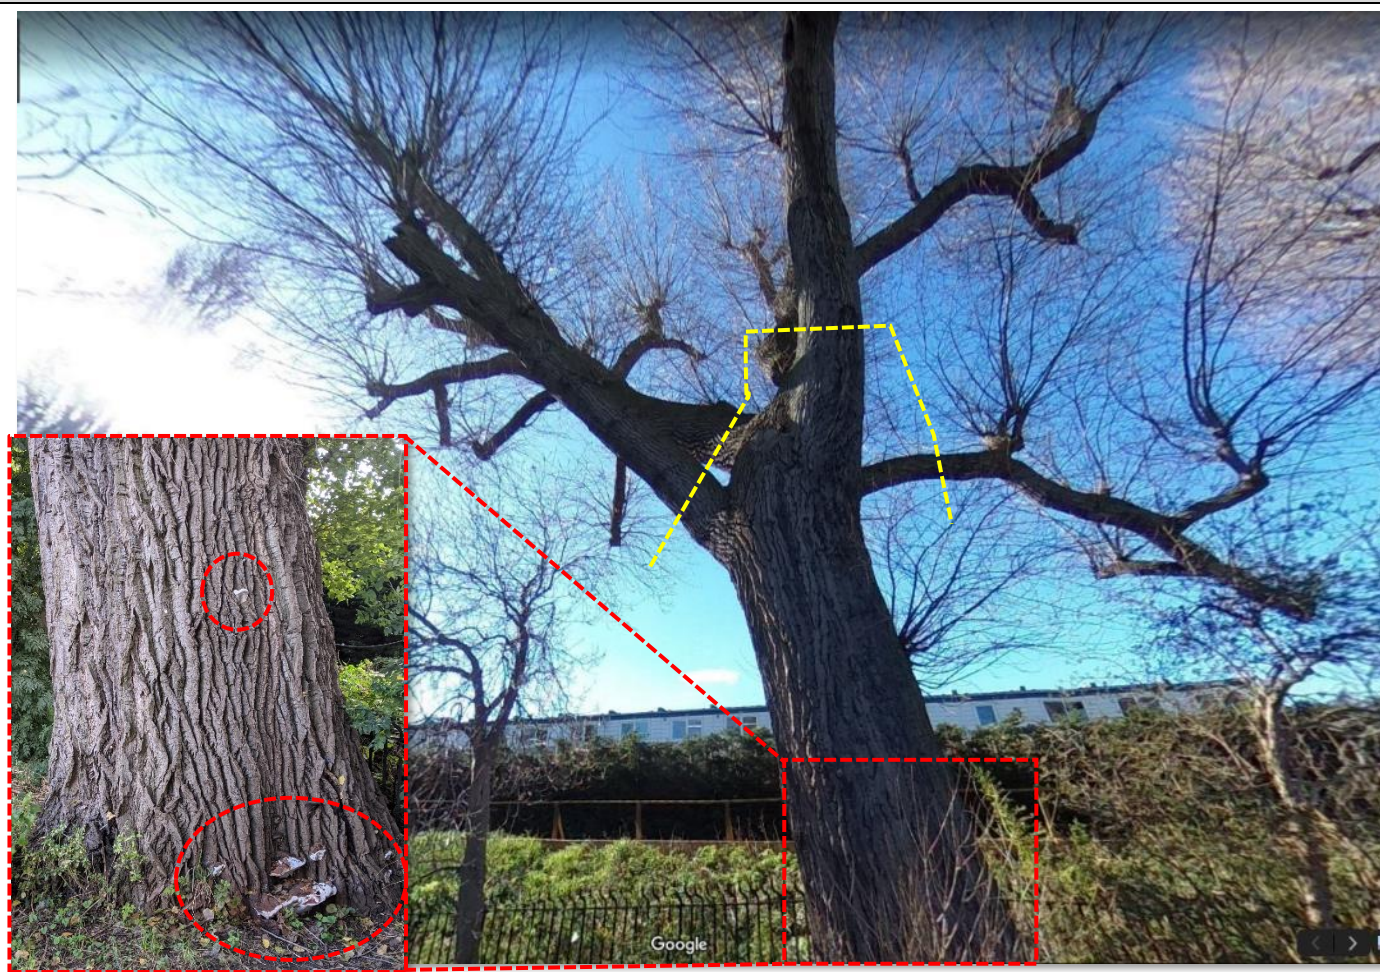
Image 1

Tree number	T014 (Tag 0656+0607)	Species	Populus x canadensis
Observations	Extensive signs of decay fungi (See images below) and cavities at base of tree (Wasp Nest) and decay cavities in main limbs throughout the tree. This tree has been reduced to a pollard framework in the past with decay evident at old reduction points. This re-growth is now subject to higher wind loading which leaves it susceptible to failure. Remedial pruning works are necessary to reduce the mechanical stress and loading at these points of weakness, reducing the risk of whole or partial tree failure, thereby extending its beneficial & safe life-expectancy.		
Works Specification	<p>Recommendations: Aerial inspection (Where safe and practicable) to check cavities for bat potential and to assess the structural integrity of the tree.</p> <p><u>Crown reduce to a 8-10m in height (Above main fork - Pruning point dependent on decay at old reduction points, to be determined by climber). Reduce lateral limbs extending to the East to lessen the weight and on this side,</u> thereby moving the centre of gravity closer the centre of the tree. This will reduce mechanical stresses to the main stem and the risk of whole or partial tree failure, including falling regrowth from height, over the Towpath. The aim is to extend the trees beneficial & safe life-expectancy by allowing it to regrow and be maintained as smaller riverside pollard.</p> <p>(NB. Pruning height subject to change dependent on the results of the Aerial inspection)</p>

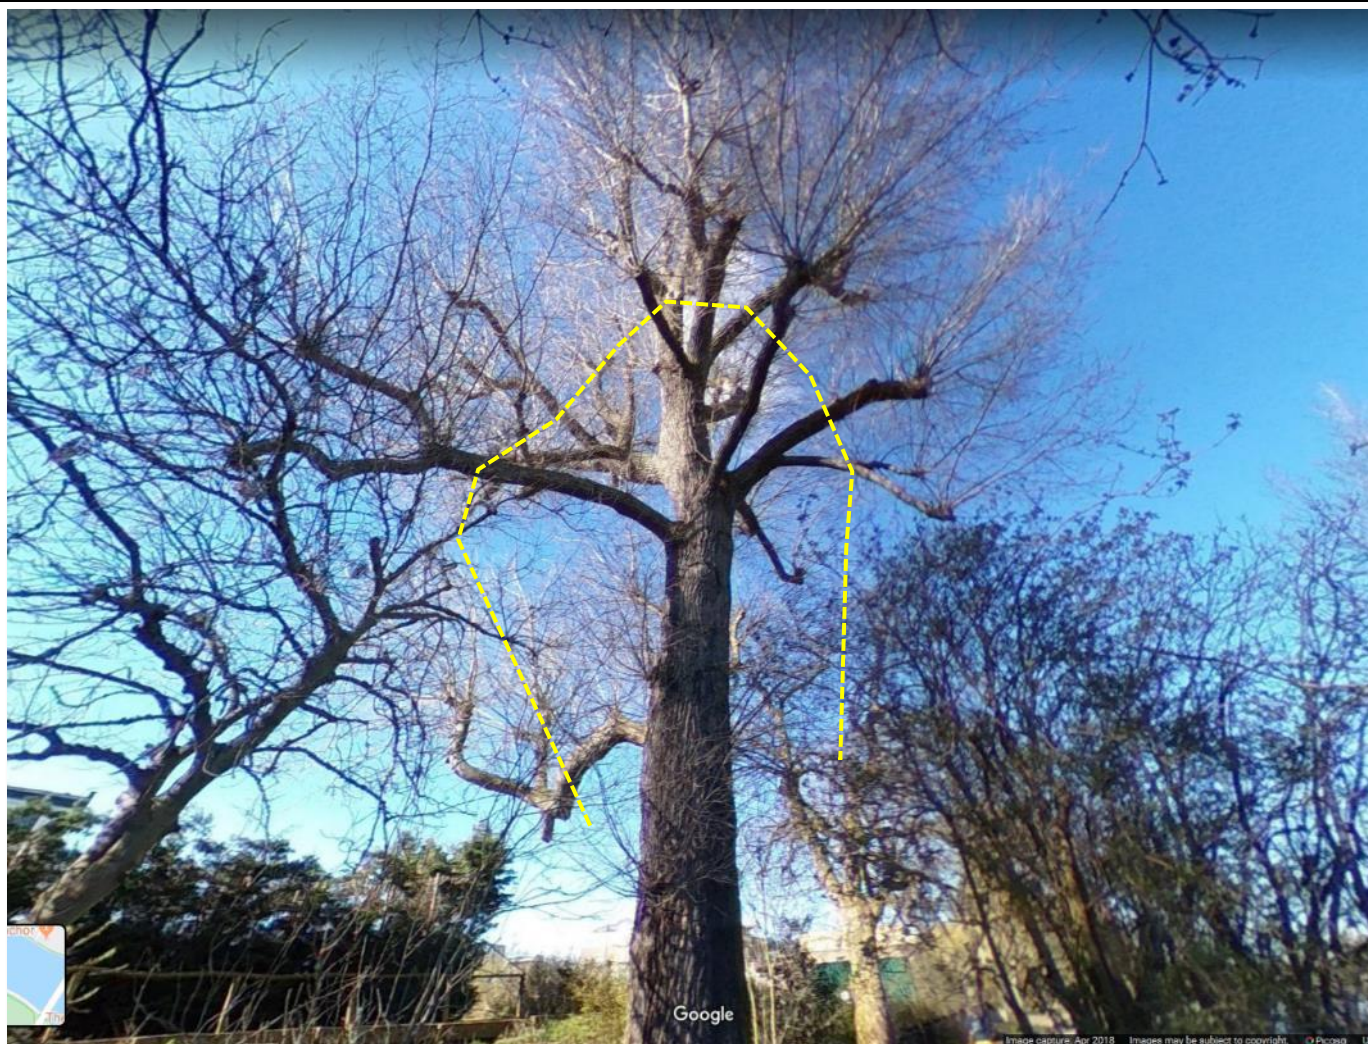
Image 1

Tree number	T015 (Tag 0606)	Species	Populus x canadensis
Observations	There is emergent Ganoderma decay fungi brackets at base of tree on the riverside (Image 2) and signs of Hornet Moth, tree has heartwood decay but at least 50cm intact radius. No obvious signs of the main stem being seriously structurally compromised at this time. However, the regrowth from the last pruning has grown to a size where it is susceptible to failure.		
Works Specification	Reduce crown below previous reduction points by approximately 4-5m (Pruning point dependent on decay at old reduction points, to be determined by climber). Allow to regrow and maintain as smaller riverside pollard.		
Google link	https://goo.gl/maps/LLSrdNyPGPz3DsBT8

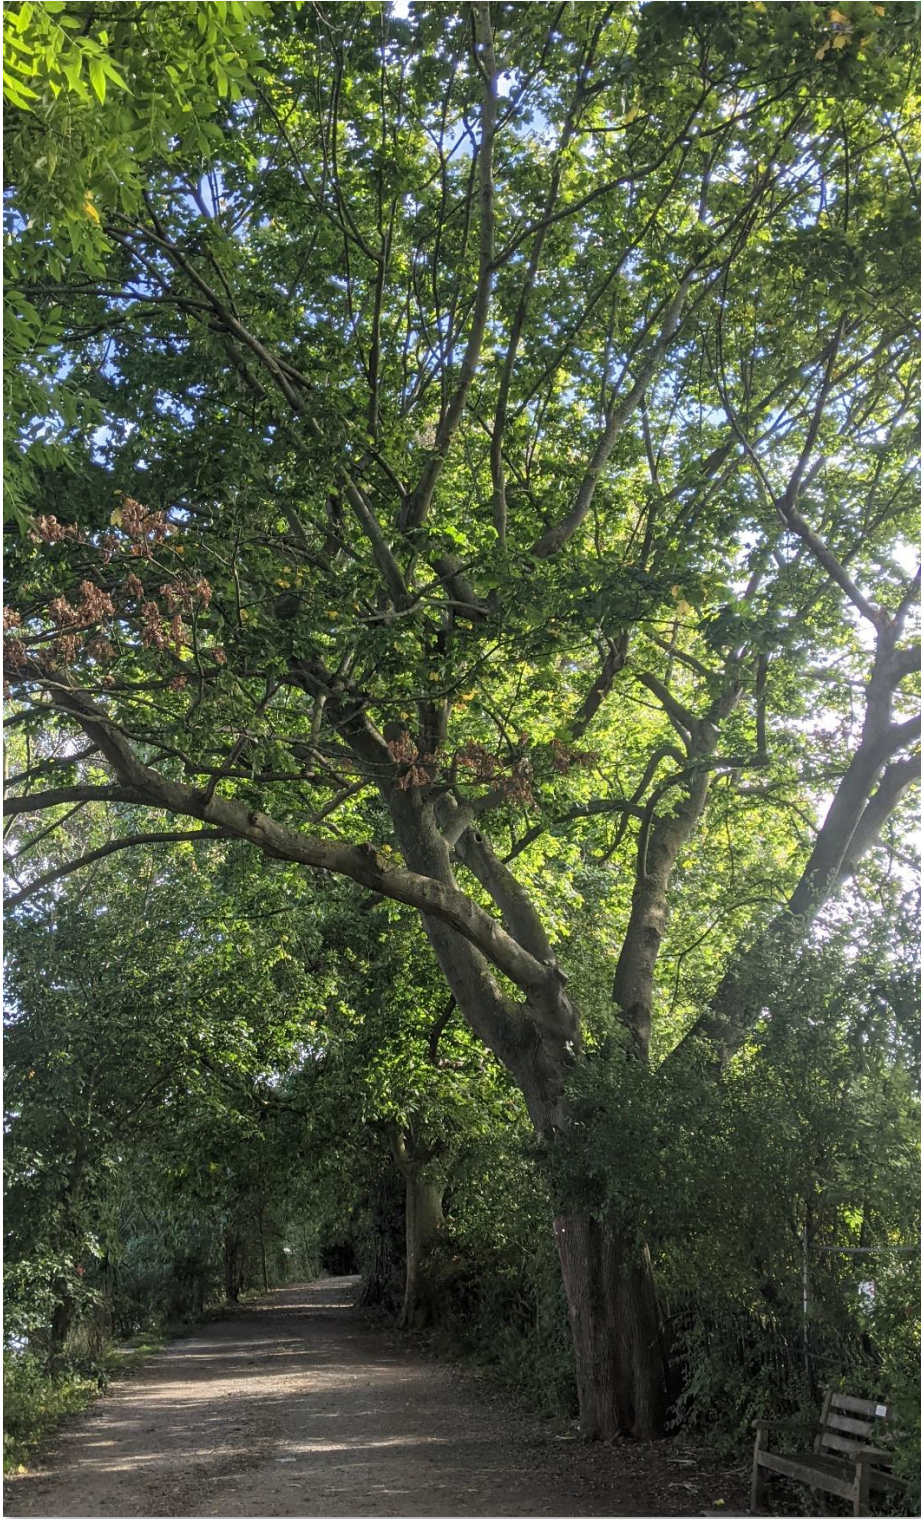
Image 1

Tree number	T017 (Tag 0590)	Species	Norway Maple
Observations	Major deadwood in crown of tree and hanging branch over footway		
Works Specification	Remove Major Deadwood and hanging Branch		
Google link	https://goo.gl/maps/nUXvajXwHAcpaCEZ7

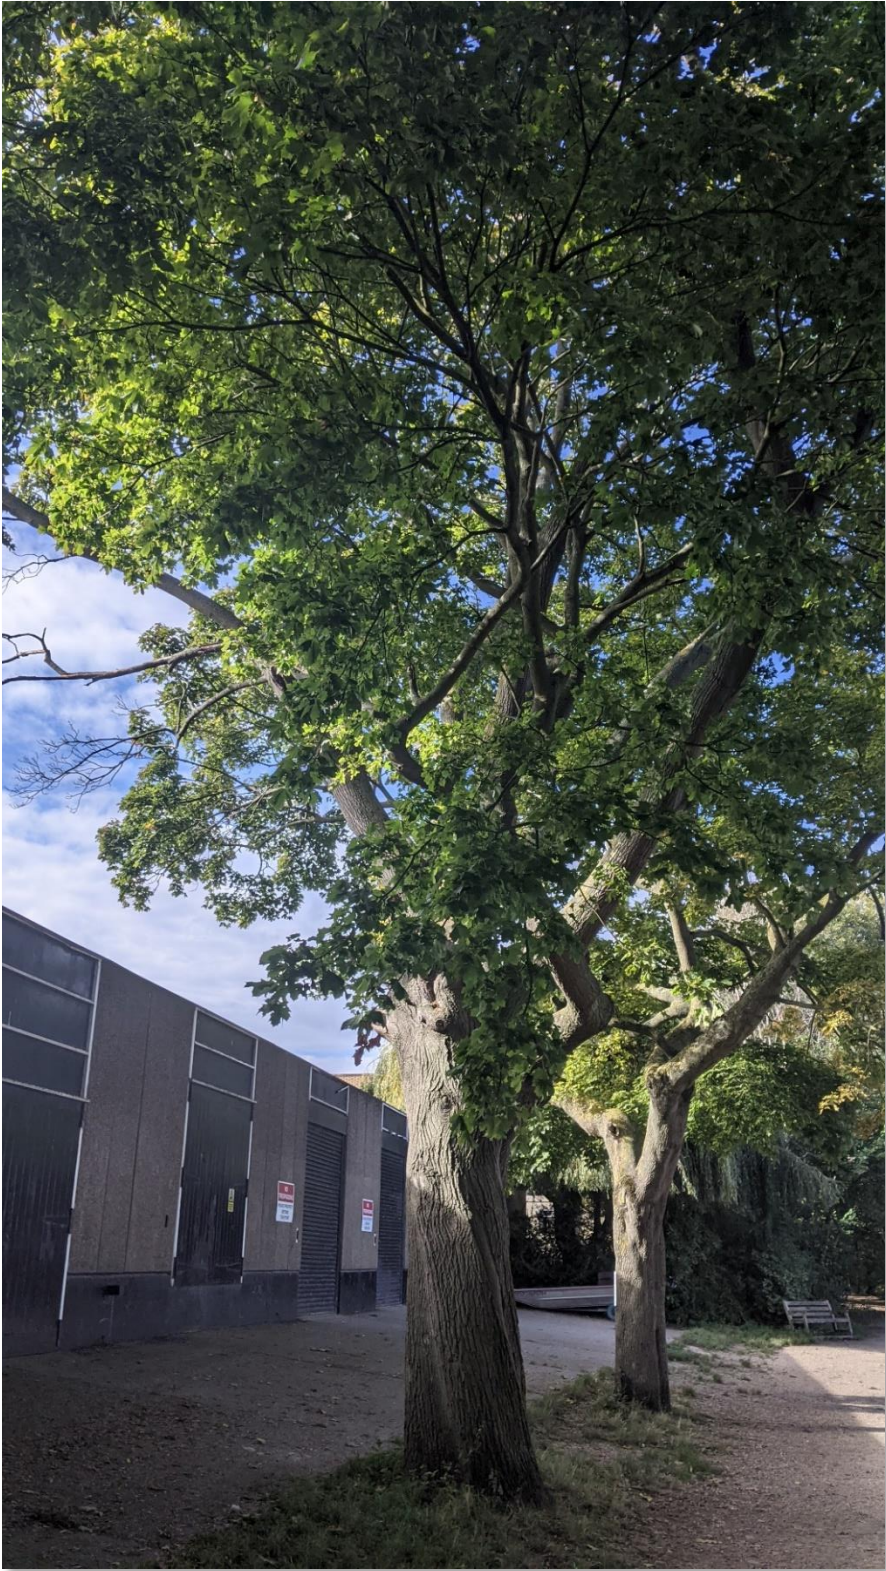
Image 1

Tree number	T018 (Tag 0589)	Species	Norway Maple
Observations	Major deadwood over towpath and Rowing Club building		
Works Specification	Remove major deadwood		
Google link	https://goo.gl/maps/g8HWzNd9LyzLrq2B9

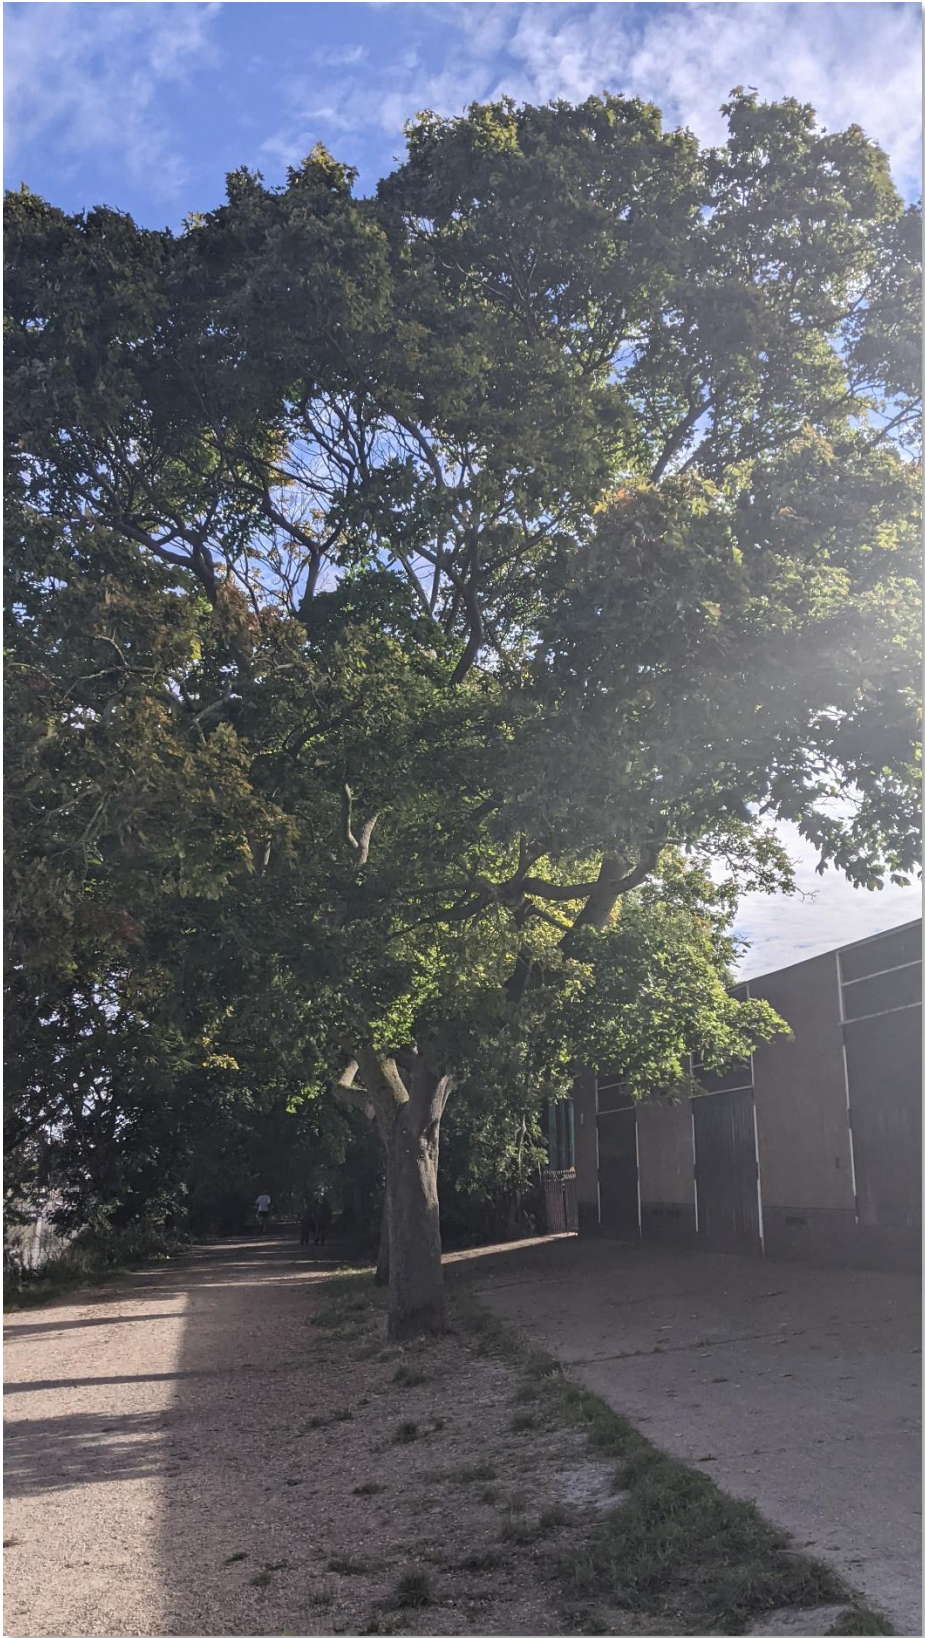
Image 1

Tree number	T019 (Tag 0589)	Species	Norway Maple
Observations	Major deadwood over towpath and Rowing Club building		
Works Specification	Remove major deadwood		
Google link	https://goo.gl/maps/b3sDHtHRtthrgmLU7

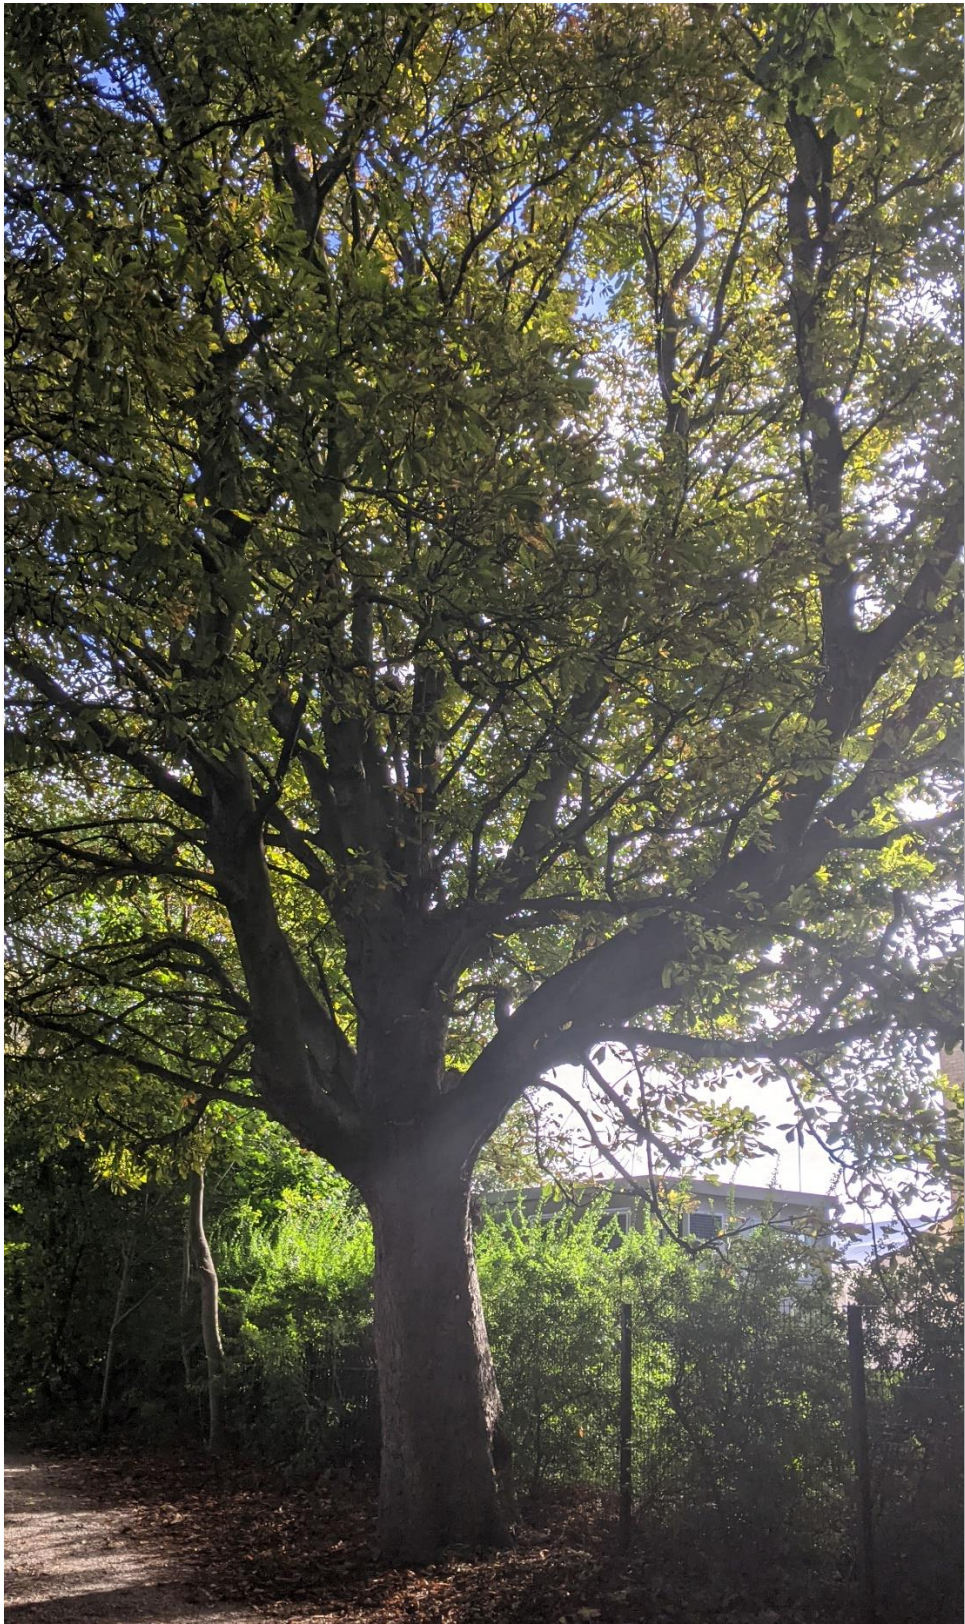
Image 1

Tree number	(Tag 0585)	Species	Norway Maple
Observations	Major deadwood in crown of tree		
Works Specification	Remove Major Deadwood		
Google link	https://goo.gl/maps/2TUy7ZrgRLYCX2mPA

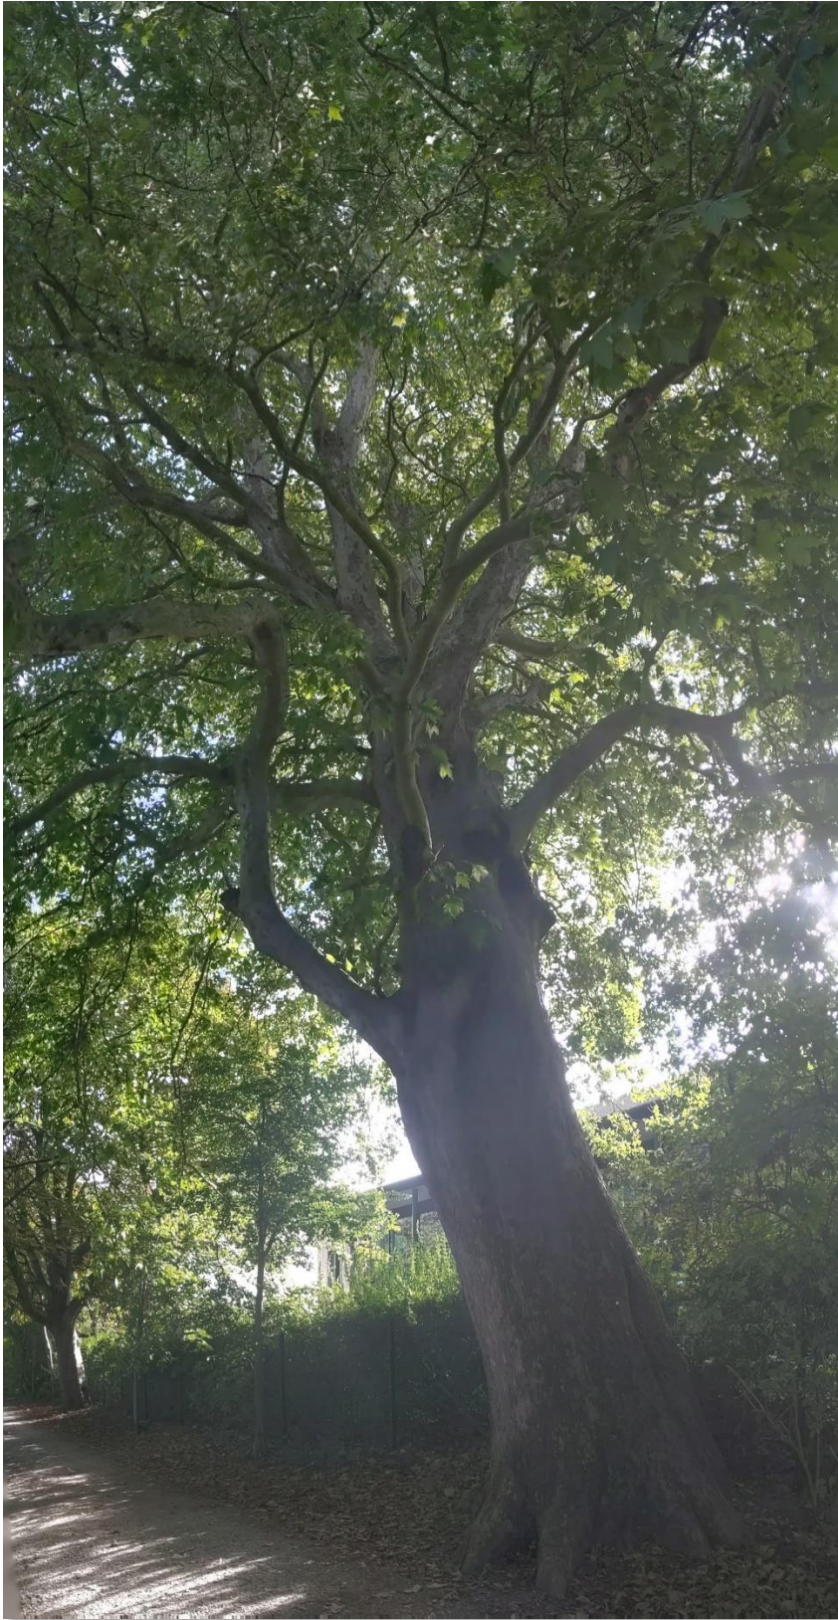
Image 1

Tree number	(Tag 0584)	Species	Platanus x hispanica
Observations	Major deadwood throughout crown of tree		
Works Specification	Remove Major Deadwood		
Google link	https://goo.gl/maps/yFBF5cDGDF67d7yCA

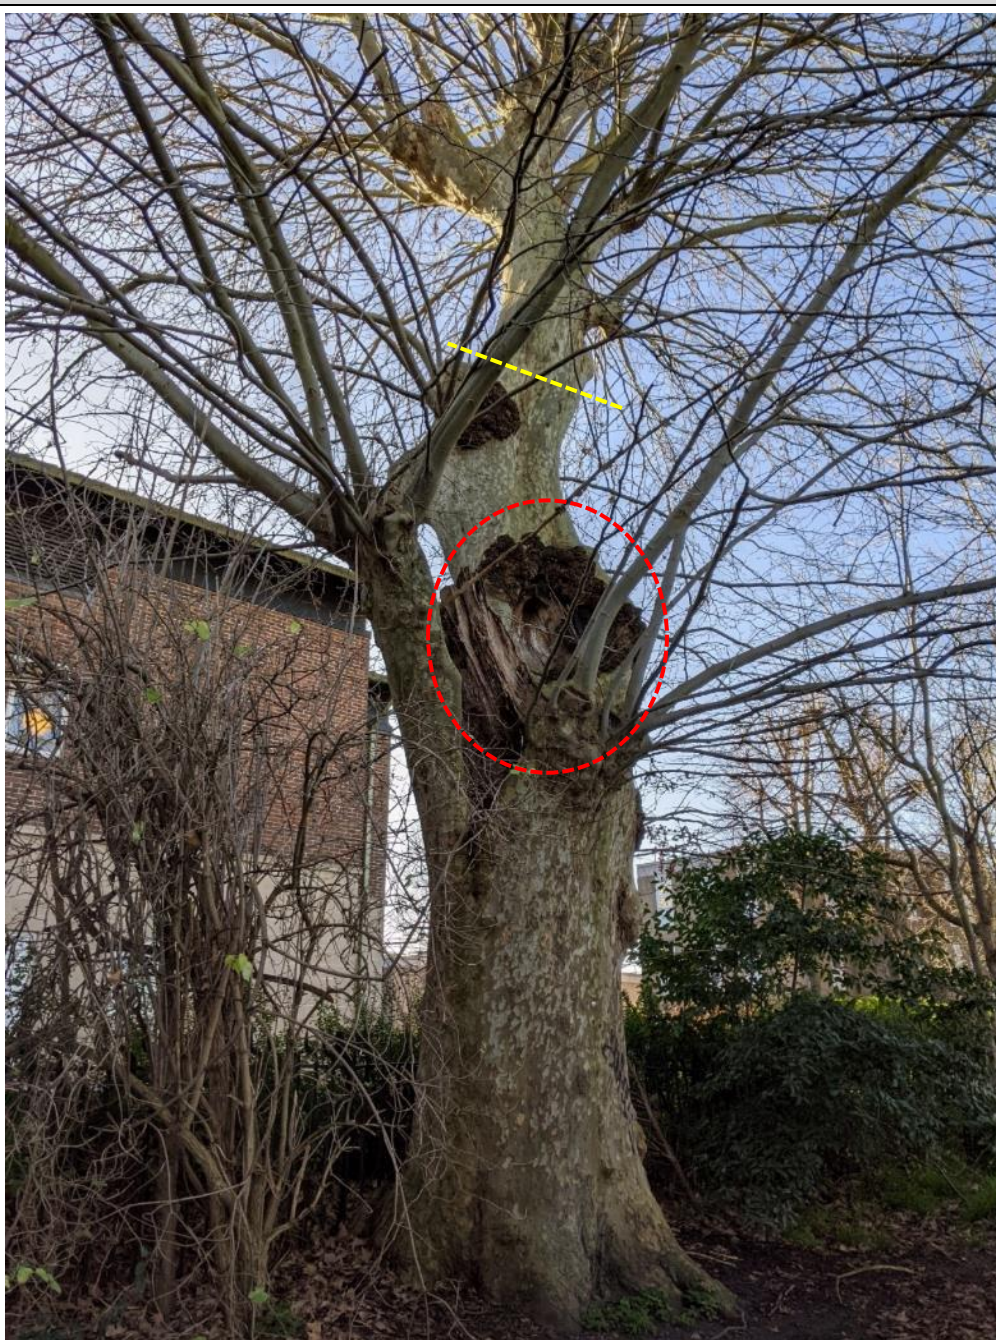
Tree number	T022 (Tag 0657)	Species	Platanus x hispanica
Observations	<p>Old pollard; Epicormic growths; Old pruning wounds; Jagged wound; Epicormic growths; Stubs; Major cavities; Fungus & decay.</p> <p>The is an old re-grown pollard and has a large wound in main the trunk where a part of the tree has failed in the past (Indicated in image 1). It has been previously reduced in the past to due to this structural defect.</p>		
Works Specification	<p>Aerial inspection to check cavities for bat potential and to assess the structural integrity of the tree.</p> <p><u>Reduce in height back to approx. 3m above the large trunk wound to remove mechanical stresses at the major decay point on the main stem to mitigate tree failure.</u> (Pruning point to be determined by climber)</p> <p>Allow to regrow and maintain as smaller riverside pollard.</p>		
Google link	https://goo.gl/maps/p3kdSCoSgHUn2Gvq6		
Image 1

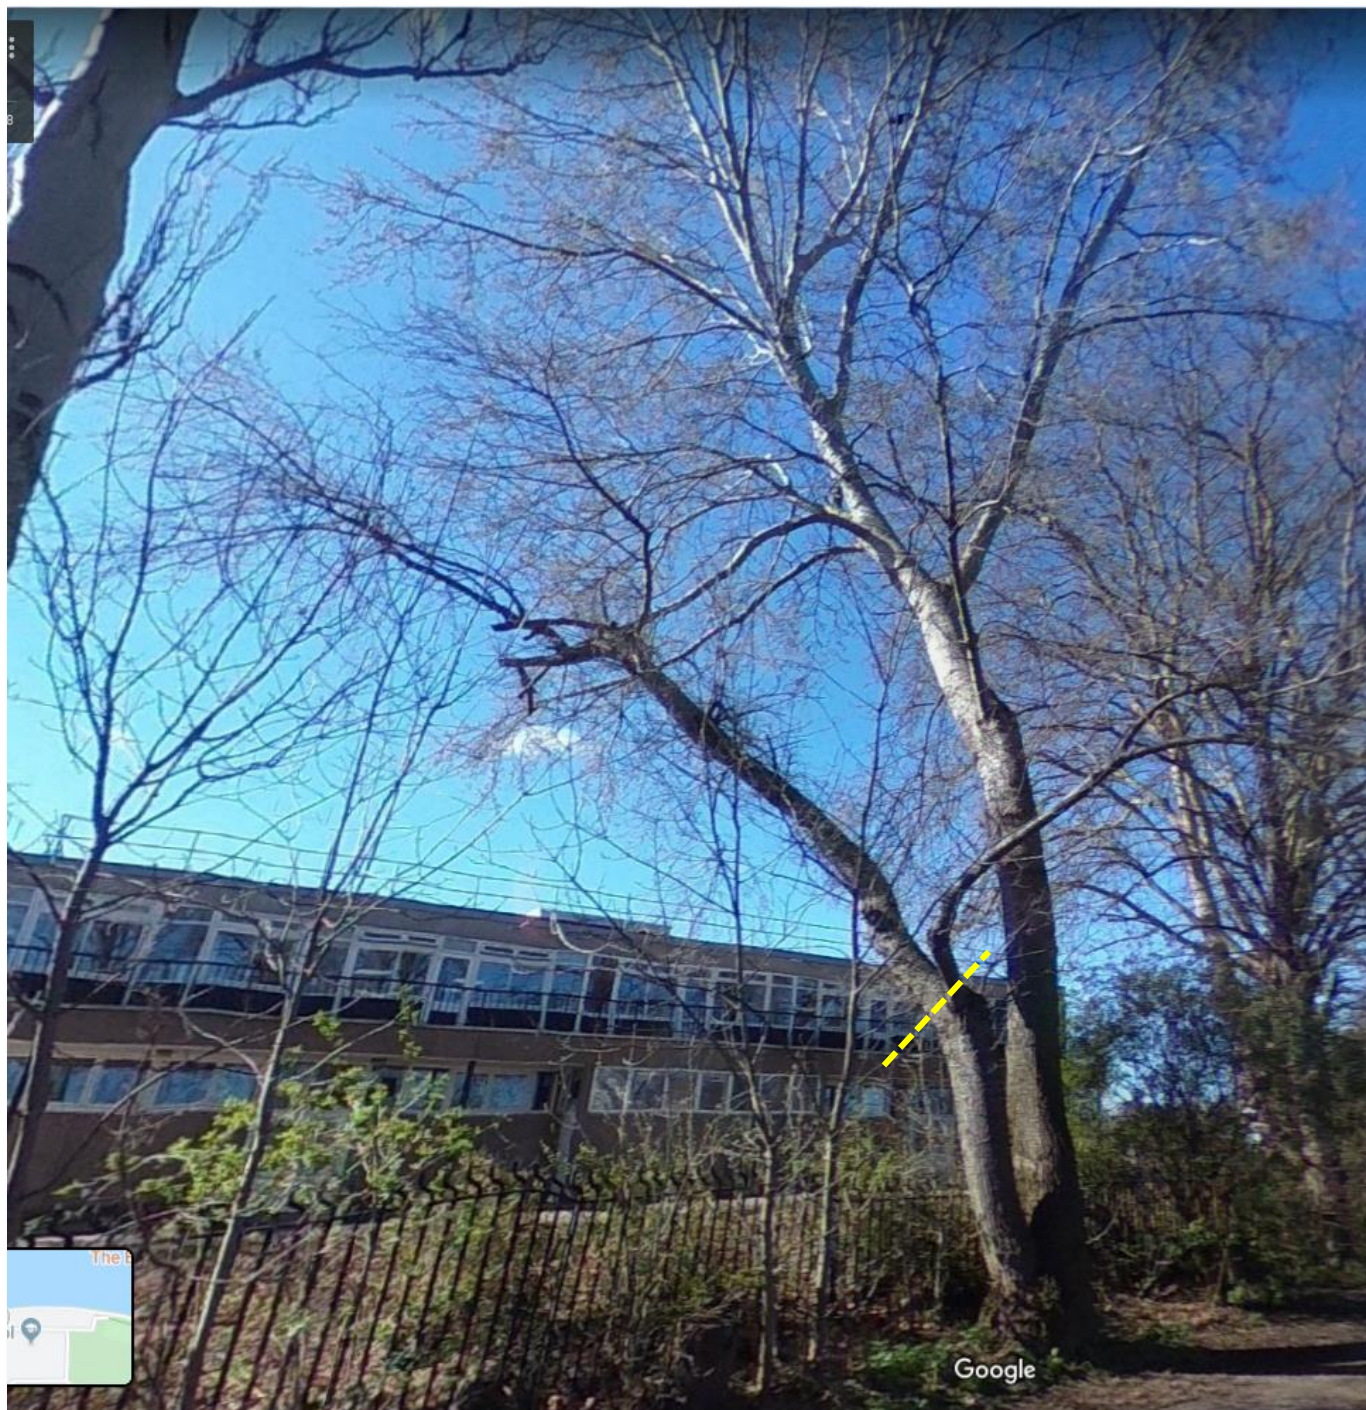
Image 1

Tree number	T028 (Tag 0557)	Species	Populus canescens
Observations	The low limb overhanging the adjacent school is decayed at the point of an old pruning wound where the limb used to fork. This represents a deteriorating failure point for this limb and need to be rectified.		
Works Specification	Recommendations: <u>Reduce limb OH school to a 3m Stump (indicated image 1)</u> NB. School will need to notified and access to site may be necessary?		
Google link	https://goo.gl/maps/S2jCatEUFrduZ89P6

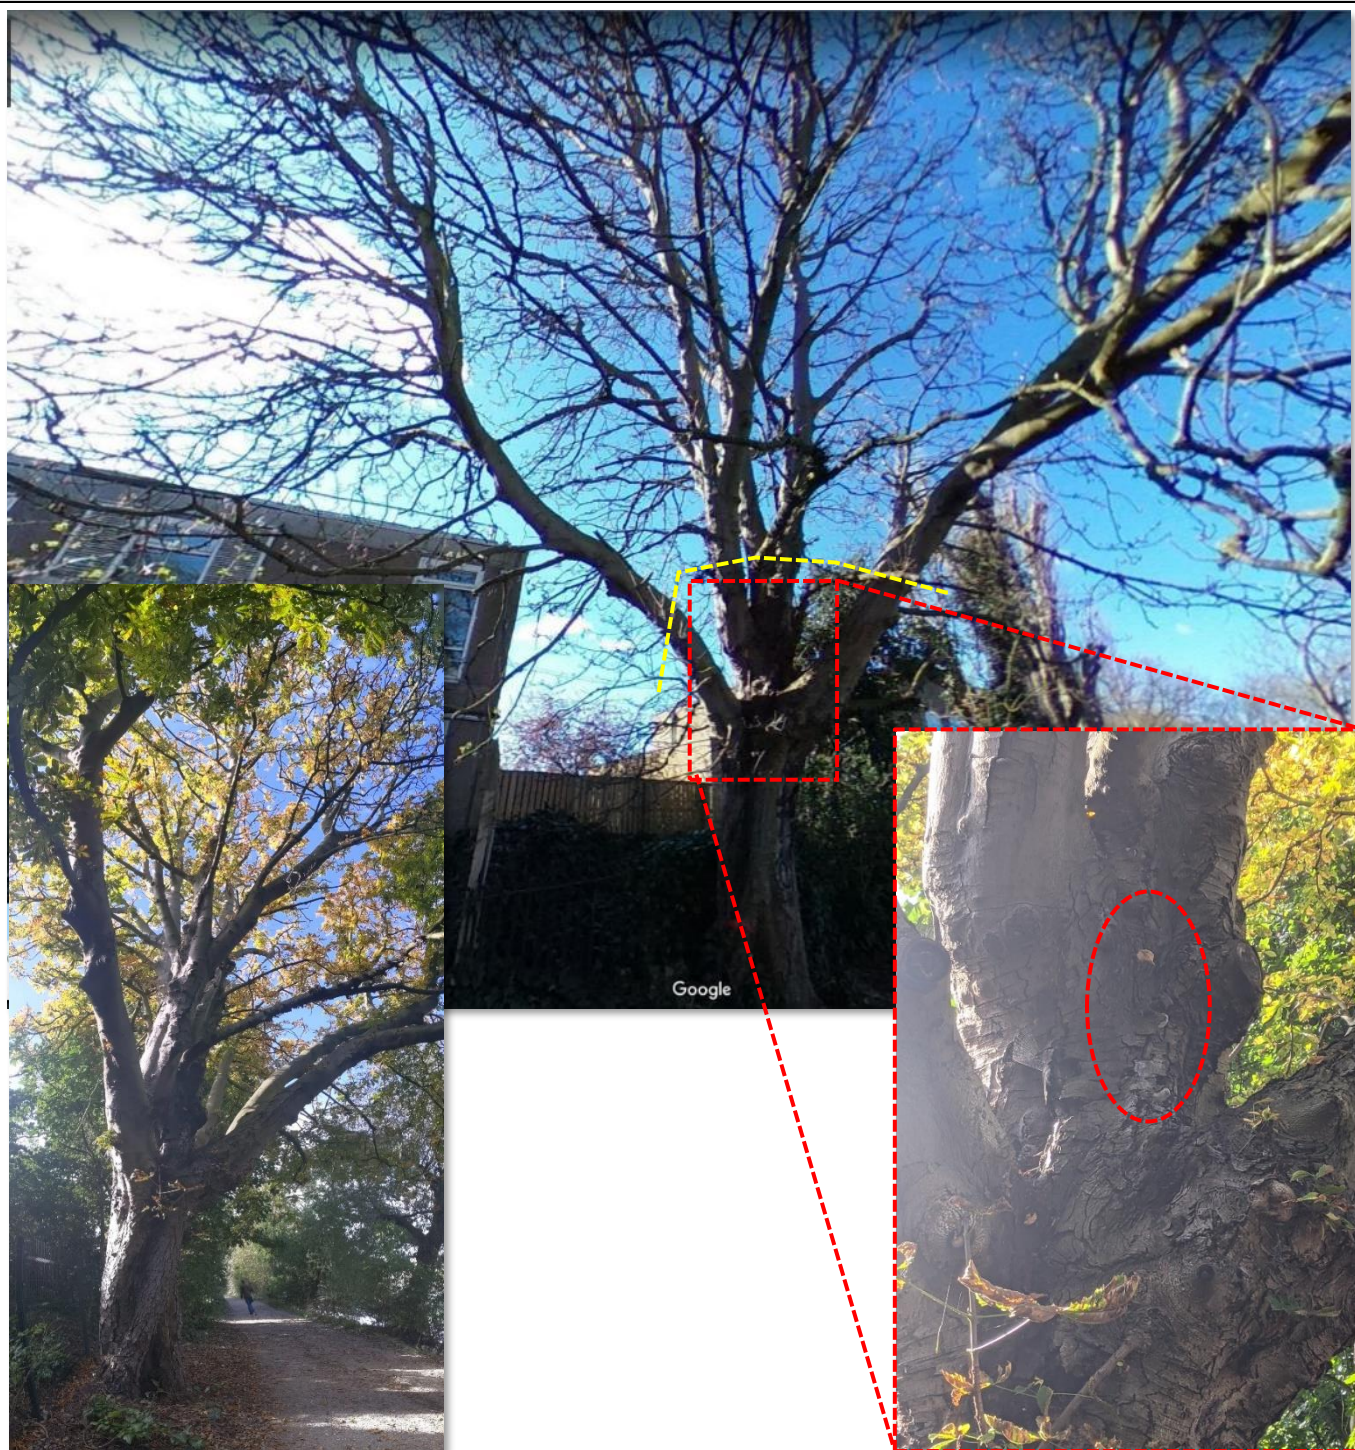
Image 1

Tree number	T034 (Tag 0552)	Species	Aesculus hippocastanum
Observations	Extensive defoliation and crown disfunction with decay forming fungi (Ganoderma) emanating from the main fork, Major deadwood in canopy overhangs school and branches interfering with adjacent building.		
Works Specification	Aerial inspection to check cavities for bat potential and to assess the structural integrity of the tree. <u>Reduce in height back to approx. 1m above the main fork to a standing trunk to remove mechanical stresses at the major decay point on the main stem to mitigate tree failure.</u> (Pruning point to be determined by climber). Maintain as standing dead timber (Monolith) for nature value and monitor for any future instability.		
Google link	https://goo.gl/maps/Vppuqn48Et8Xoqpy9

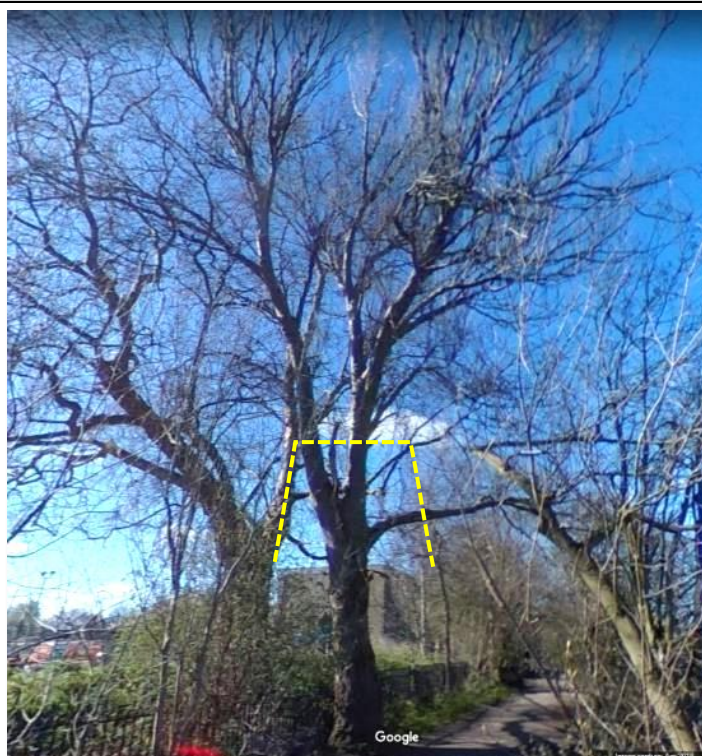
Image 1

Tree number	T039 (Tag 0526)	Species	Populus alba
Observations	Significant cavities and decay fungi (<i>Laetiporus sulfureus</i>) present at main fork which heightens the real risk of tree failure. Remedial pruning works are necessary to reduce the mechanical stress and loading at these points of weakness, reducing the risk of whole or partial tree failure, thereby extending the trees beneficial & safe life-expectancy. NB. Possible signs that bats may be present (Image 3)		
Works Specification	Aerial inspection to check cavities for bat potential and to assess the structural integrity of the tree. <u>Reduce to Standing trunk approx. 2m above main fork, while retaining cavities where possible</u> (Final height to be determined by climber due dependent on structural condition limbs). Maintain as standing timber (Monolith) for nature value and monitor for any future instability.		
Google link	https://goo.gl/maps/qPTvGLGuHYRLBAqr7
