Thames Towpath Closure - Barnes West: Essential Tree Safety Works Nov 2021

The following works have been identified by the Arboriculturists of the London Borough of Richmond upon Thames as essential to maintain the safety of the public.

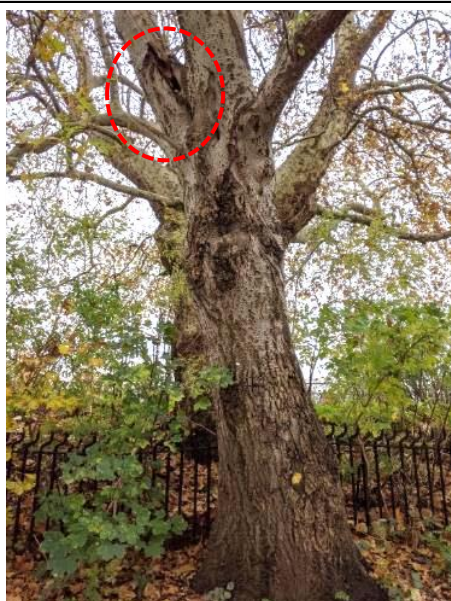
Image 2

Tree number	T039 (Tag 0526)	Species	Populus alba
Observations	Significant cavities and decay fungi (<i>Laetiporus sulfureus</i>) present at main fork which heightens the real risk of tree failure. Remedial pruning works are necessary to reduce the mechanical stress and loading at these points of weakness, reducing the risk of whole or partial tree failure, thereby extending the trees beneficial & safe life-expectancy. NB. Possible signs that bats may be present (Image 3)		
Works Specification	Aerial inspection to check cavities for bat potential and to assess the structural integrity of the tree. <u>Reduce to Standing trunk approx. 2m above main fork, while retaining cavities where possible</u> (Final height to be determined by climber due dependent on structural condition limbs). Maintain as standing timber (Monolith) for nature value and monitor for any future instability.		
Google link	https://goo.gl/maps/qPTvGLGuHYRLBAqr7

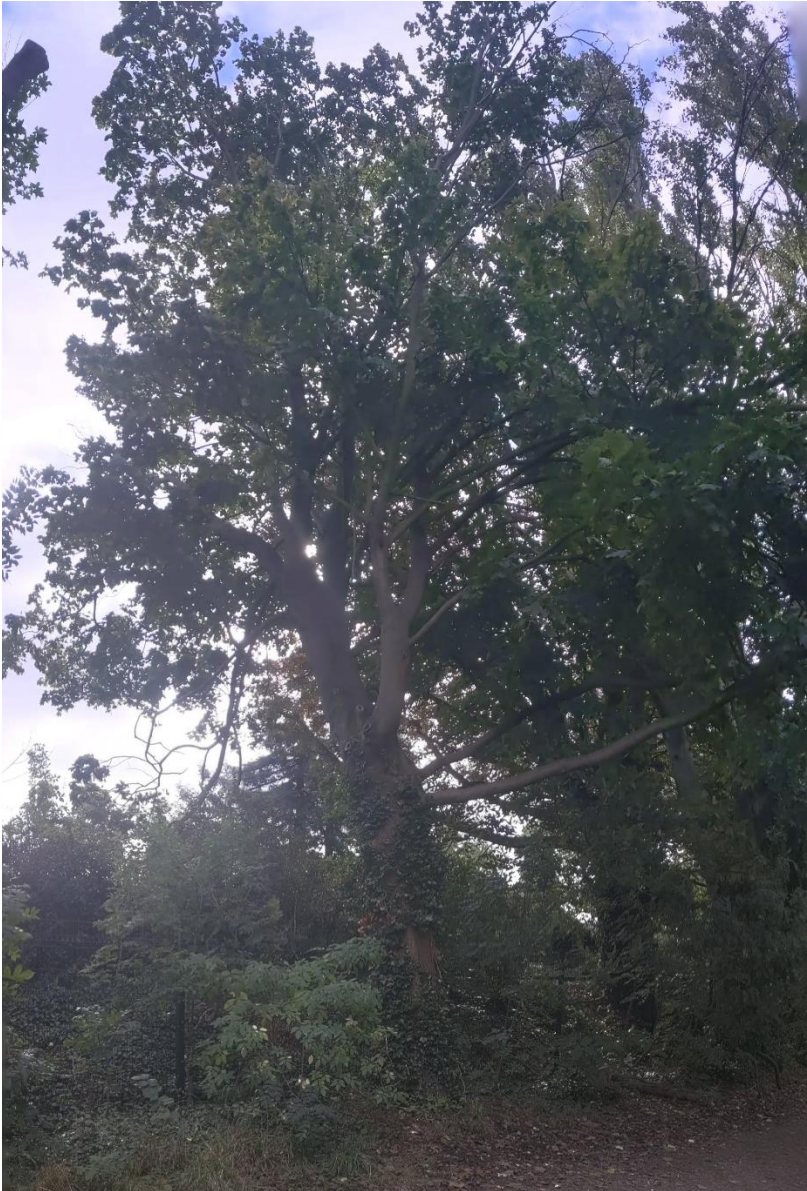
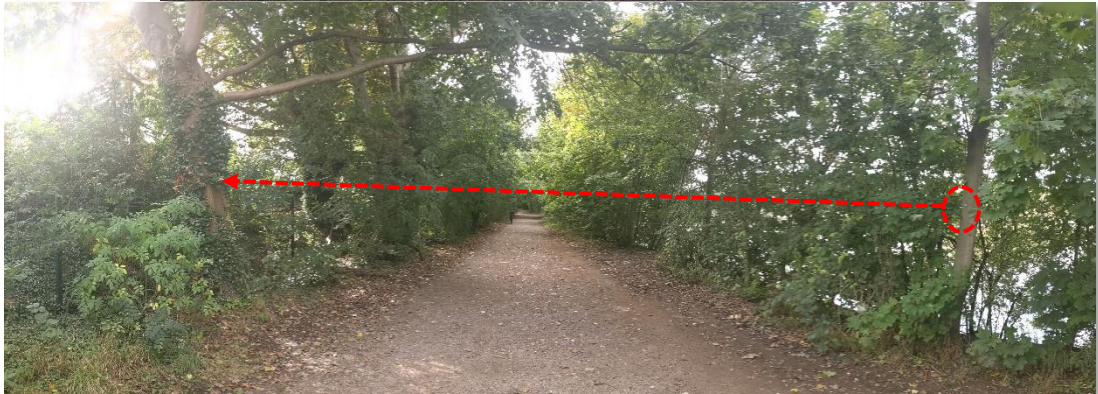
Tree number	Opposite Tag 0578 (Sycamore) *indicated below	Species	Norway maple
Observations	Major deadwood in crown of tree		
Works Specification	Remove Major Deadwood		
Google link	https://goo.gl/maps/tpRQ4qeqWURBJb1m6		
Image 1

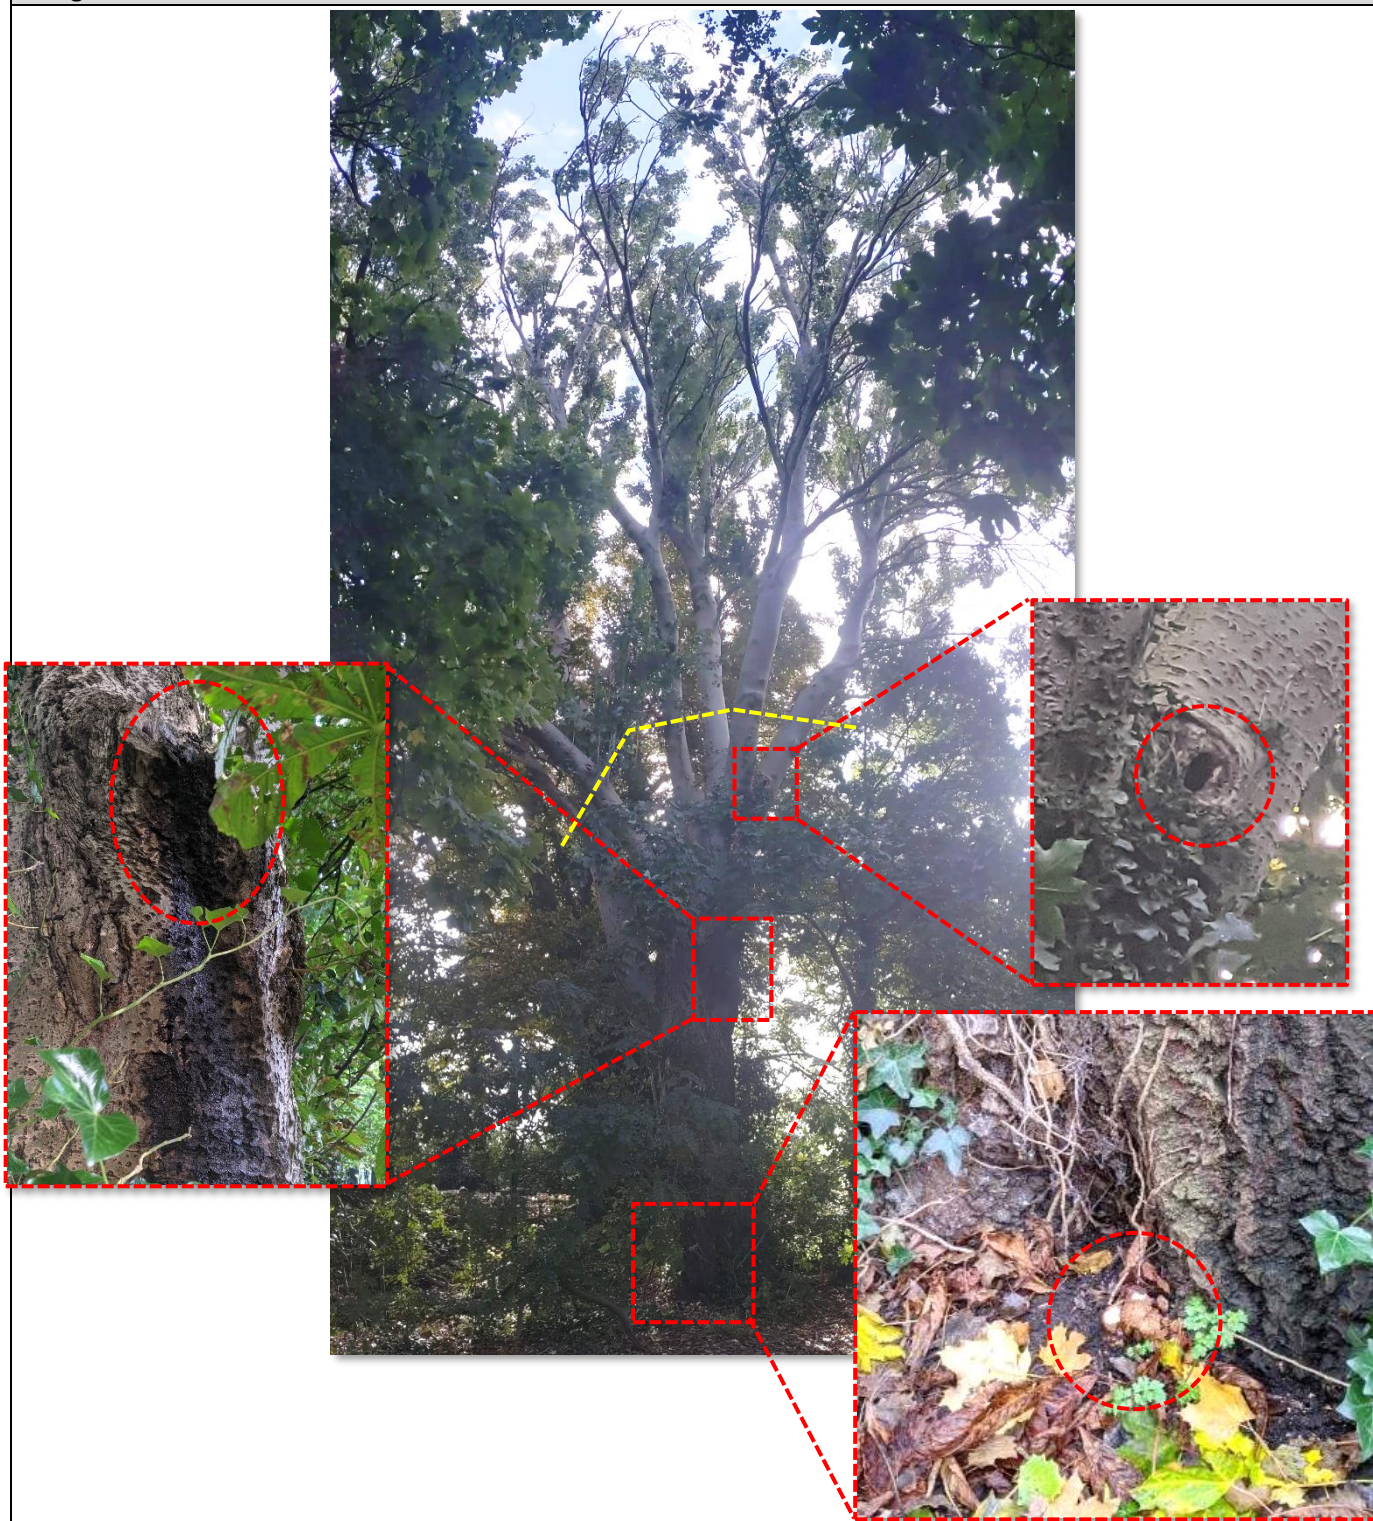
Tree number	T043 (Tag 0783)	Species	Populus alba
Observations	Decay fungi <i>Pholiota squarrosa</i> found at base (Image 2) and <i>Laetiporus sulfureus</i> on truncated low limb. Significant crown defoliation and major decay cavities at main fork (Weeping with water).		
Works Specification	Aerial inspection to check cavities for bat potential and to assess the structural integrity of the tree. <u>Reduce to truncated pollard framework at approximately 5-6m (shown in yellow), while retaining cavities where possible</u> (Final height to be determined by climber due dependent on structural condition limbs). Maintain as standing timber (Monolith) for nature value and monitor for any future instability.		
Google link	https://goo.gl/maps/BuKLyoM71UoQfbG39		
Image 1

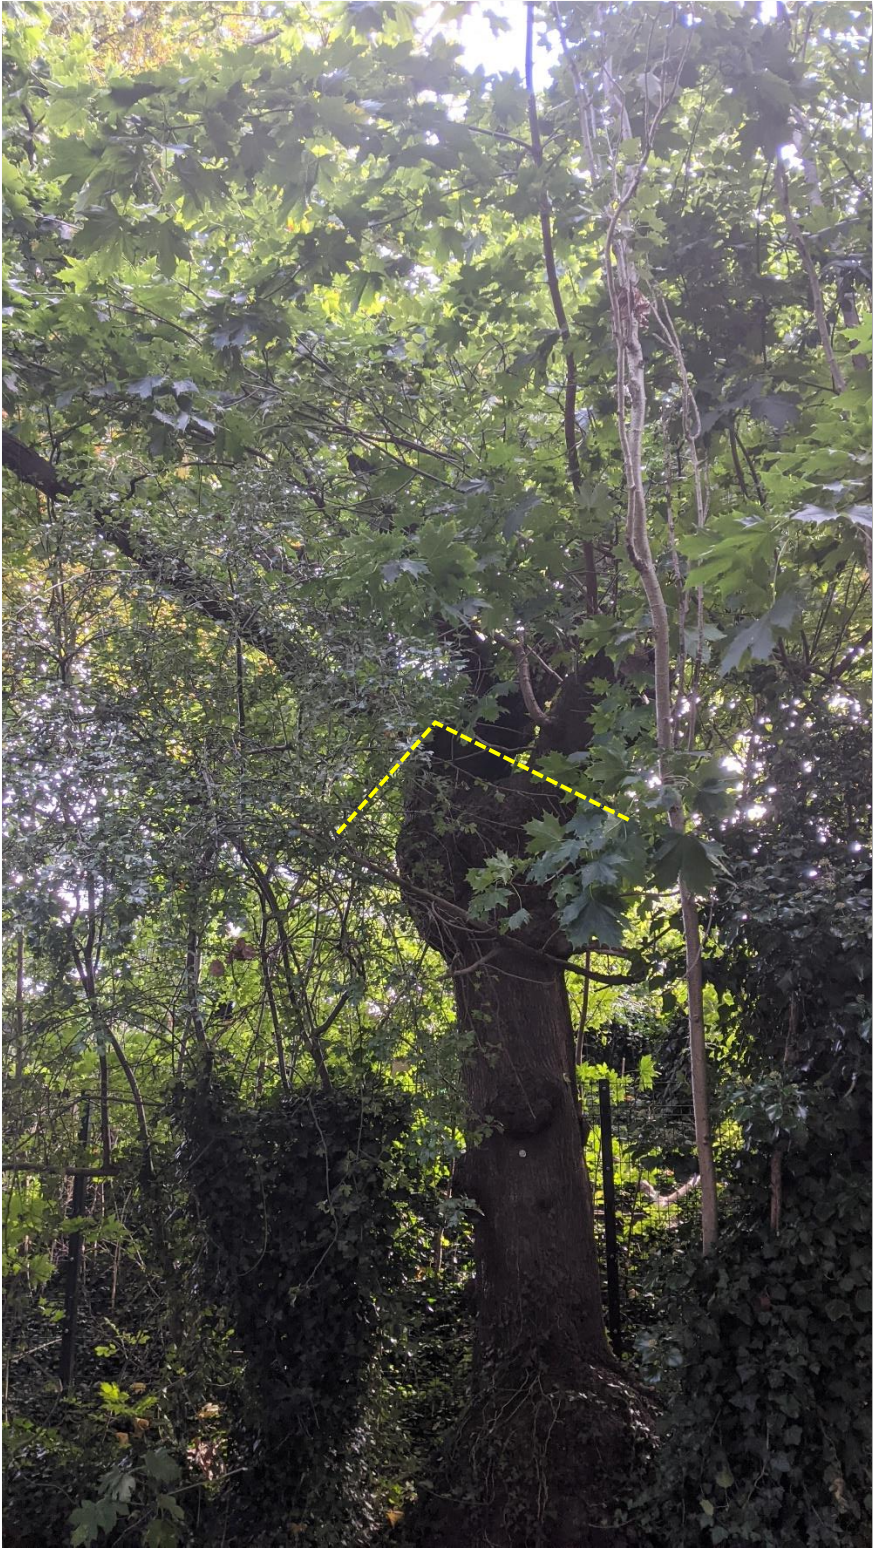
Tree number	T044 (Tag 0784)	Species	Norway Maple
Observations	Decay cavities present in main fork and crown diminished by decay and deadwood.		
Works Specification	Aerial inspection to check cavities for bat potential and to assess the structural integrity of the tree. <u>Reduce to truncated pollard framework approximately at main fork (shown in yellow), while retaining cavities where possible</u> (Final height to be determined by climber due dependent on structural condition of tree).		
Google link	https://goo.gl/maps/fz7y9pVF4mDFeucP6		
Image 1
