September 2024 - Reactive Tree Works Programme

Introduction

Dated 12/09/2024

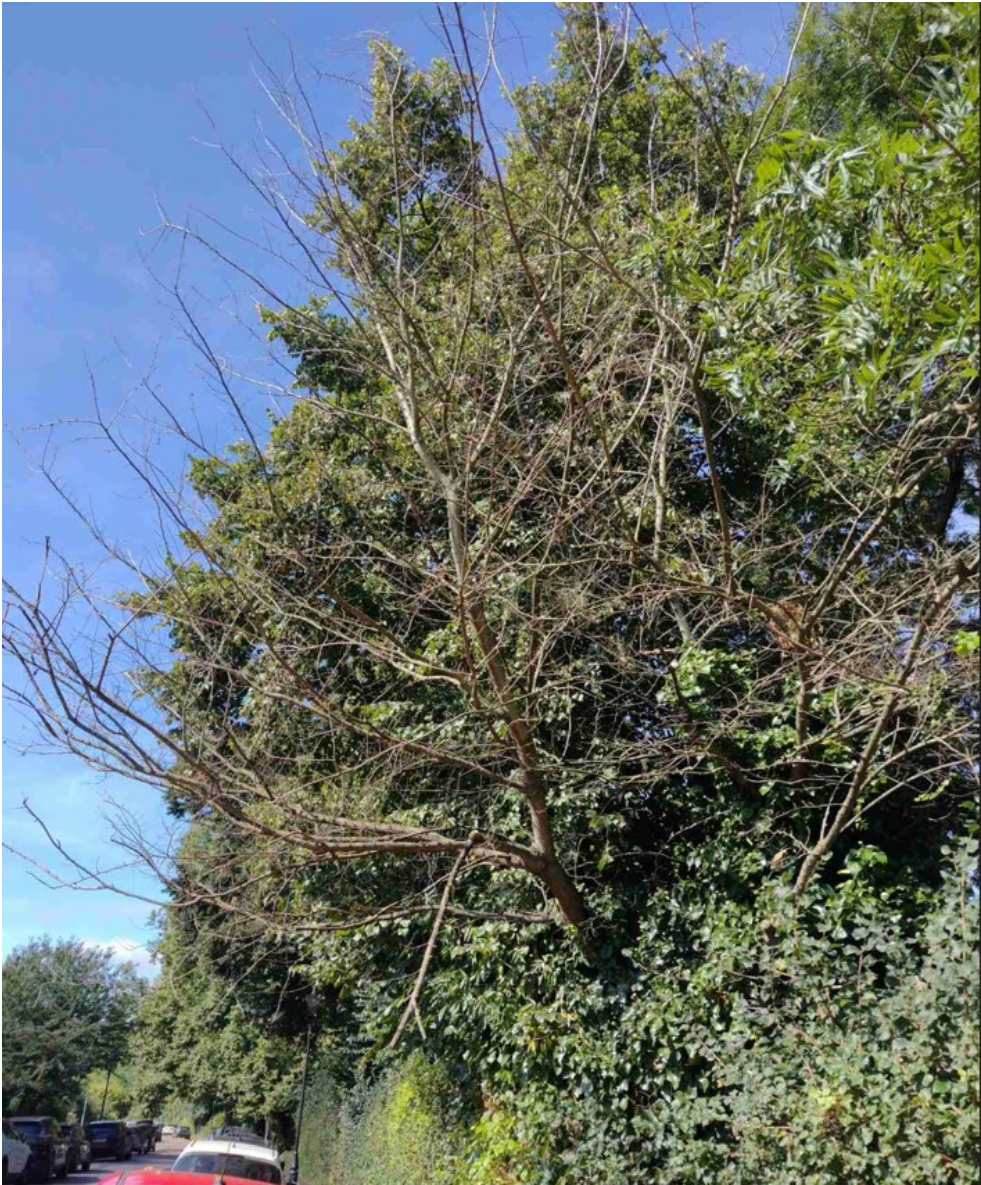
Ward	Barnes
Road	Church Road
Location	Opposite 3- ///views.pasta.truth
Species	Elm (<i>Ulmus sp.</i>)
Height	6.0m
Physiological Condition	Dead
Structural Condition	Dead
Inspection findings/reason for exemption	This tree is dead; removal is required to prevent natural failure and manage risk.

Image shows tree in street scene

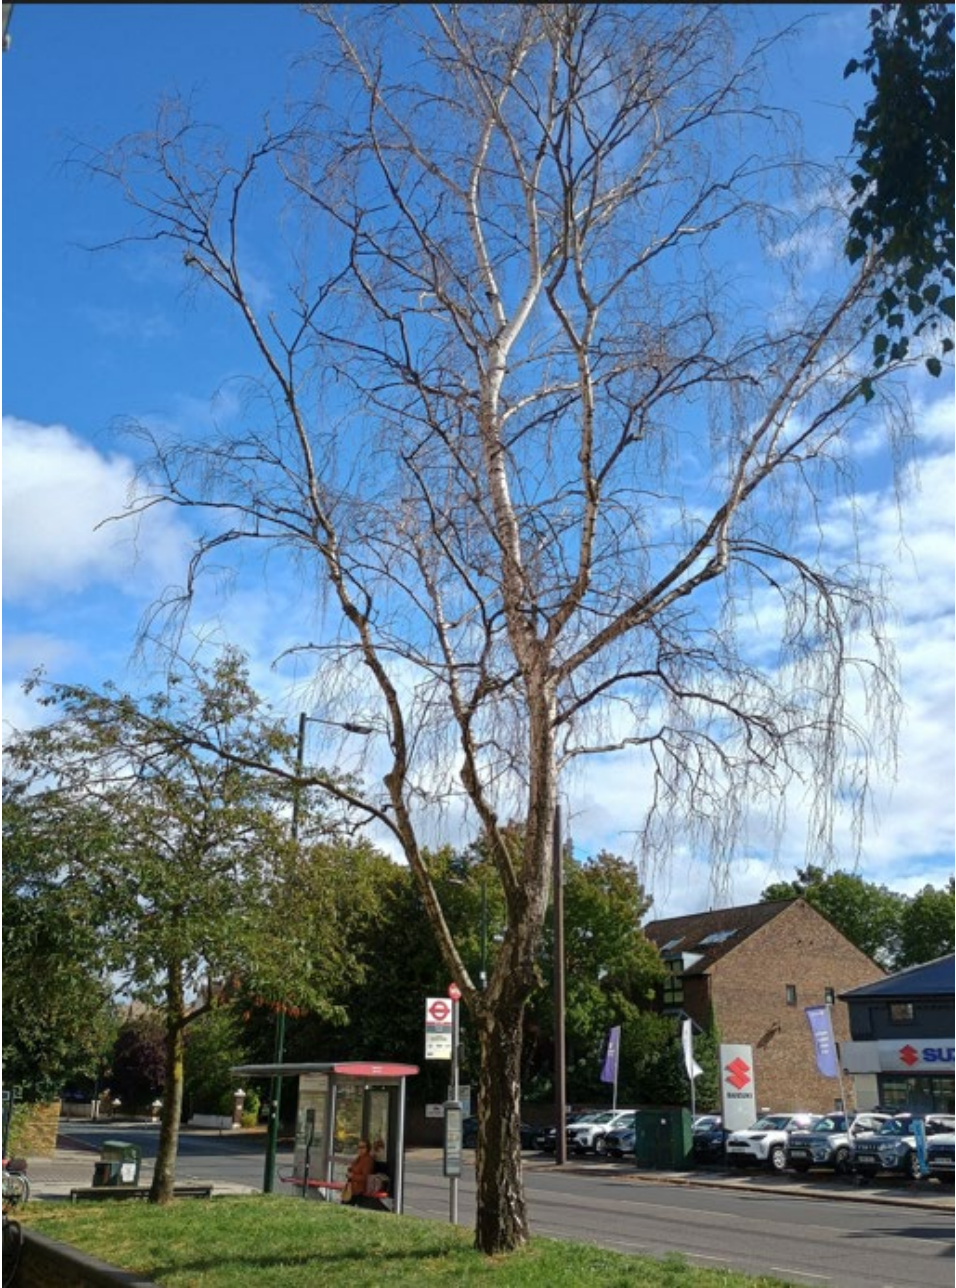
Ward	Barnes
Road	Castelnau
Location	Opposite 155
Species	Silver Birch (<i>Betula pendula</i>)
Height	15.0m
Physiological Condition	Dead
Structural Condition	Dead
Inspection findings/reason for exemption	This tree is dead; removal is required to prevent natural failure, manage risk, and facilitate replanting.

Image shows dead tree in street scene.

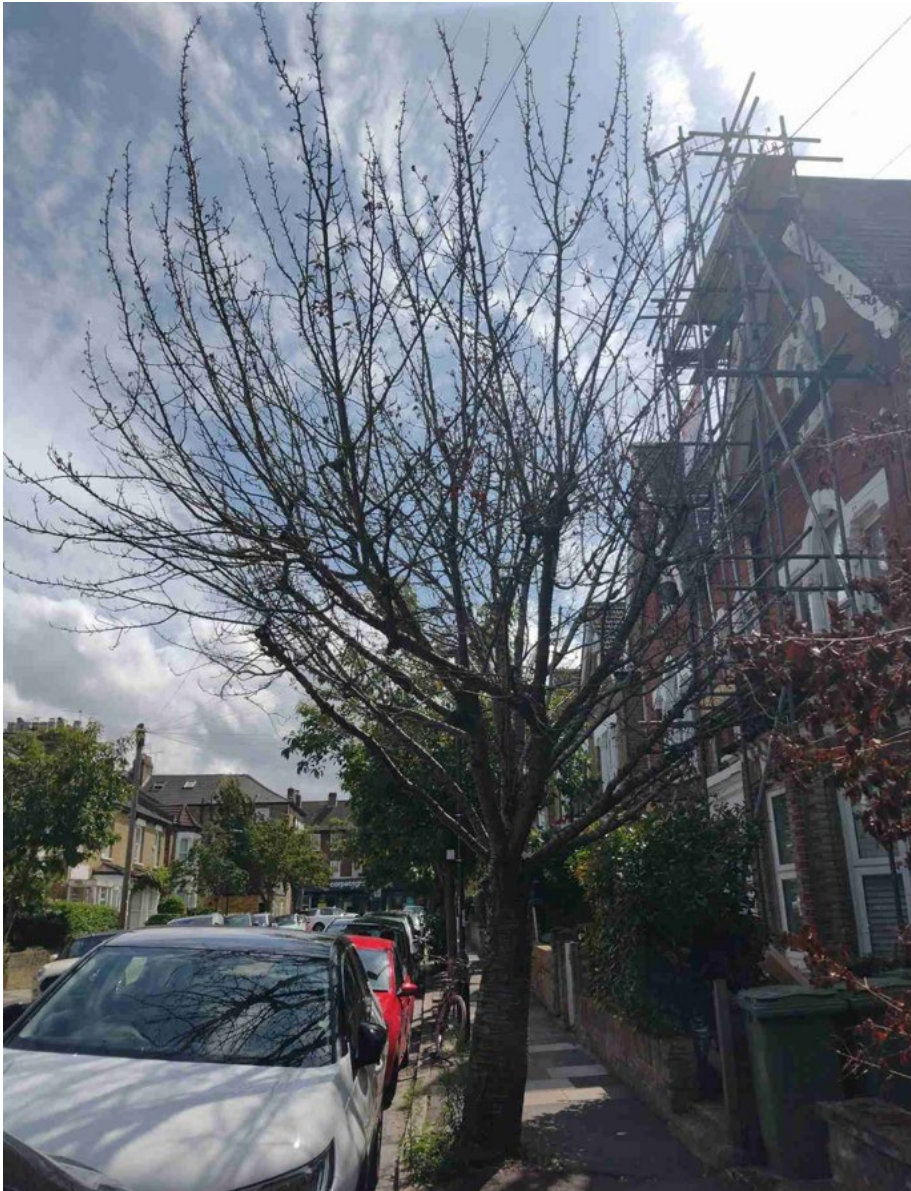
Ward	East Sheen
Road	Elm Road
Location	Outside 11/13
Species	Sweet Cherry (<i>Prunus avium</i>)
Height	8.0m
Physiological Condition	Dead
Structural Condition	Dead
Inspection findings/reason for exemption	This tree is dead; removal is required to prevent natural failure, manage risk, and facilitate replanting

Image shows dead tree in street scene.

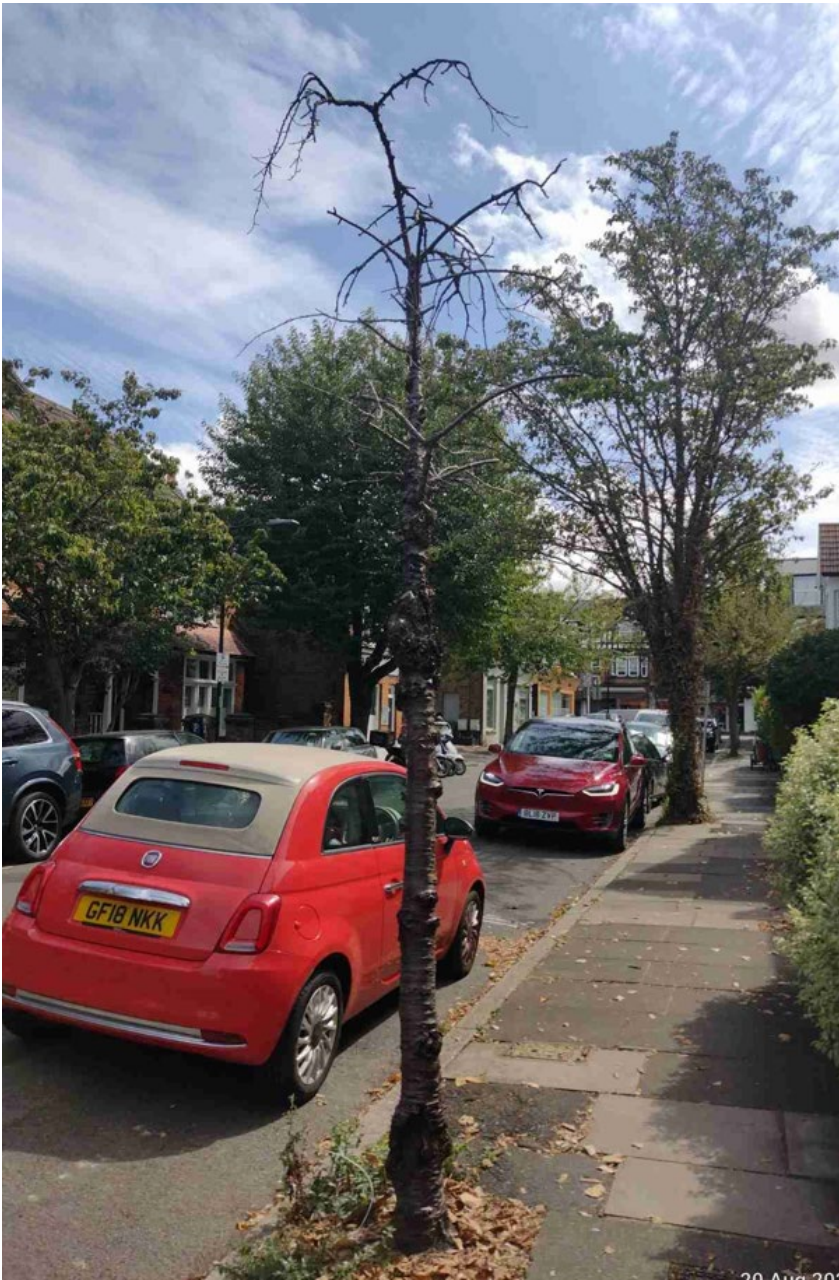
Ward	East Sheen
Road	Thornton Road
Location	Outside 11/13
Species	Japanese flowering cherry (<i>Prunus serrula</i>)
Height	5.0m
Physiological Condition	Dead
Structural Condition	Dead
Inspection findings/reason for exemption	This tree is dead; removal is required to prevent natural failure, manage risk, and facilitate replanting

Image shows dead tree in street scene.

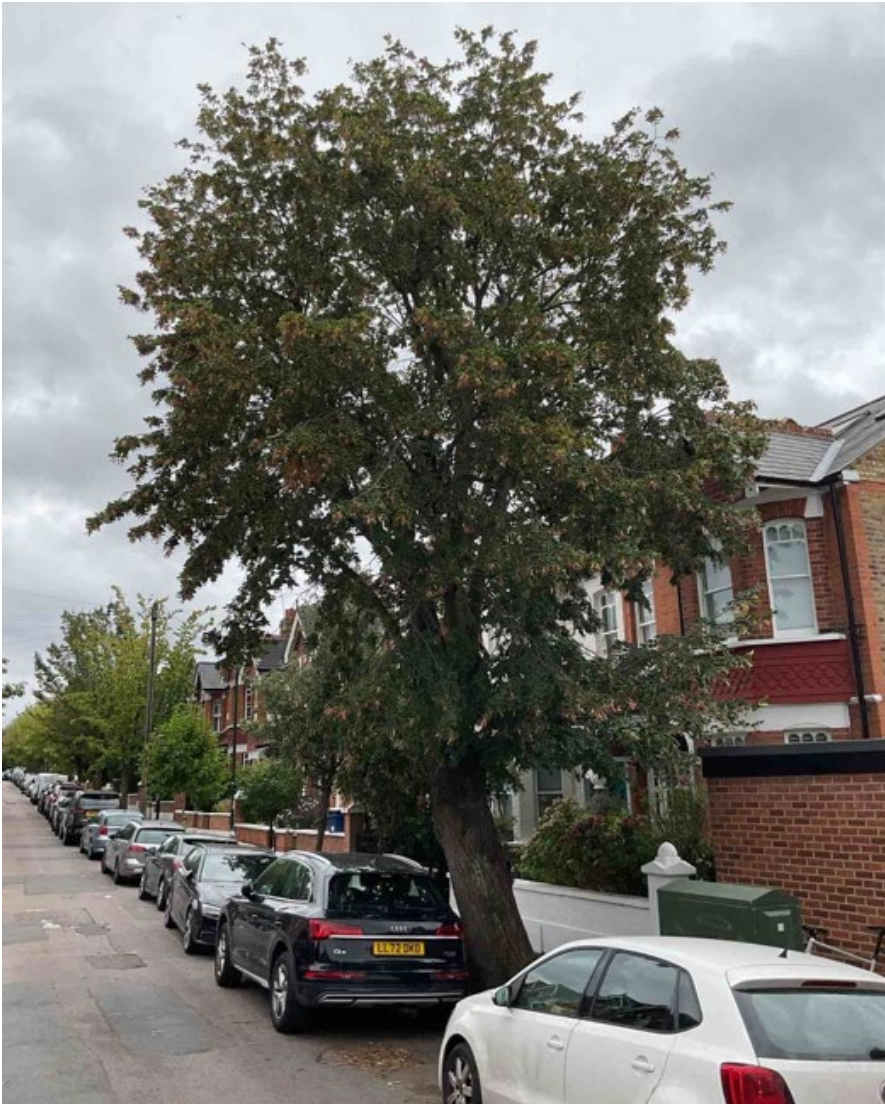
Ward	East Sheen
Road	Palmerston Road
Location	Outside 1
Species	Common Lime (<i>Tilia x europaea</i>)
Height	12.5m
Physiological Condition	Fair
Structural Condition	Poor
Inspection findings/reason for exemption	A fungal fruiting body of the decay pathogen <i>Ganoderma</i> sp. is present around the base of the stem and at 1.5 m from ground level. Colonisation by this fungus causes a white rot of the stem and root system that can cause entire trees to collapse through fracture or windthrow. Investigation with a probe revealed an unacceptable degree of decay. Removal is required to prevent natural failure, manage risk, and facilitate replanting.

Image shows tree in street scene.

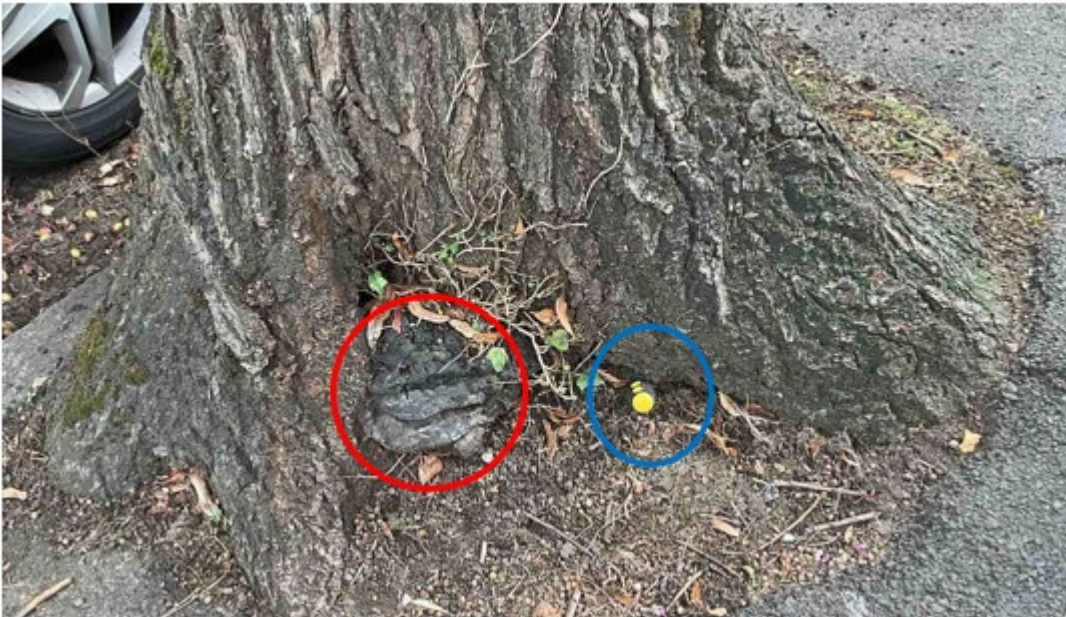
Image shows fungal fruiting body circled in red and probe showing decay circled in blue.

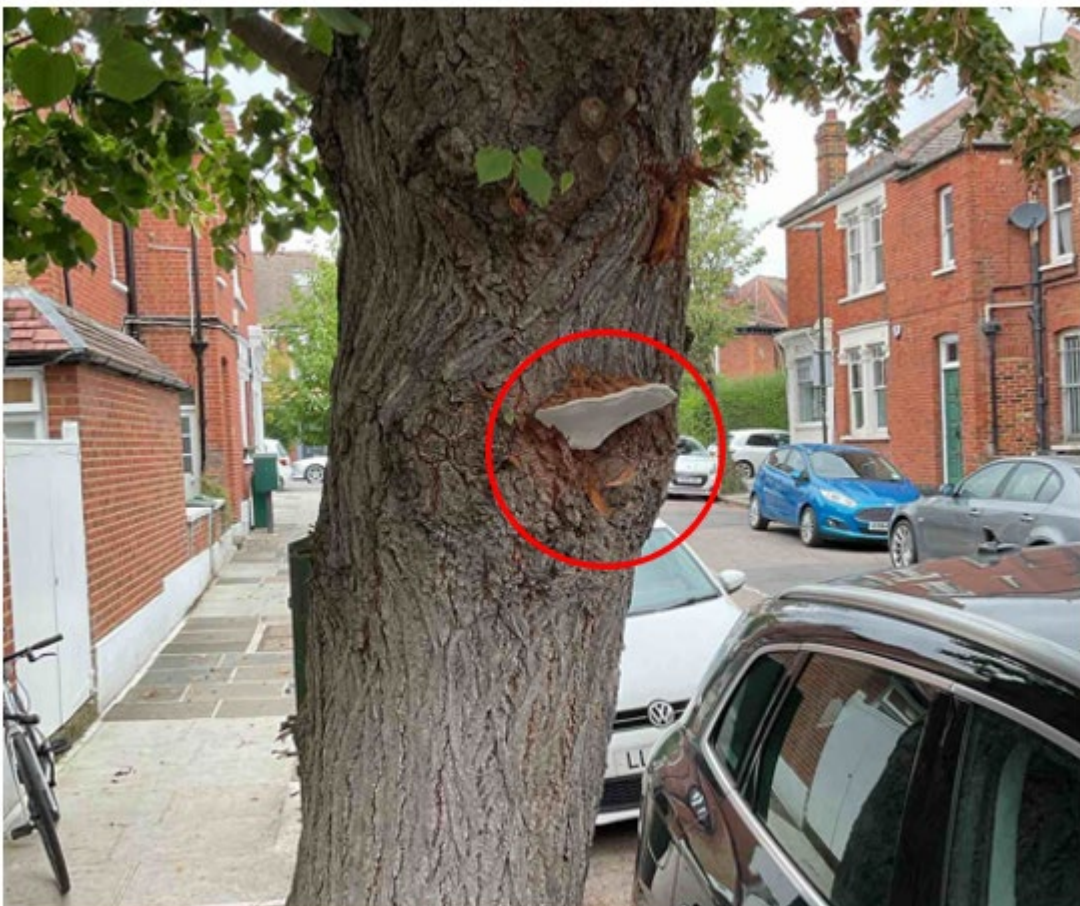
Image shows fungal fruiting body circled in red.

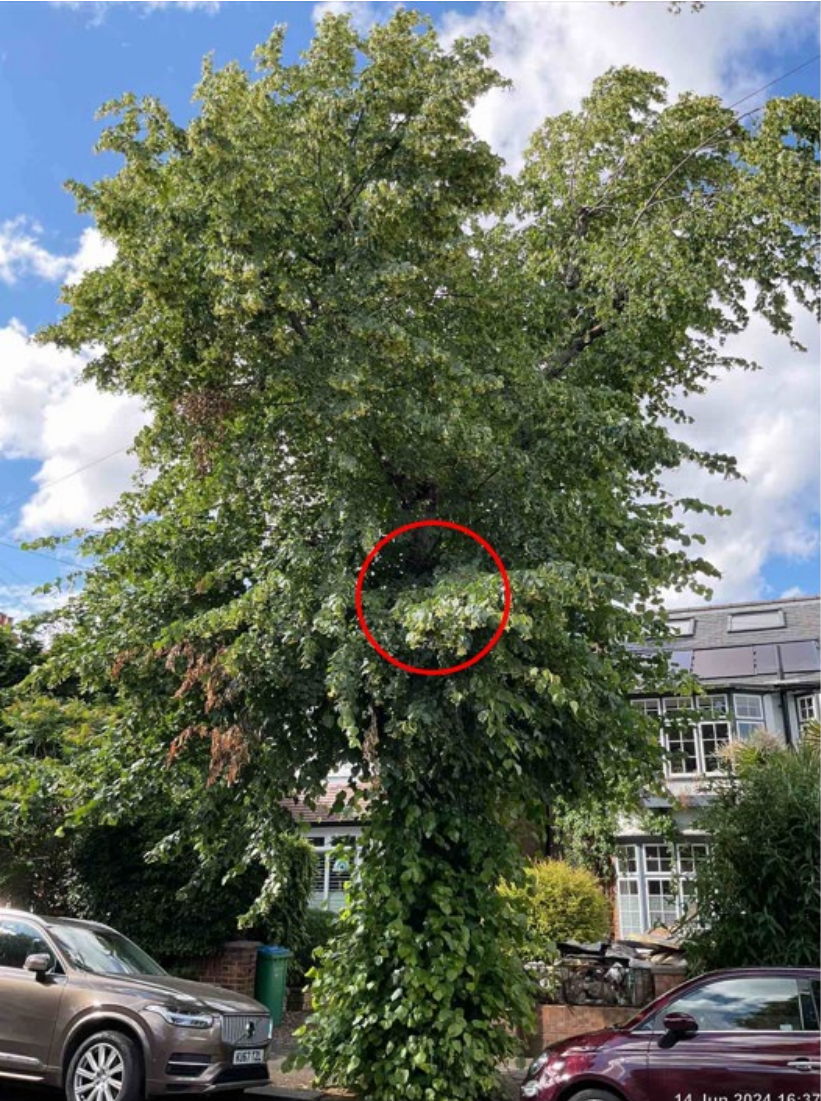
Ward	Fulwell and Hampton Hill
Road	Princes Road
Location	Outside 60
Species	Common Lime (<i>Tilia x europaea</i>)
Height	14.5m
Physiological Condition	Poor
Structural Condition	Poor
Inspection findings/reason for exemption	This tree has had a dead stem fail from the primary union on the trunk. On inspection it was revealed an unacceptable amount of decay in the union at the base of the remaining stems. Removal is required to prevent further natural failure, manage risk, and facilitate replanting

Image shows tree in street scene with location of failed union circled.

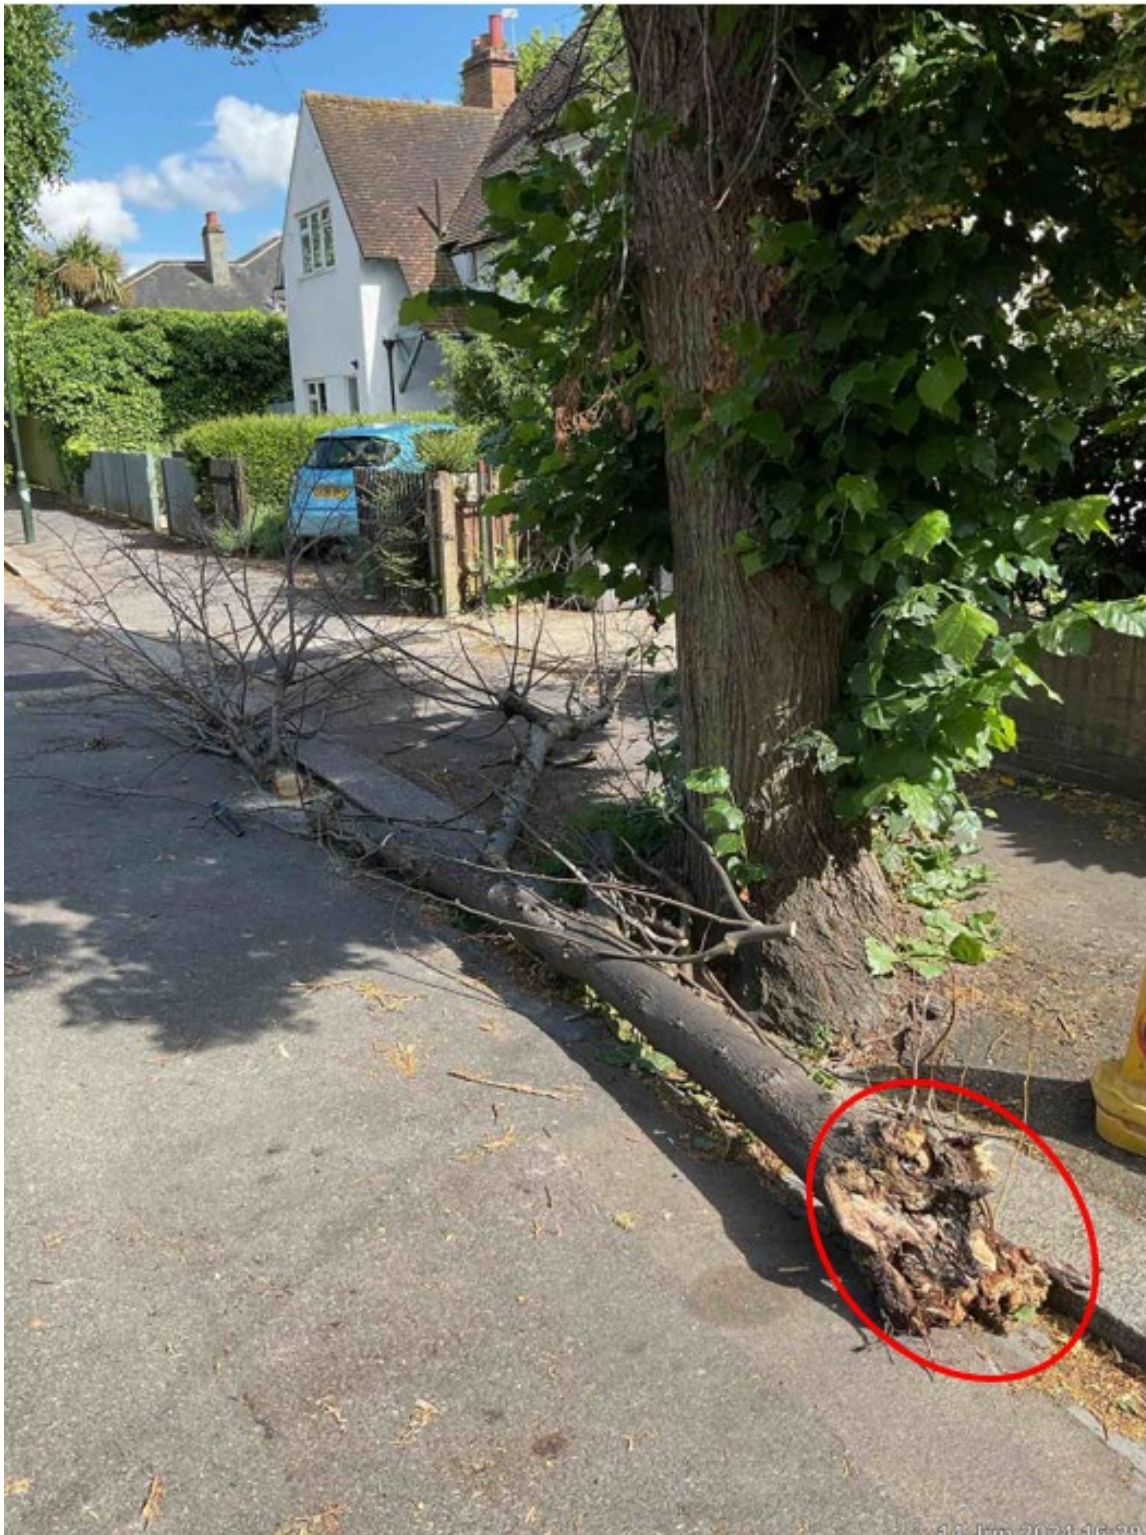
Image shows failed dead limb with decayed base circled.

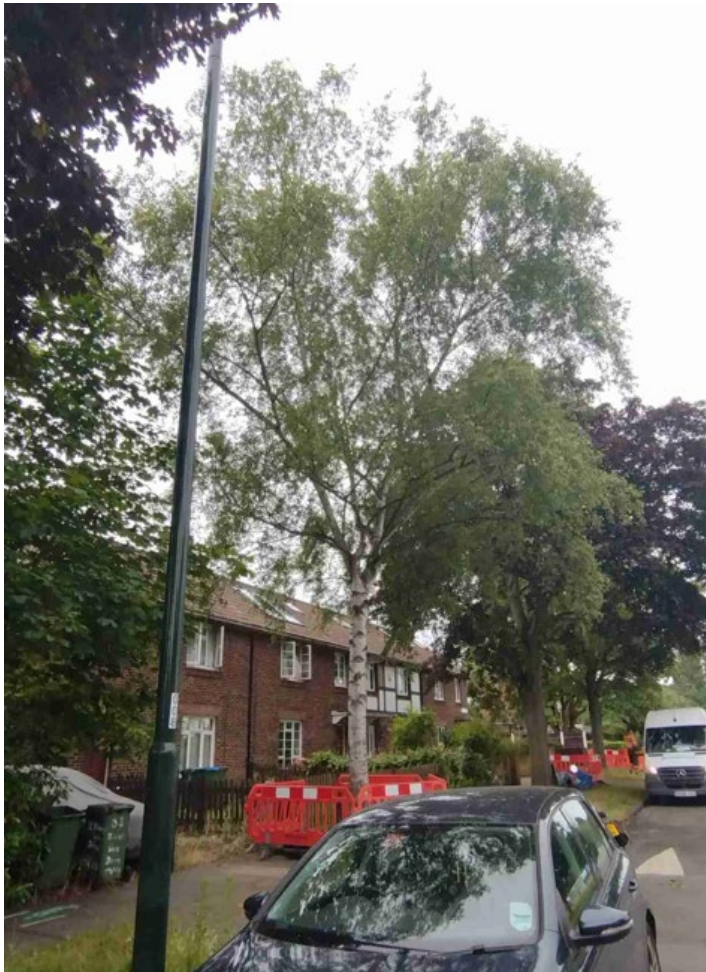
Ward	Ham, Petersham and Richmond Riverside
Road	Riverside Drive
Location	Outside 32
Species	Silver Birch (<i>Betula pendula</i>)
Height	14.5m
Physiological Condition	Fair
Structural Condition	Poor
Inspection findings/reason for exemption	This tree has had an unacceptable amount of damage to its root system caused by contractors ground excavations to gain access for maintenance to underground services. Removal is required to prevent natural failure and manage risk and facilitate replanting. The events at this site which have led to the proposed removal of this tree are the subject of a current investigation by the Council and this involves dialogue with the representatives of Cadent Gas.

Image shows tree in street scene

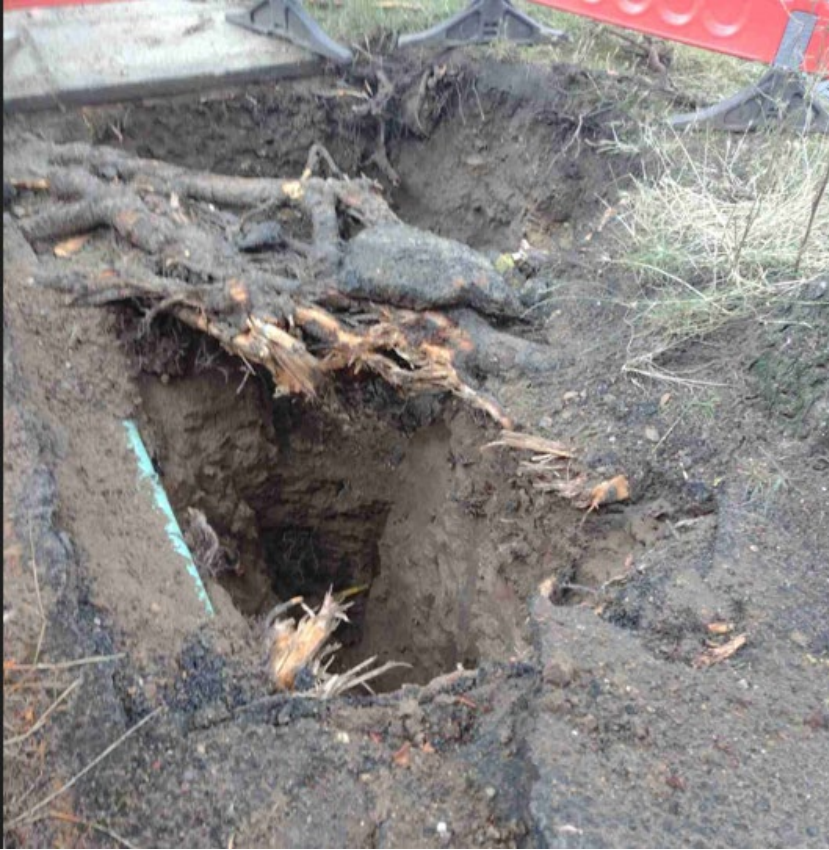
Image shows root damage caused by excavation for maintenance to underground services.

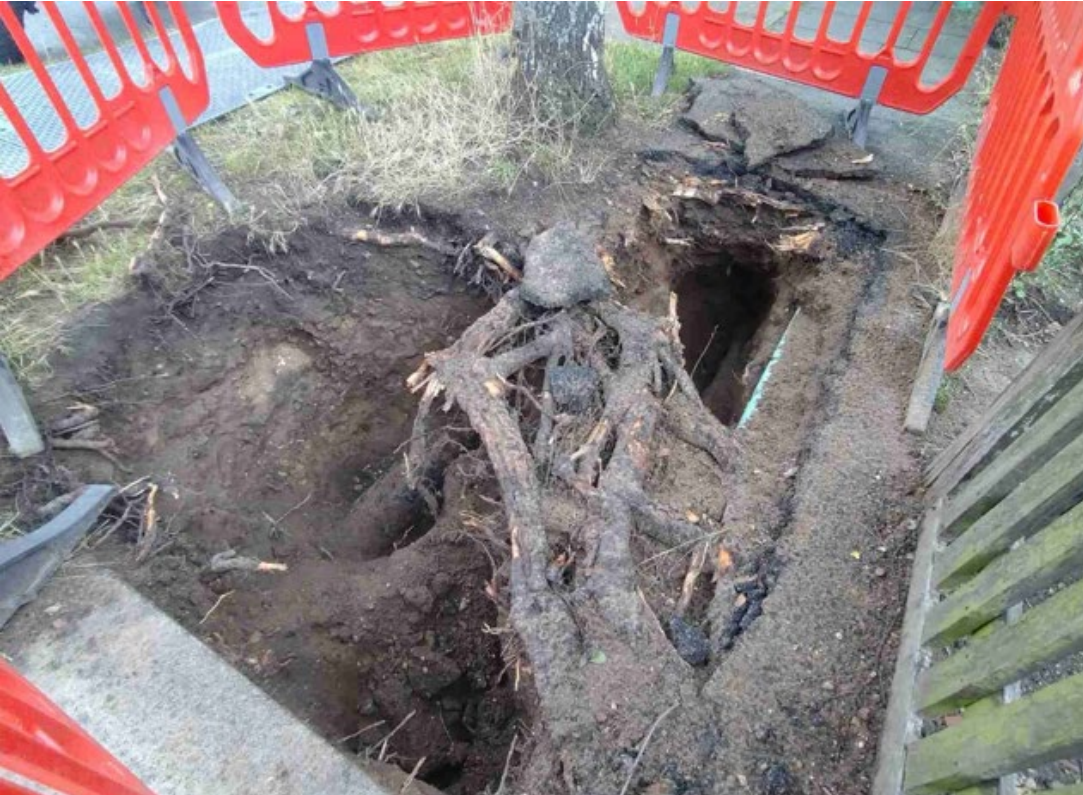
Image shows root damage caused by excavation for maintenance to underground services

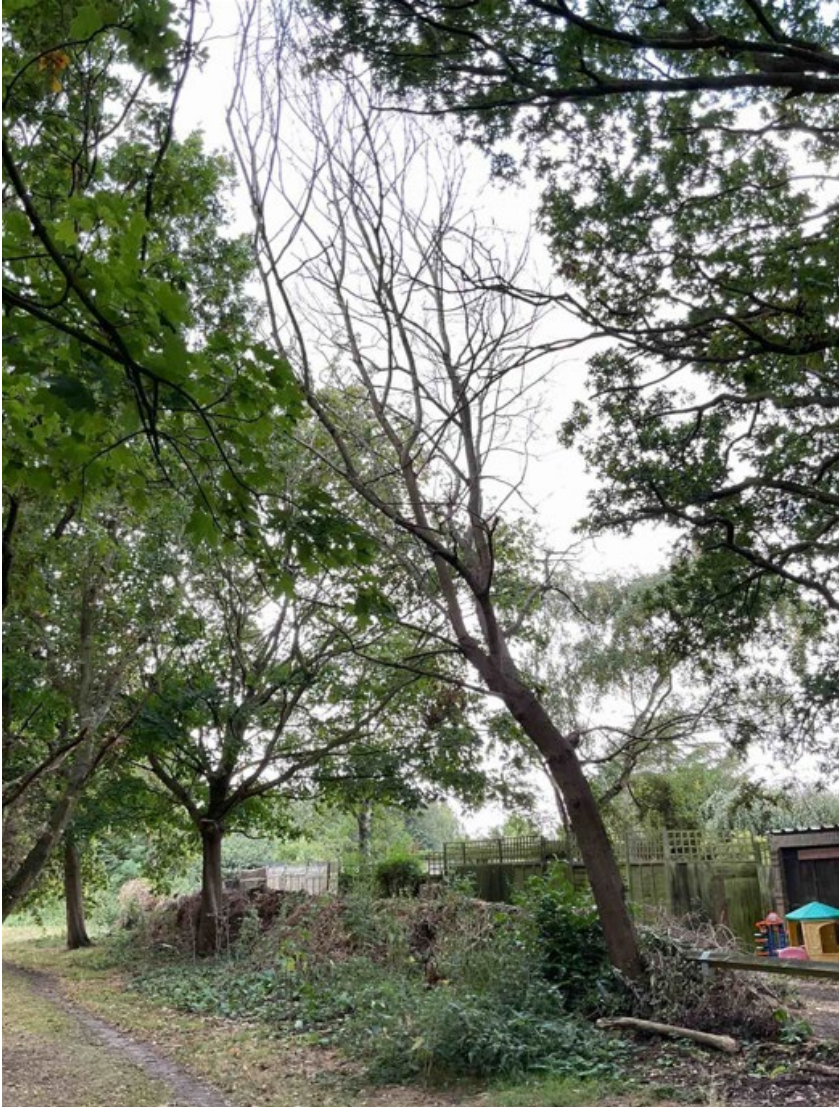
Ward	Hampton
Road	Buckingham Road
Location	Hampton Common- ///mime.taped.jazz
Species	Norway Maple (<i>Acer platanoides</i>)
Height	16.0m
Physiological Condition	Dead
Structural Condition	Dead
Inspection findings/reason for exemption	This tree is dead; removal is required to prevent natural failure, manage risk, and facilitate replanting

Images show Dead tree in park scene.

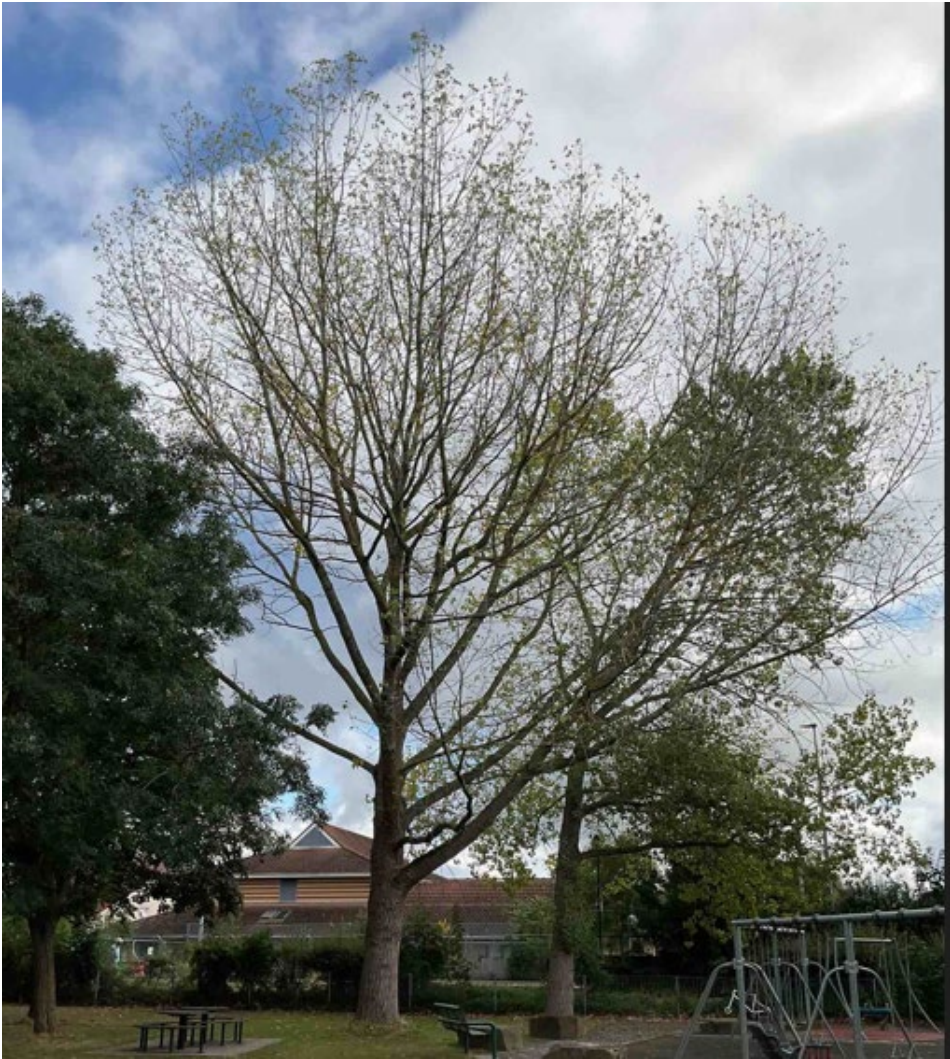
Ward	Hampton North
Road	The Avenue
Location	Nursery Green Play area- ///rested.remain.trim
Species	Black Poplar (<i>Populus nigra</i>)
Height	25.0m
Physiological Condition	Poor
Structural Condition	Poor
Inspection findings/reason for exemption	This tree has bark discolouration that could indicates the presence of pathogen <i>Phytophthora</i> sp. which causes rotting of the roots of hosts which can cause entire trees to fail. The tree is moribund with over 90% of the crown being dead. Removal is required to prevent natural failure, manage risk, and facilitate replanting

Image shows moribund tree in park scene.

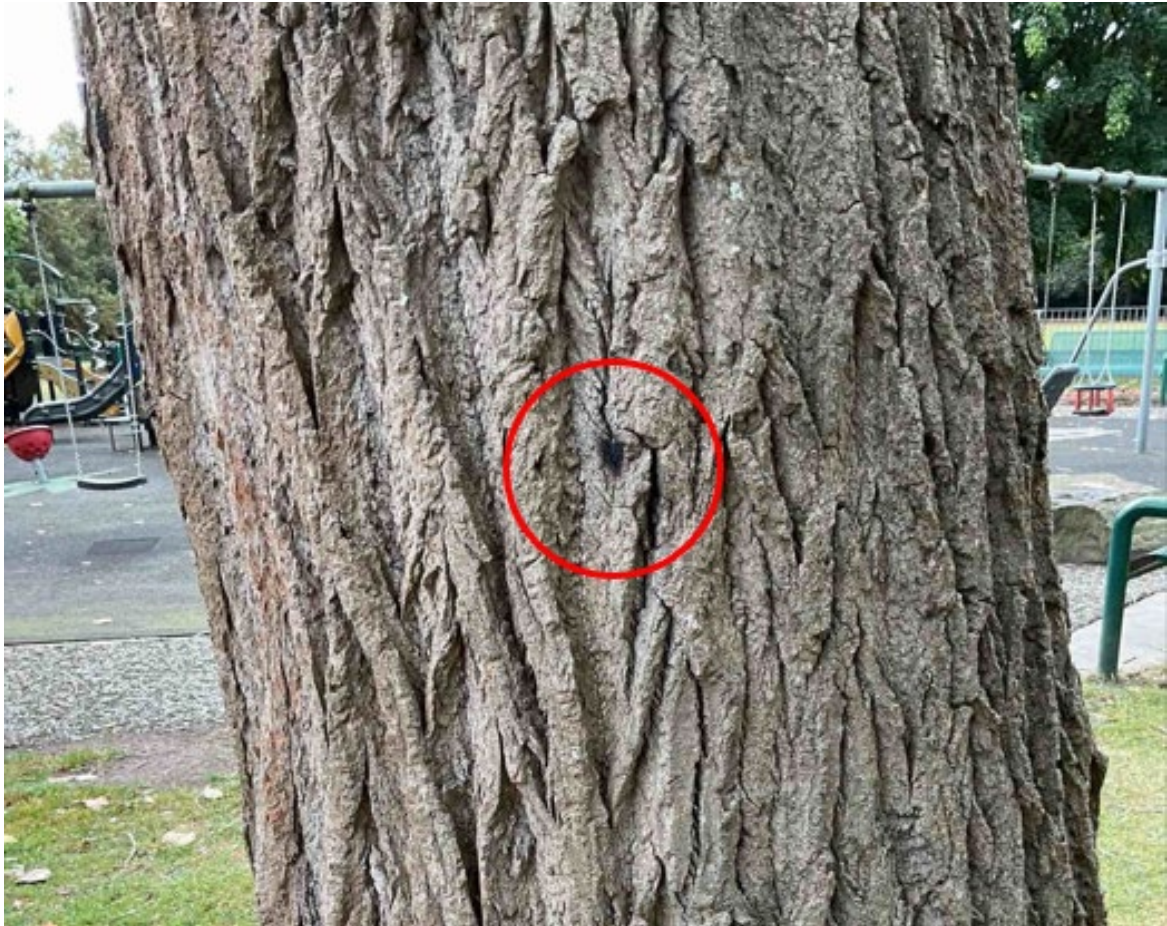
Image shows bark discolouration that could indicates the presence of Phytophthora sp. circled.

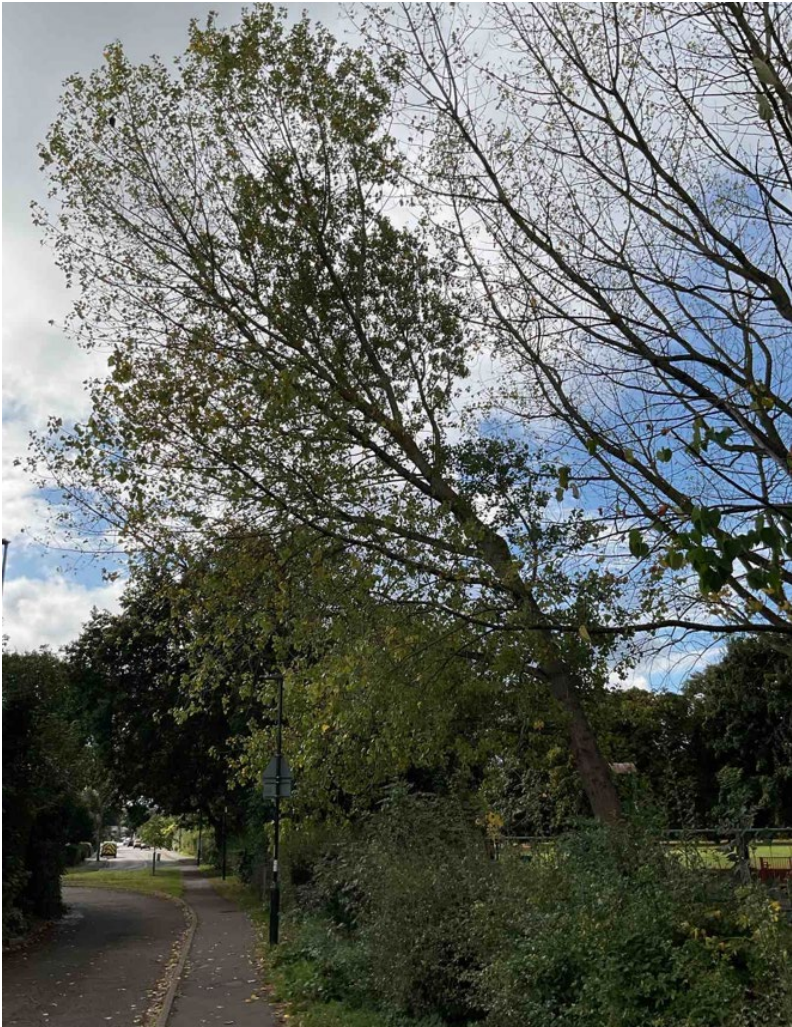
Ward	Hampton North
Road	The Avenue
Location	Nursery Green Play area- ///cakes.assume.door
Species	Black Poplar (<i>Populus nigra</i>)
Height	21.0m
Physiological Condition	Good
Structural Condition	Poor
Inspection findings/reason for exemption	This tree has a progressive lean from when it was last inspected through the ward survey in 2021. There is also an increase in root heave at the base of the tree. With the removal of the neighbouring tree which is in terminal decline this will also increase the wind exposure of the tree which will add increased wind stresses to the stem. Removal is required to prevent natural failure, manage risk, and facilitate replanting.

Image shows leaning tree in park scene.

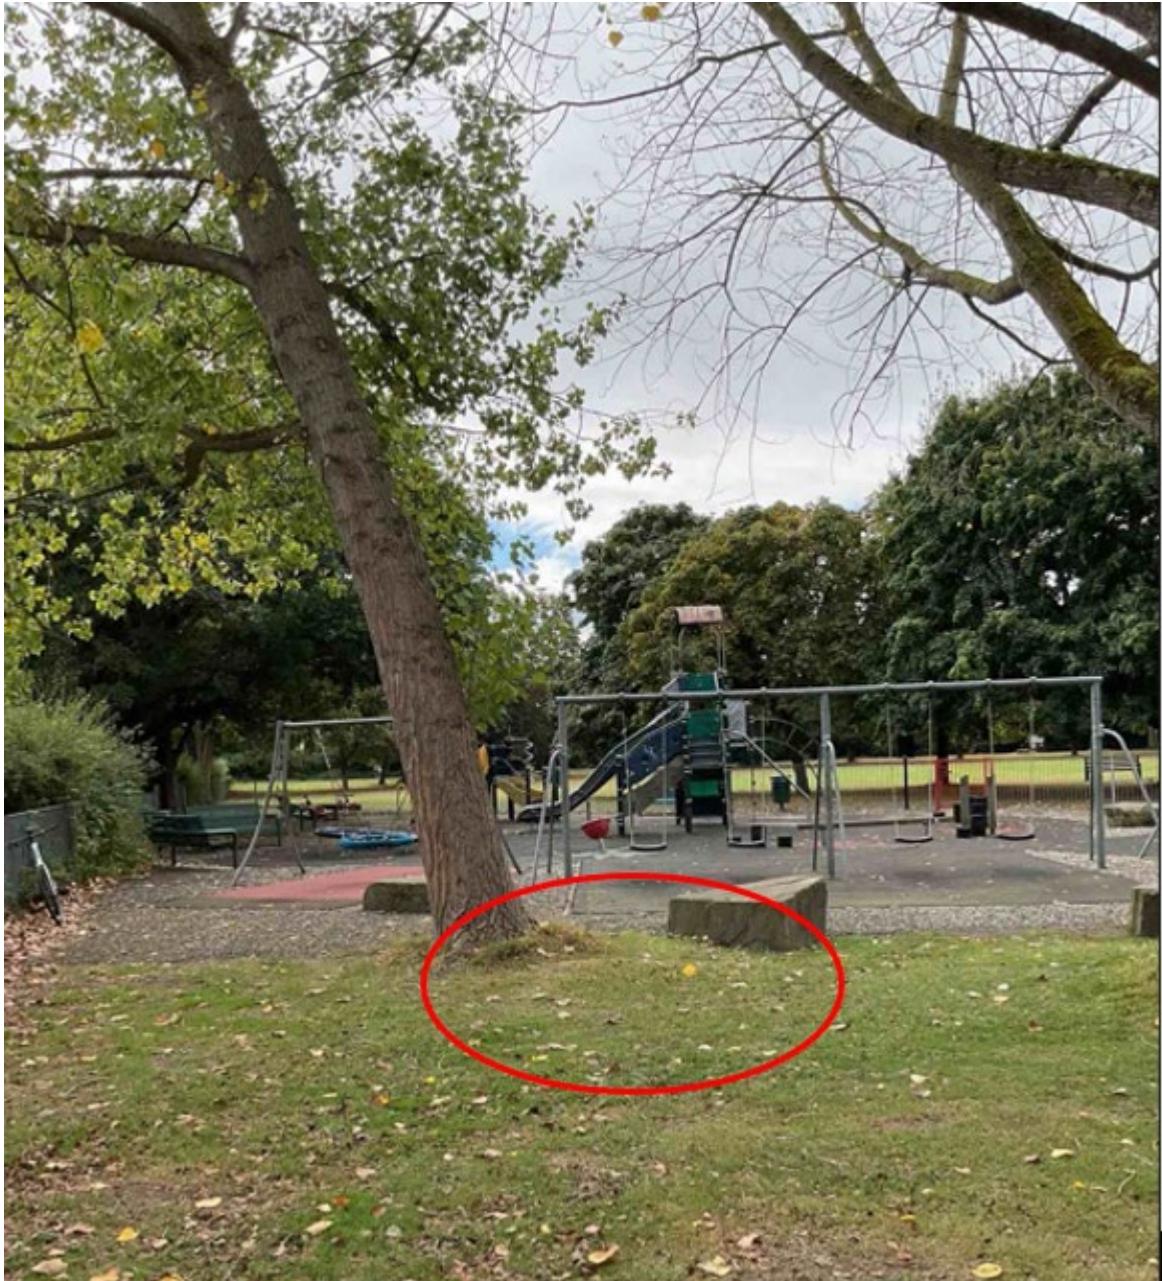
Image shows leaning stem and root heave circled in red.

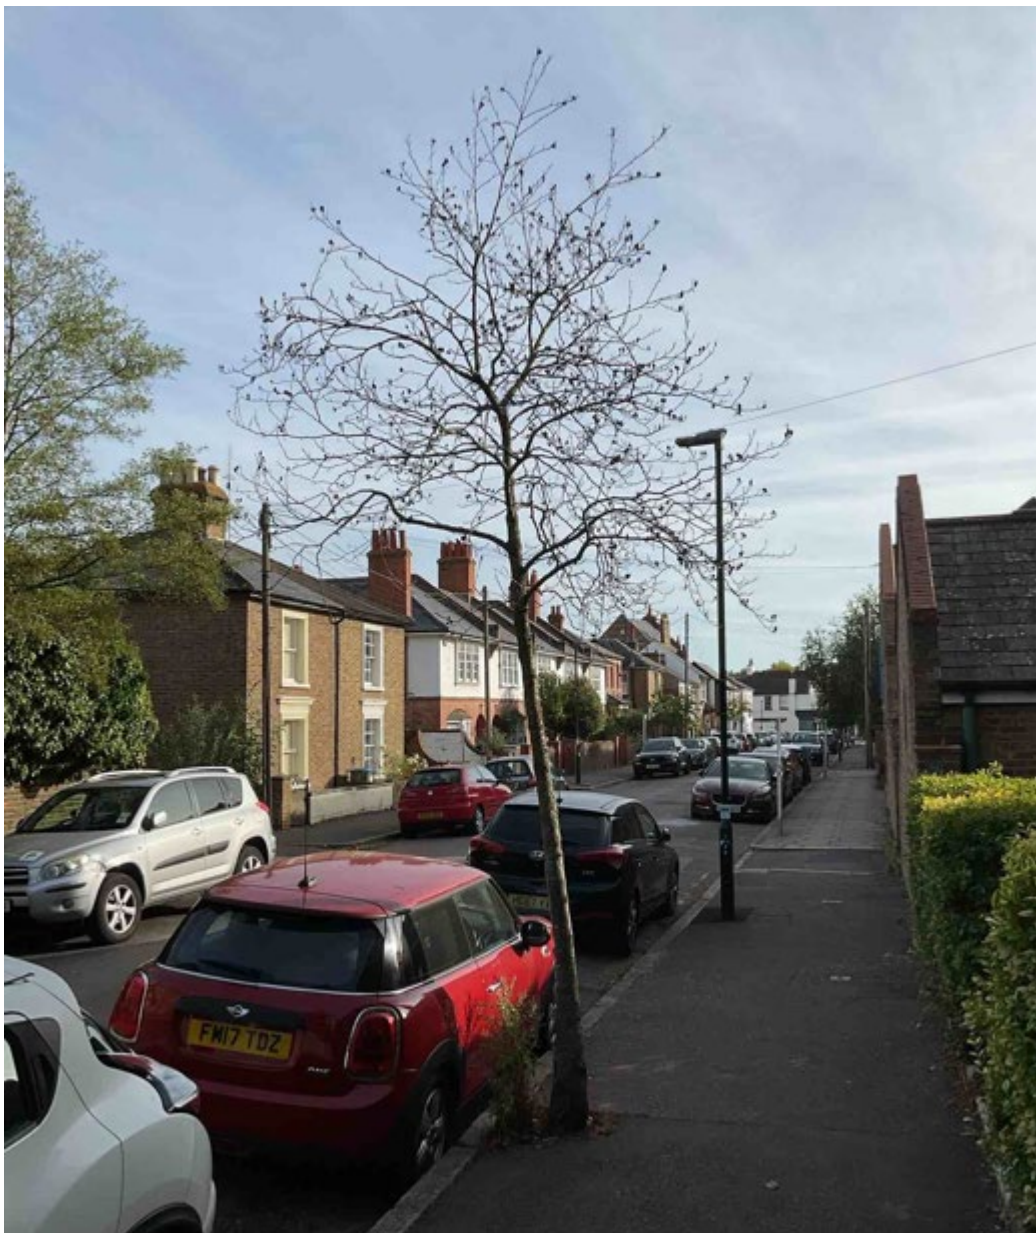
Ward	Hampton Wick and South Teddington
Road	St Johns Road
Location	Opposite 6 Church Grove rear end of back garden
Species	Italian Alder (<i>Alnus cordata</i>)
Height	6.0m
Physiological Condition	Dead
Structural Condition	Dead
Inspection findings/reason for exemption	This tree is dead; removal is required to prevent natural failure, manage risk, and facilitate replanting

Image shows dead tree in street scene.

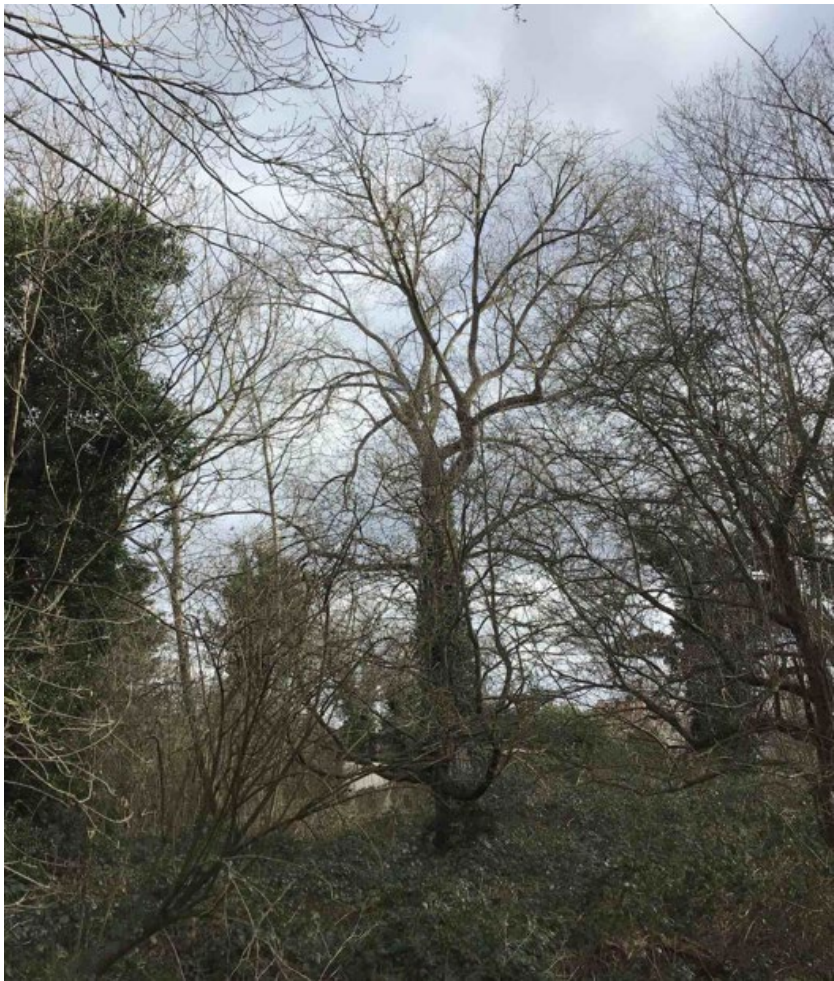
Ward	Heathfield
Road	Hospital Bridge Road
Location	Crane Park- ///shovels.dated.discouraged
Species	Black Poplar (<i>Populus nigra</i>)
Height	31.0m
Physiological Condition	Poor
Structural Condition	Poor
Inspection findings/reason for exemption	A fruiting body of the decay fungus <i>Rigidoporus</i> is present at the base of this tree. This fungus causes a brown rot that does not stimulate the tree to produce adaptive growth which can cause entire trees to collapse through fracture or windthrow. A detailed investigation of this tree using sonic tomography revealed an unacceptable degree of decay. Removal is required to prevent natural failure and manage risk. The stump will be left as a 2m high monolith for ecology purposes.

Images shows tree in park scene.

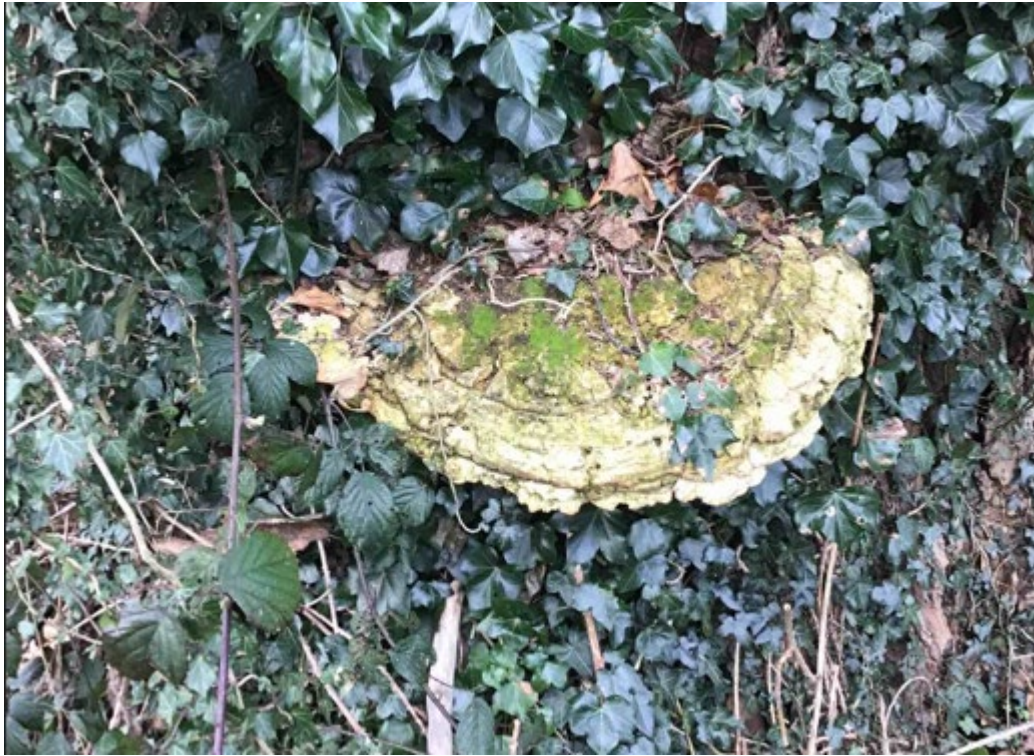
Images shows fungus *Rigidoporus* fruiting body at base of tree.

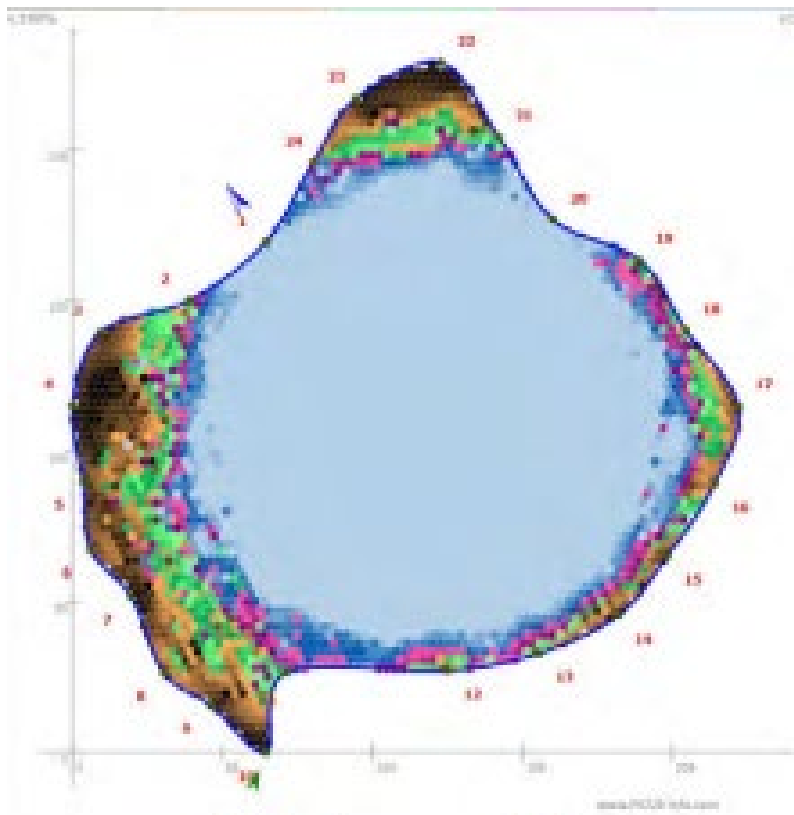
Image shows results from decay detection investigation at the base of the tree – green, blue and purple indicate decayed wood
