September 2024 - Reactive Tree Works Programme

Introduction

Dated 12/09/2024

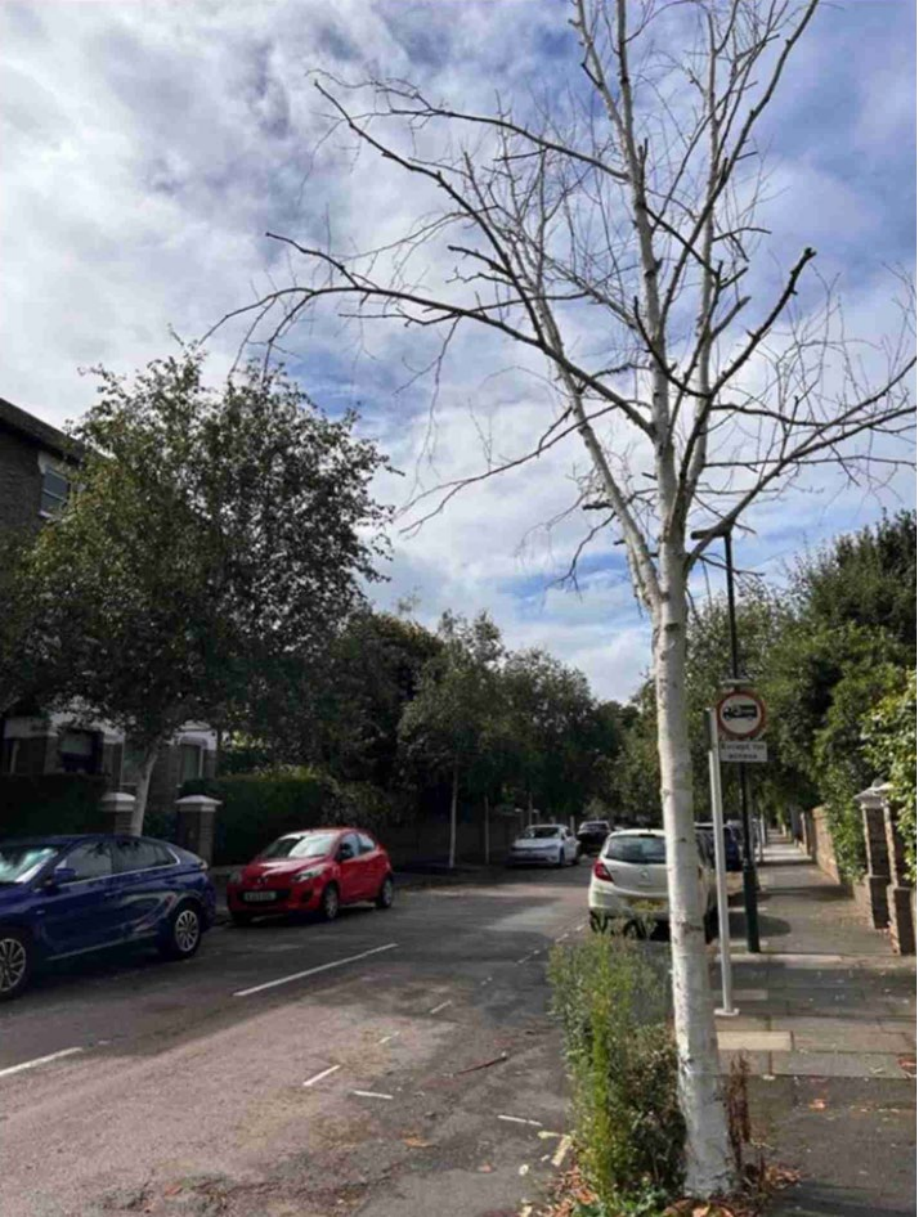
Ward	Kew
Road	Princes Road
Location	Adjacent to Flats 1-10 Lawman Court front edge of building
Species	Birch (<i>Betula sp.</i>)
Height	9.0m
Physiological Condition	Dead
Structural Condition	Dead
Inspection findings/reason for exemption	This tree is dead; removal is required to prevent natural failure, manage risk, and facilitate replanting

Image shows dead tree in street scene.

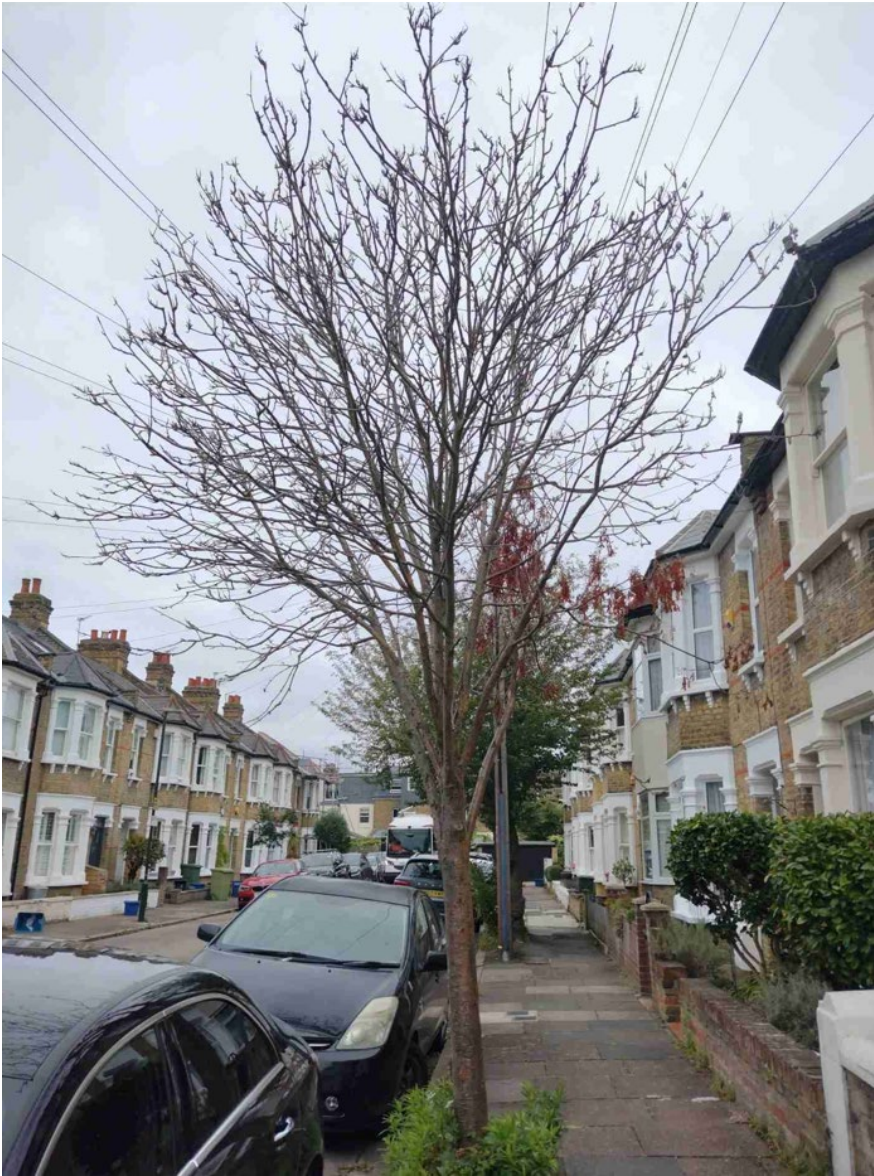
Ward	Mortlake and Barnes Common
Road	Buxton Road
Location	Outside 15/17
Species	Rowan (<i>Sorbus aucuparia</i>)
Height	6.0m
Physiological Condition	Dead
Structural Condition	Dead
Inspection findings/reason for exemption	This tree is dead; removal is required to prevent natural failure, manage risk, and facilitate replanting

Image shows dead tree in street scene.

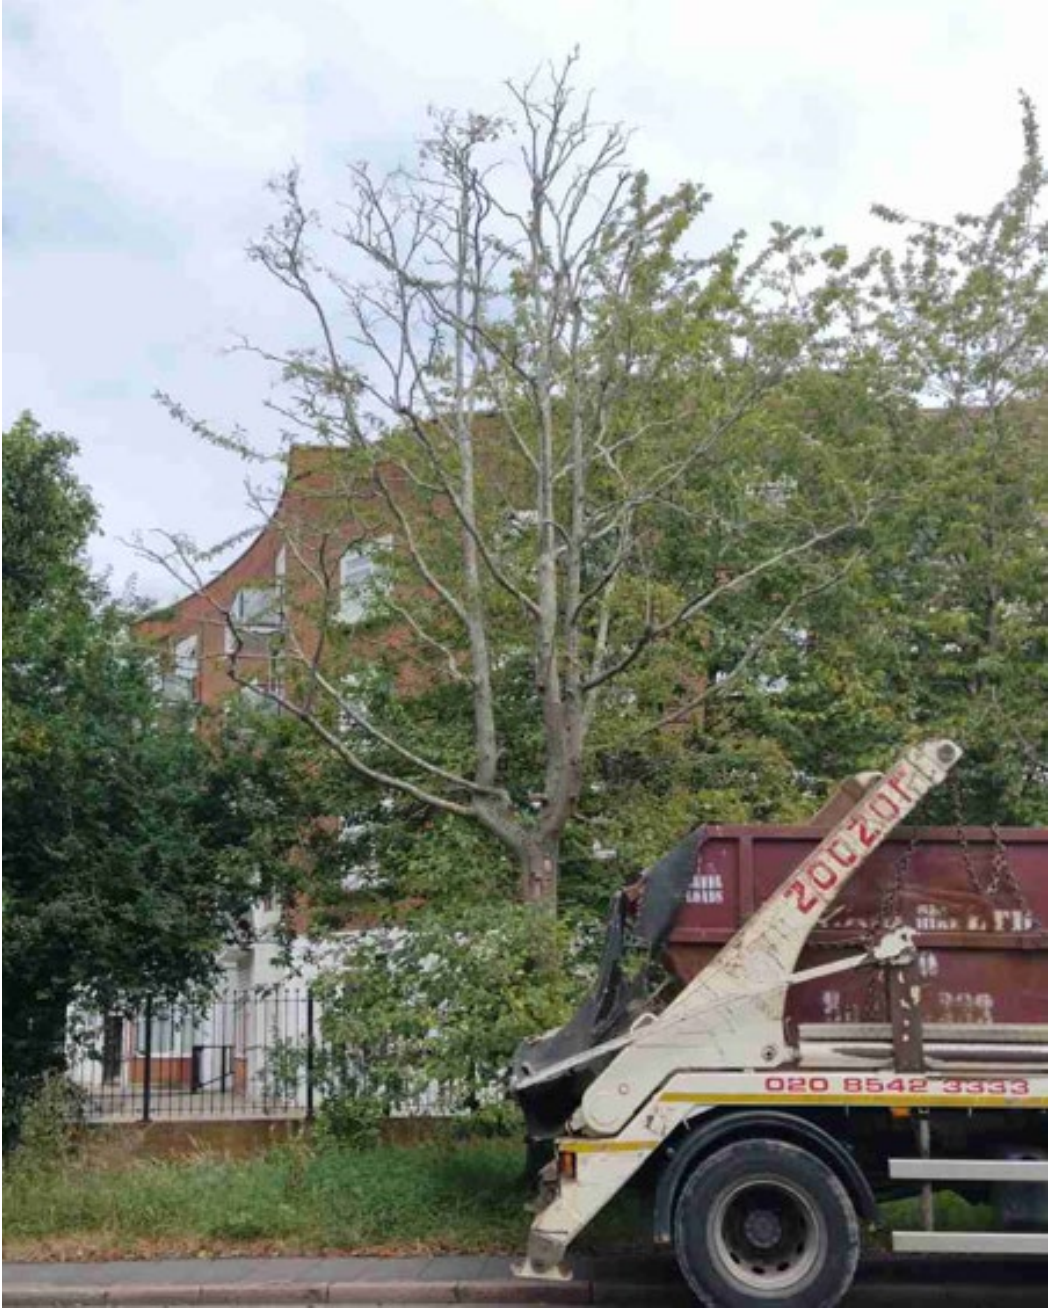
Ward	Mortlake and Barnes Common
Road	Lower Richmond Road
Location	Opposite 123- ///pram.dark.charge
Species	Common Alder (<i>Alnus glutinosa</i>)
Height	12.0m
Physiological Condition	Dead
Structural Condition	Dead
Inspection findings/reason for exemption	This tree is dead; removal is required to prevent natural failure, manage risk, and facilitate replanting

Image shows dead tree in street scene.

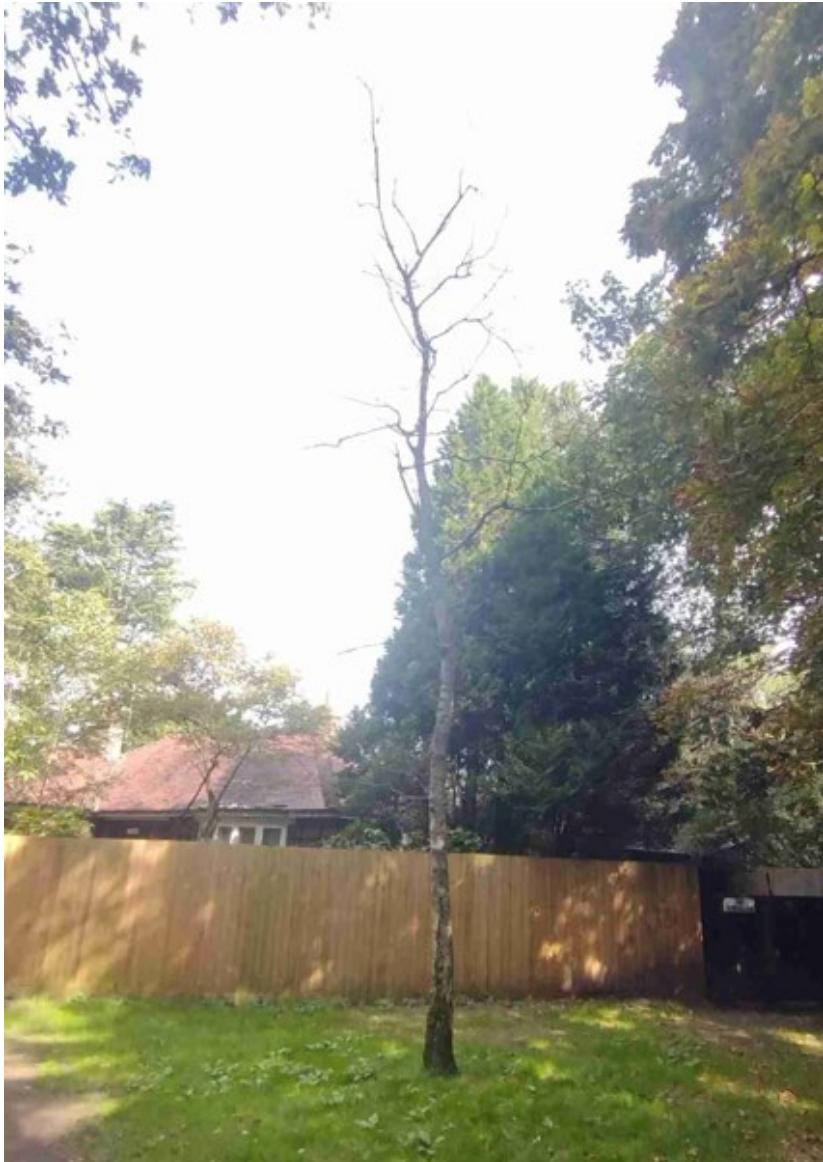
Ward	South Richmond
Road	Sheen Common Drive
Location	East sheen common - ///door.native.thank Outside 'The bungalow'
Species	Silver Birch (<i>Betula pendula</i>)
Height	14.0m
Physiological Condition	Dead
Structural Condition	Dead
Inspection findings/reason for exemption	This tree is dead; removal is required to prevent natural failure, manage risk, and facilitate replanting

Image shows dead tree in park scene.

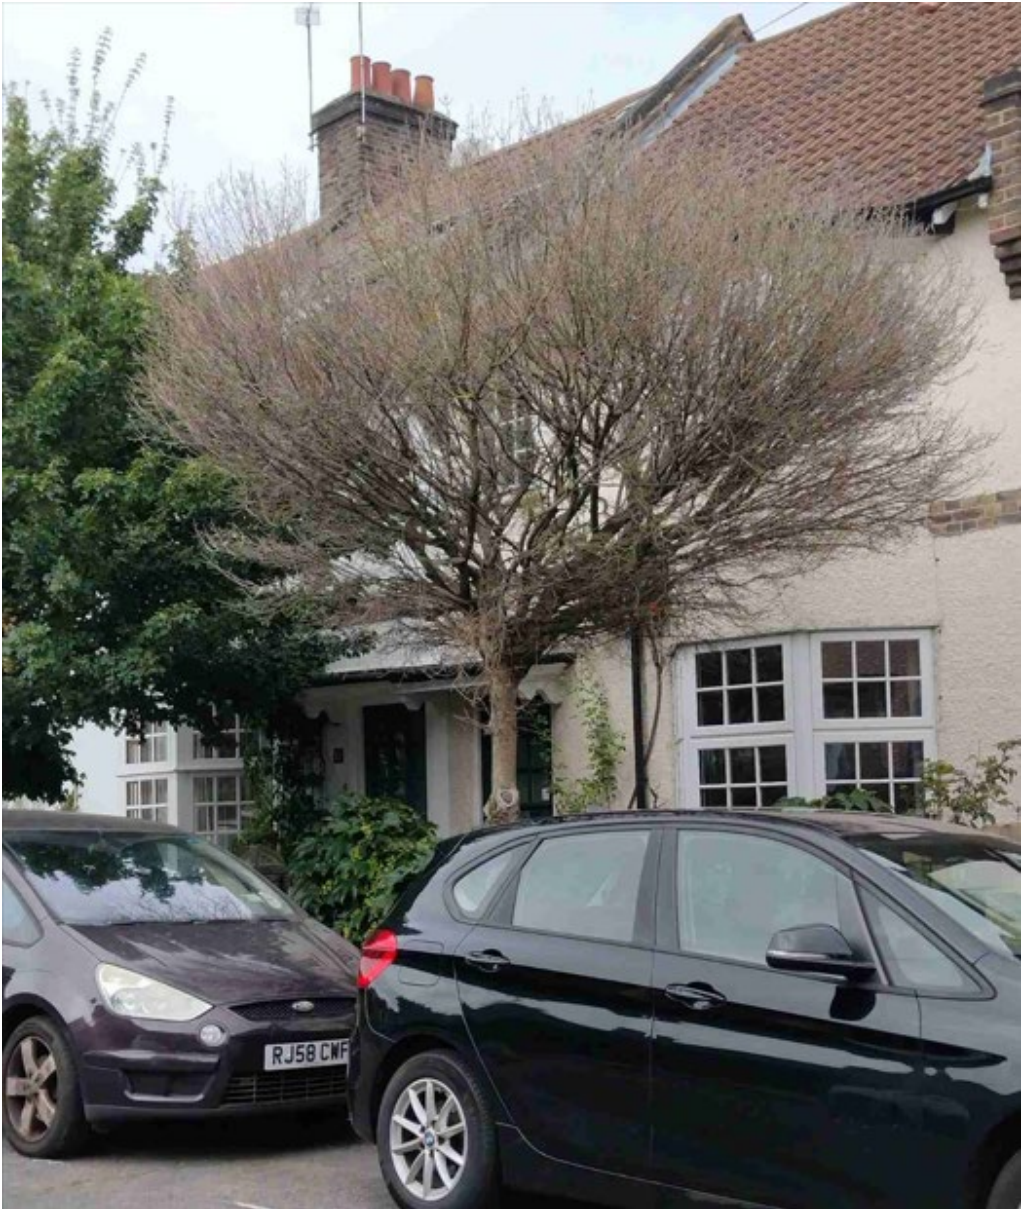
Ward	St Margarets and North Twickenham
Road	Hartington Road
Location	Outside 49
Species	Field Maple (<i>Acer campestre</i>)
Height	5.0m
Physiological Condition	Dead
Structural Condition	Dead
Inspection findings/reason for exemption	This tree is dead; removal is required to prevent natural failure, manage risk and facilitate replanting

Image shows dead tree in street scene

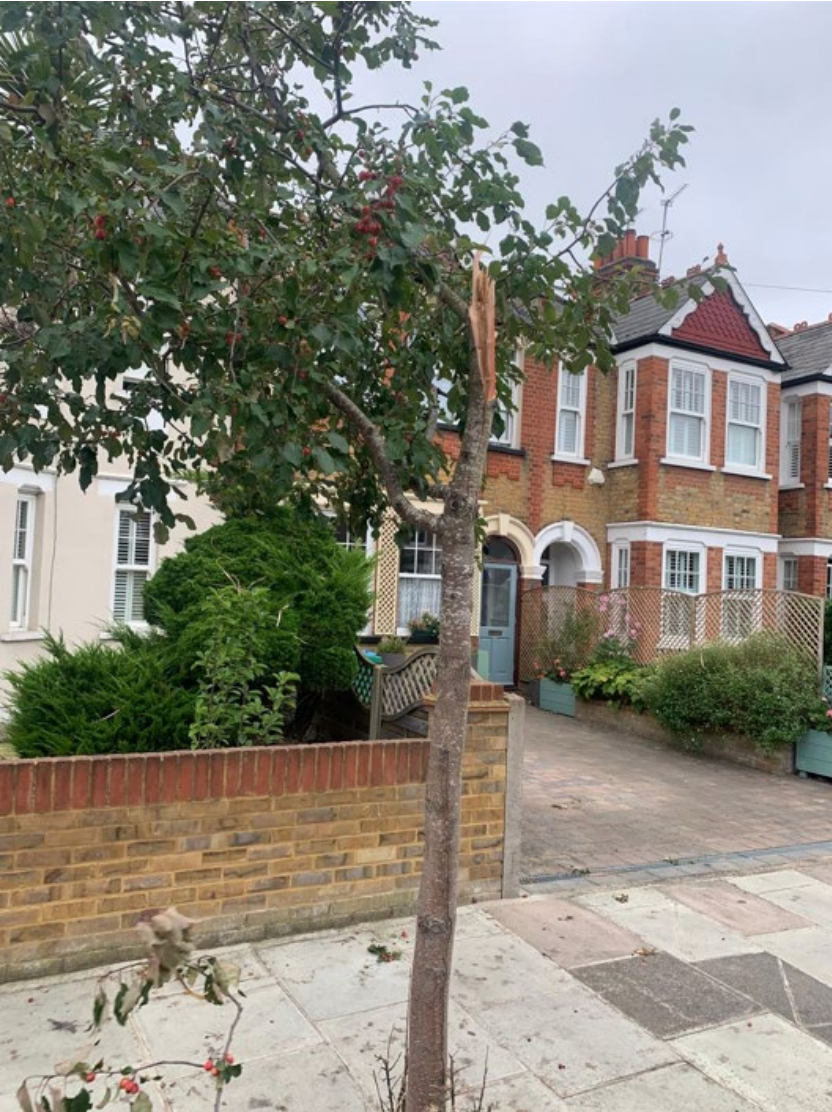
Ward	Teddington
Road	Church Road
Location	Outside 8
Species	Apple (<i>Malus sp.</i>)
Height	4.0m
Physiological Condition	Poor
Structural Condition	Poor
Inspection findings/reason for exemption	The main leader of this tree has failed in high winds. The remaining tree will not grow into a viable specimen with exposed branches also liable to further failure. Removal is required to prevent natural failure, manage risk, and facilitate replanting

Image shows tree in street scene with wound from failed leader.

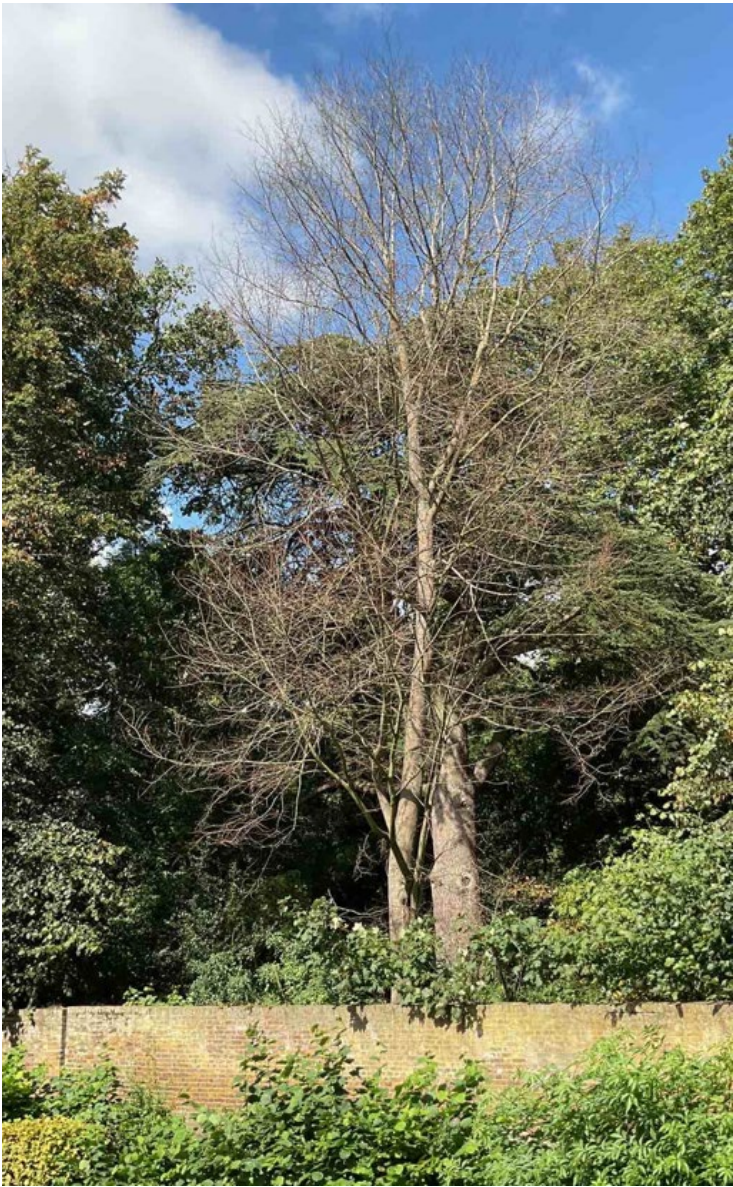
Ward	Twickenham Riverside
Road	Riverside
Location	Orleans Gallery Woods- /// worth.flies.invent
Species	Lime (Tilia sp.)
Height	21.0m
Physiological Condition	Dead
Structural Condition	Dead
Inspection findings/reason for exemption	This tree is dead; removal is required to prevent natural failure, manage risk. The stump will be left as a 1m high monolith for ecology purposes.

Image shows dead tree in park scene.

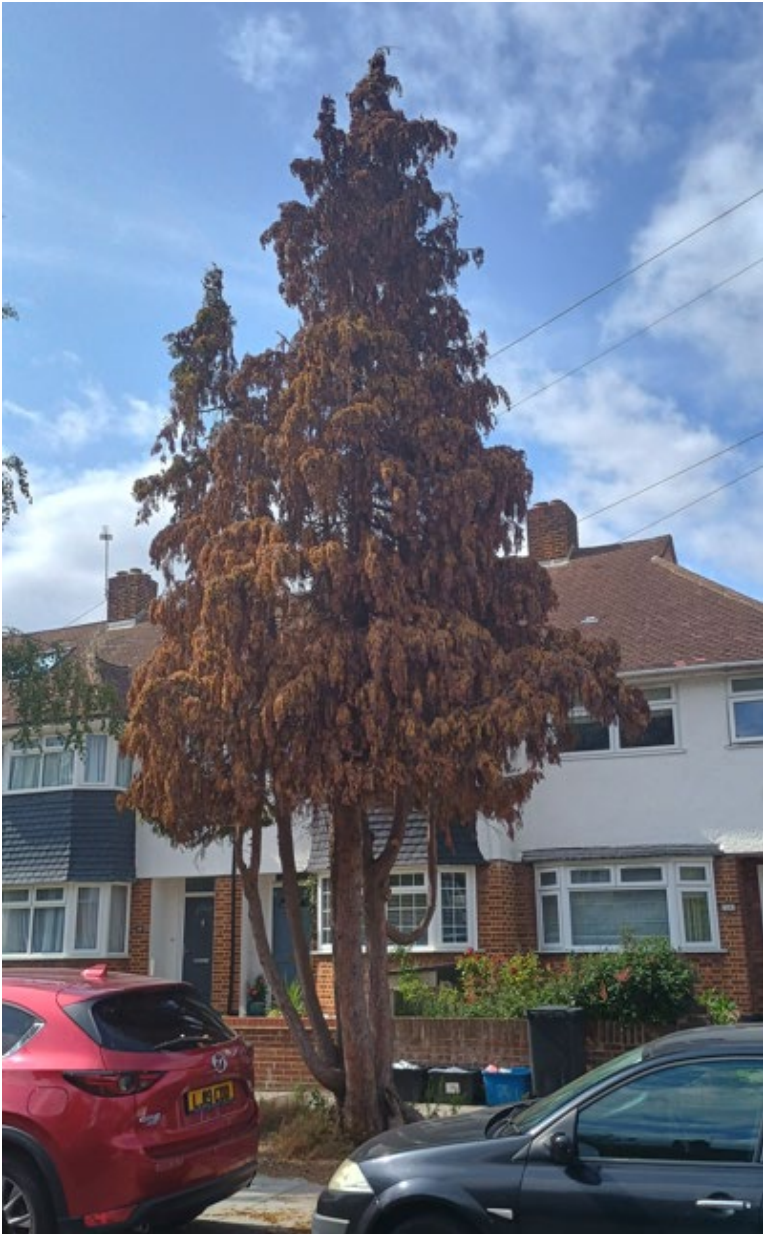
Ward	West Twickenham
Road	Lincoln Avenue
Location	Outside 38
Species	Lawson Cypress (<i>Chamaecyparis lawsoniana</i>)
Height	10.0m
Physiological Condition	Dead
Structural Condition	Dead
Inspection findings/reason for exemption	This tree is dead; removal is required to prevent natural failure, manage risk, and facilitate replanting

Images show dead tree in street scene.
