## January 2025 - Reactive Tree Works Programme

### Introduction

Dated 16.01.2025

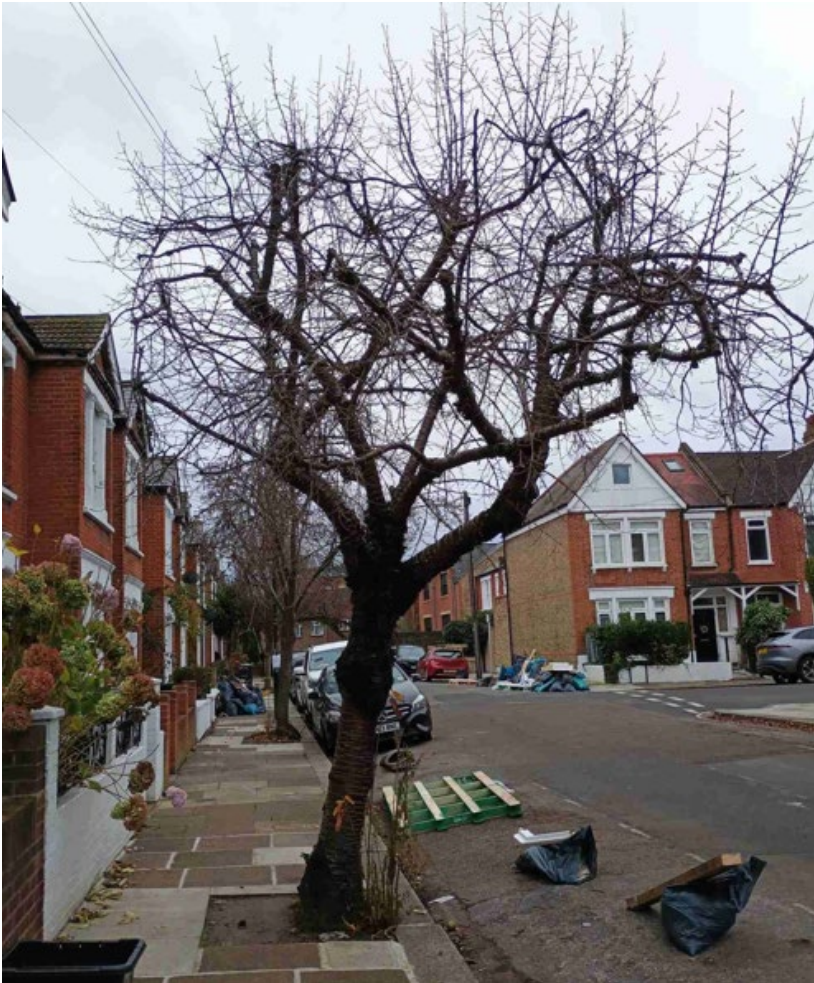
<b>Ward</b>	Barnes
<b>Road</b>	Lyric Road
<b>Location</b>	Outside 47/49
<b>Species</b>	Tibetan cherry ( <i>Prunus serrula</i> 'Tibetica')
<b>Height</b>	7.5m
<b>Physiological Condition</b>	Fair
<b>Structural Condition</b>	Poor
<b>Inspection findings/reason for exemption</b>	A fungal fruiting body of the decay fungi Ganoderma sp. is present at the stem base. Colonisation by this fungus causes a white rot of the stem and root system that can cause entire trees to collapse through fracture or windthrow. A resonance test revealed an unacceptable degree of decay in the trunk of this tree. Removal is required to prevent natural failure, manage risk, and facilitate replanting.

Image shows tree in street scene,

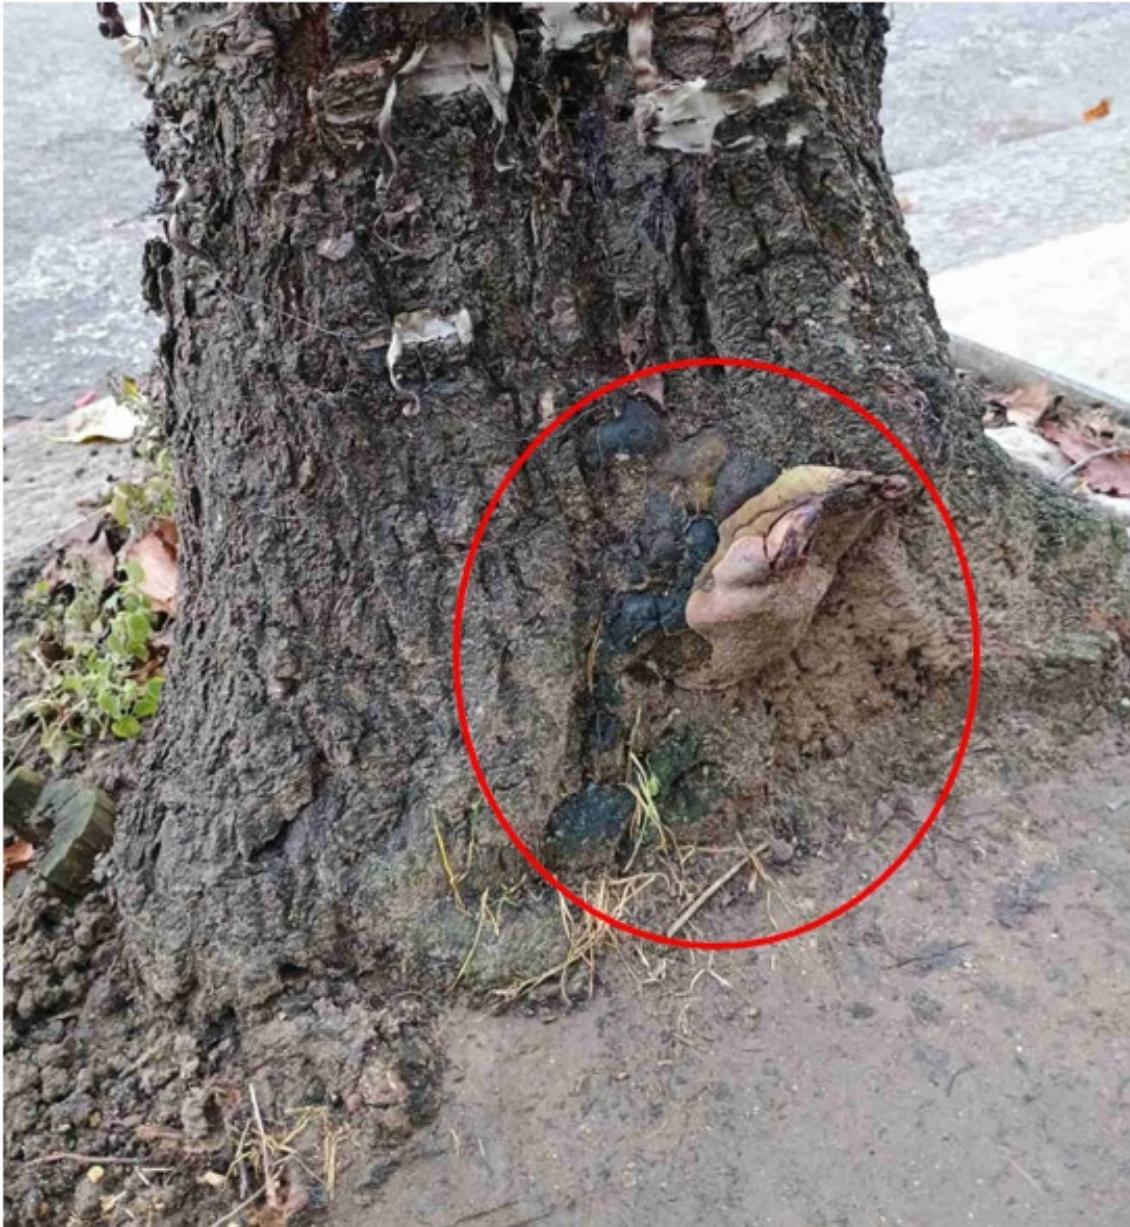
***Image shows fungal fruiting bodies circled in red on lower trunk.***

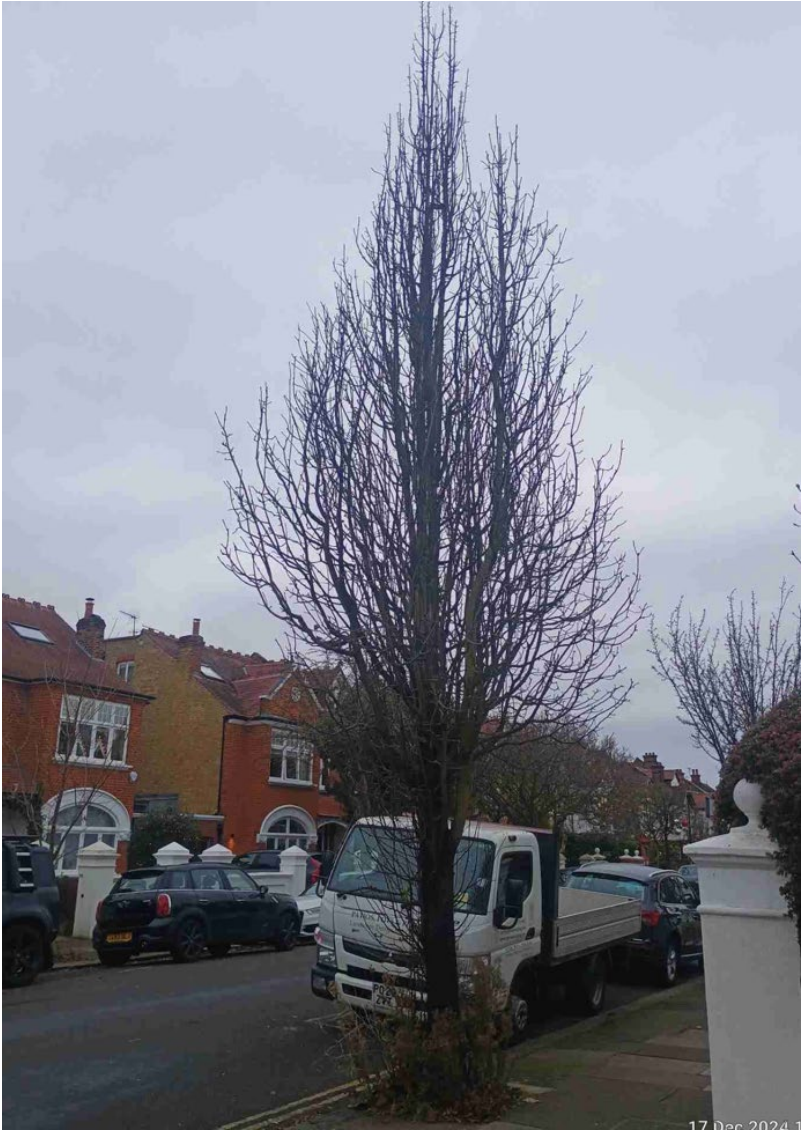
<b>Ward</b>	Barnes
<b>Road</b>	Nassau Road
<b>Location</b>	Outside 45
<b>Species</b>	Lebanese wild apple ( <i>Malus trilobata</i> )
<b>Height</b>	8.5m
<b>Physiological Condition</b>	Poor
<b>Structural Condition</b>	Fair
<b>Inspection findings/reason for exemption</b>	This tree is moribund; removal is required to prevent natural failure, manage risk and facilitate replanting.

**Image shows moribund tree in street scene.**

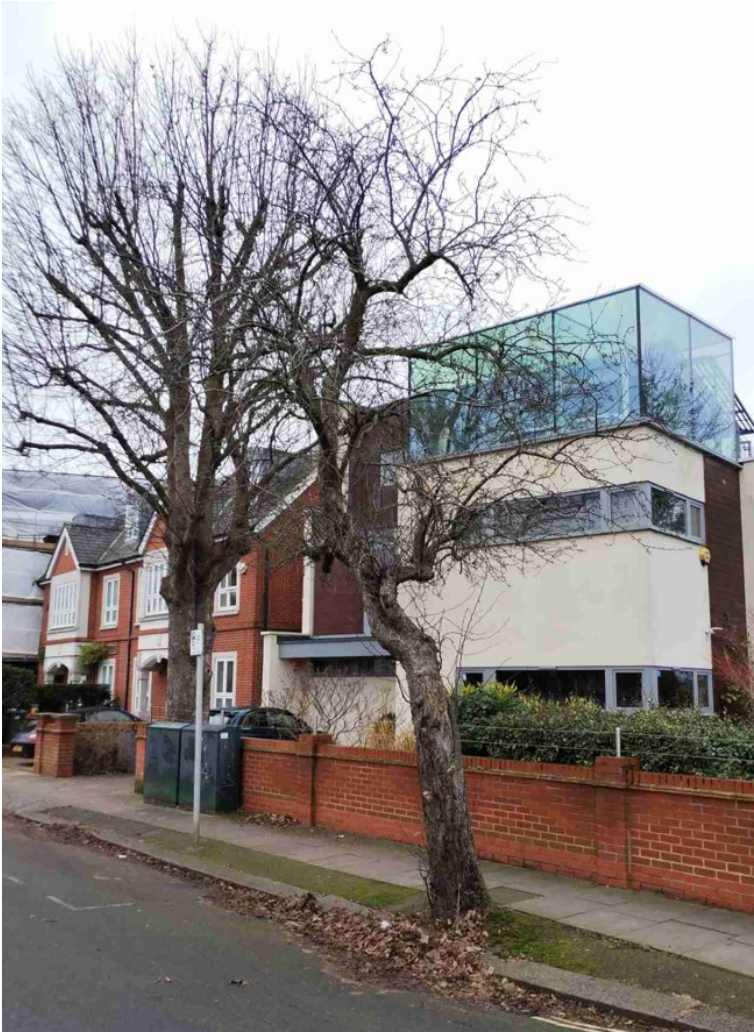
<b>Ward</b>	Barnes
<b>Road</b>	Gerard Road
<b>Location</b>	Outside 76
<b>Species</b>	Flowering Crab Apple ( <i>Malus x purpurea v eleyi</i> )
<b>Height</b>	8.0m
<b>Physiological Condition</b>	Poor
<b>Structural Condition</b>	Poor
<b>Inspection findings/reason for exemption</b>	A fungal fruiting body of the decay fungi Ganoderma sp. is present at the stem base. Colonisation by this fungus causes a white rot of the stem and root system that can cause entire trees to collapse through fracture or windthrow. A resonance test revealed an unacceptable degree of decay in the trunk of this tree. Removal is required to prevent natural failure, manage risk, and facilitate replanting.

**Image shows tree in street scene.**

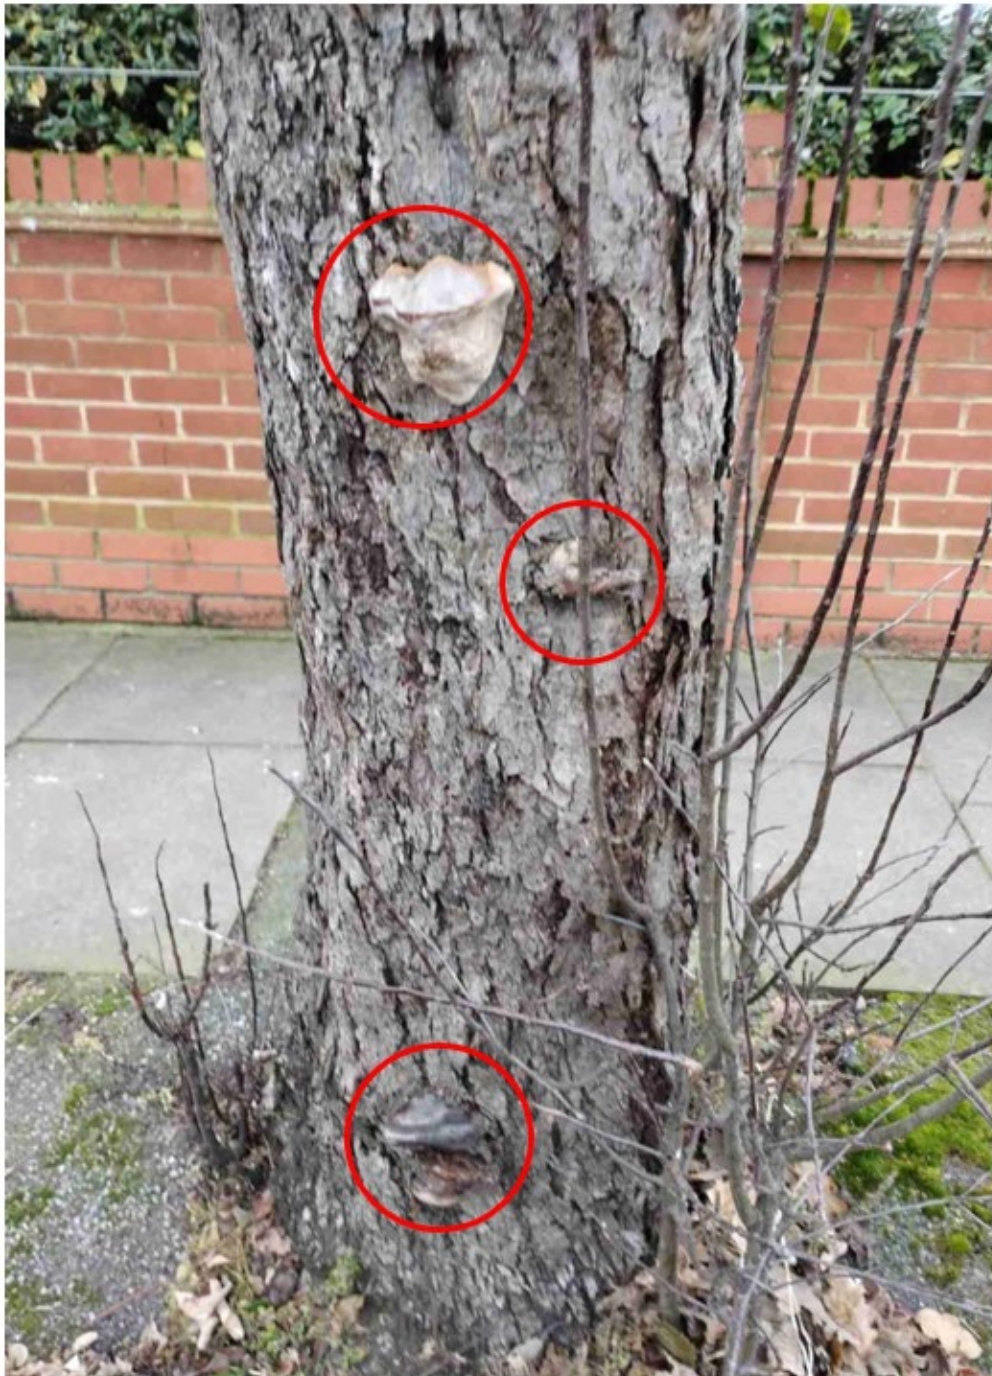
***Image shows fungal fruiting bodies circled in red on lower trunk.***

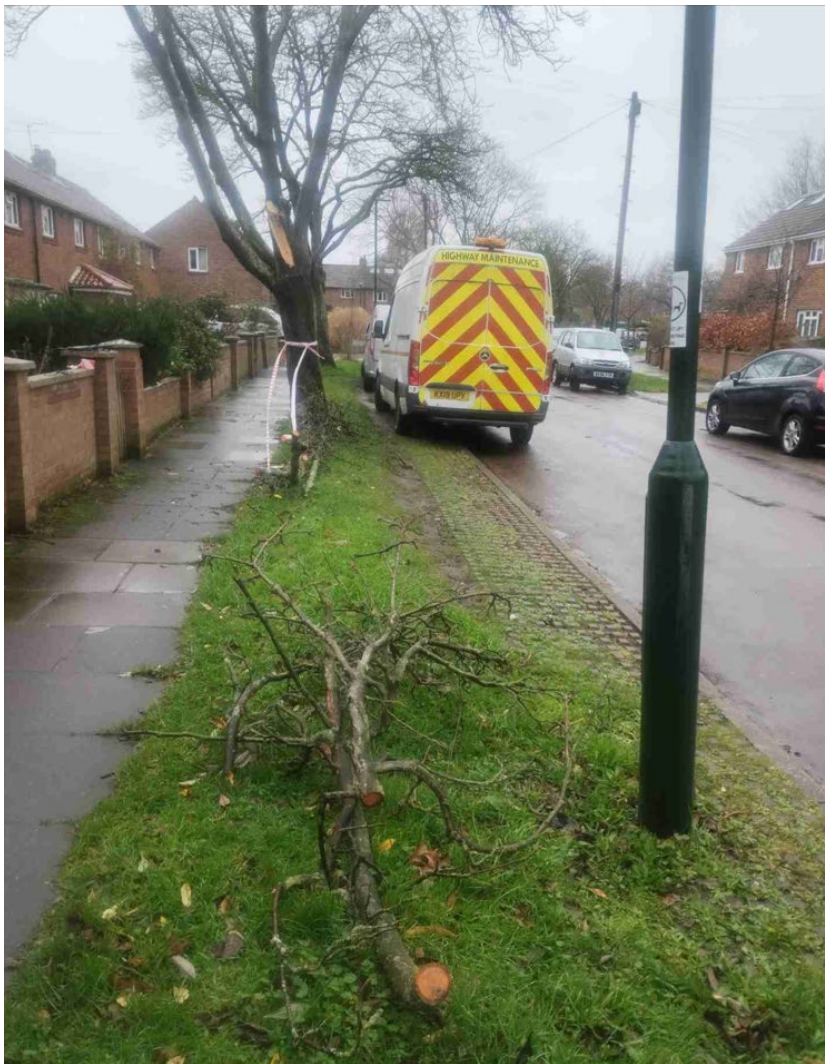
<b>Ward</b>	Ham, Petersham and Richmond Riverside
<b>Road</b>	Buckingham Road
<b>Location</b>	Outside 25
<b>Species</b>	Swedish whitebeam ( <i>Sorbus x intermedia</i> )
<b>Height</b>	10.0m
<b>Physiological Condition</b>	Fair
<b>Structural Condition</b>	Poor
<b>Inspection findings/reason for exemption</b>	Major stem has failed from crown tree in recent storm due to a wide month union which is a weak form of branch union that is a point for failure to occur from which also had an unacceptable level of decay in the surrounding area. Removal is required to prevent further natural stem failures, manage risk, and facilitate replanting.

**Image shows tree in street scene with failed stem.**

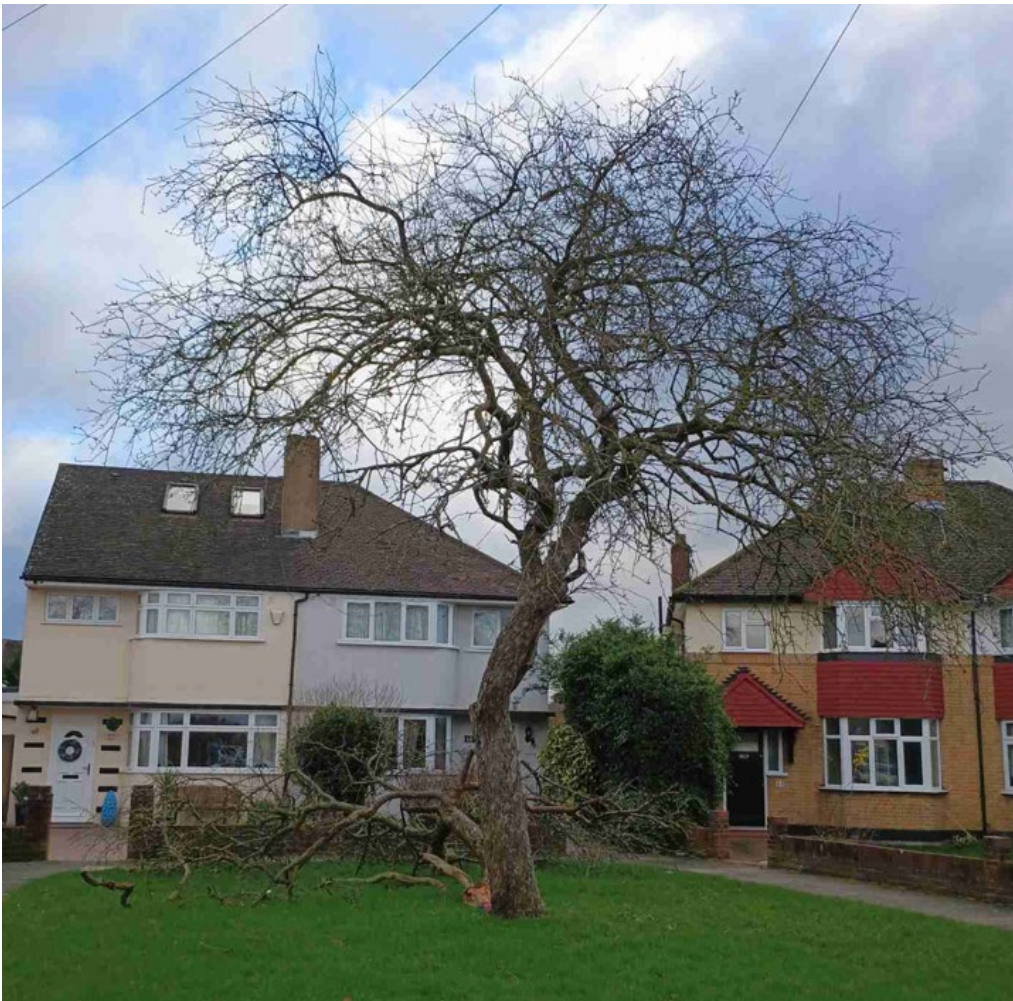
<b>Ward</b>	Heathfield
<b>Road</b>	Ashley Drive
<b>Location</b>	Verge outside 46-48
<b>Species</b>	Japanese flowering crab apple ( <i>Malus floribunda</i> )
<b>Height</b>	8.0m
<b>Physiological Condition</b>	Poor
<b>Structural Condition</b>	Poor
<b>Inspection findings/reason for exemption</b>	A fungal fruiting body of the decay fungi Ganoderma sp. is present at the stem base. Colonisation by this fungus causes a white rot of the stem and root system that can cause entire trees to collapse through fracture or windthrow. A recent stem failure and crown dieback indicates that the tree is under considerable physiological stress and has advanced decay to trunk. Removal is required to prevent further natural failure, manage risk, and facilitate replanting

**Image shows tree with failed stem in street scene.**

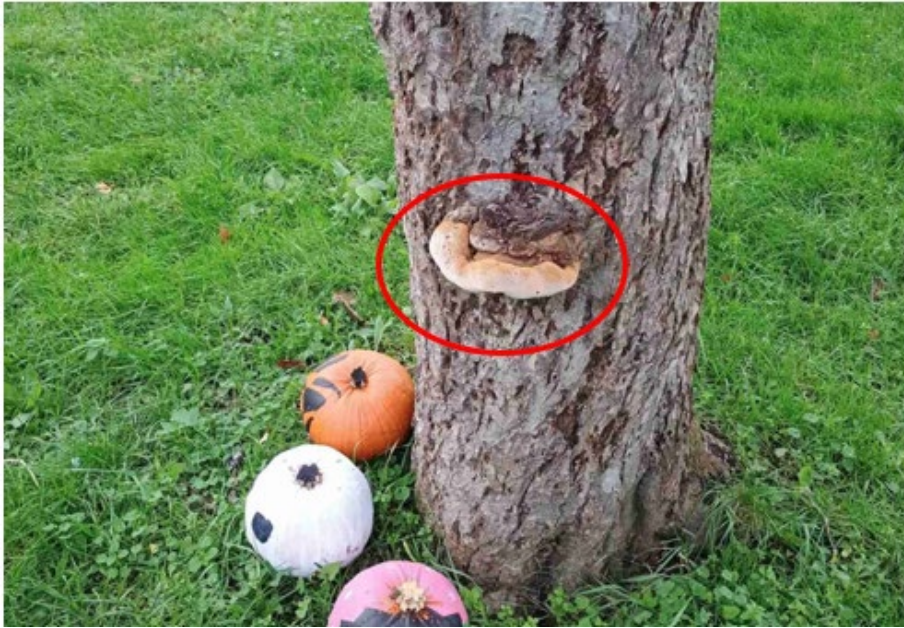
***Image shows fungal fruiting body on trunk circled in red.***

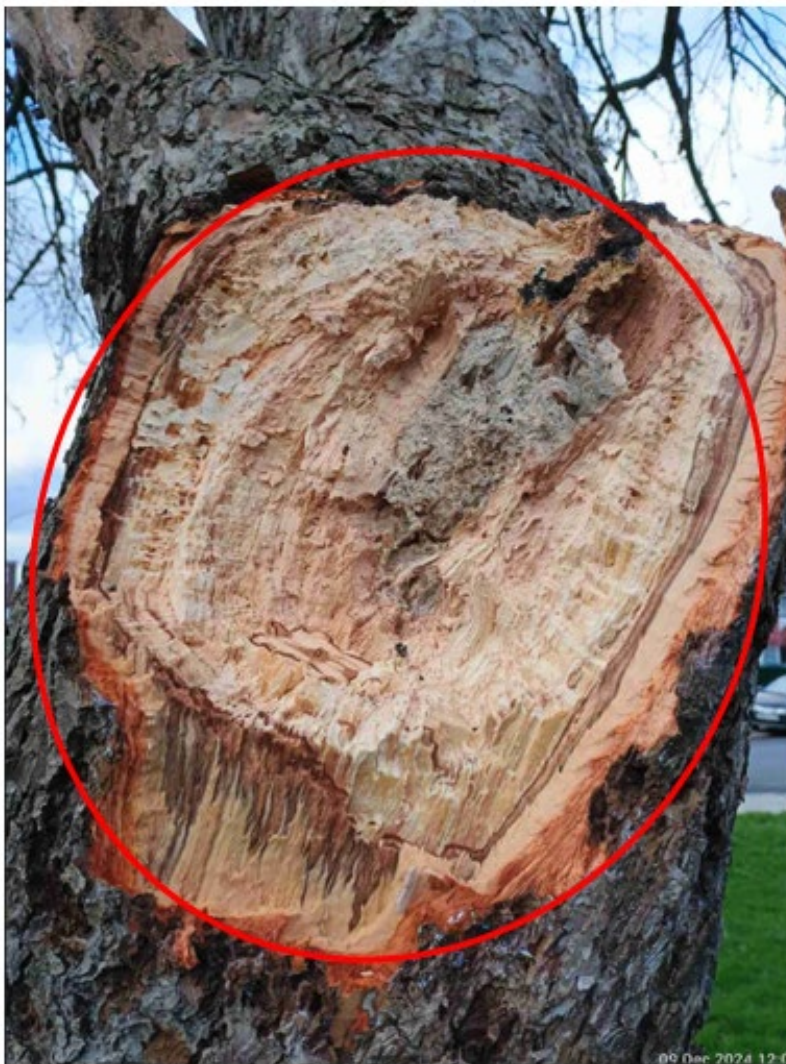
***Image shows exposed internal decay in trunk circled in red.***

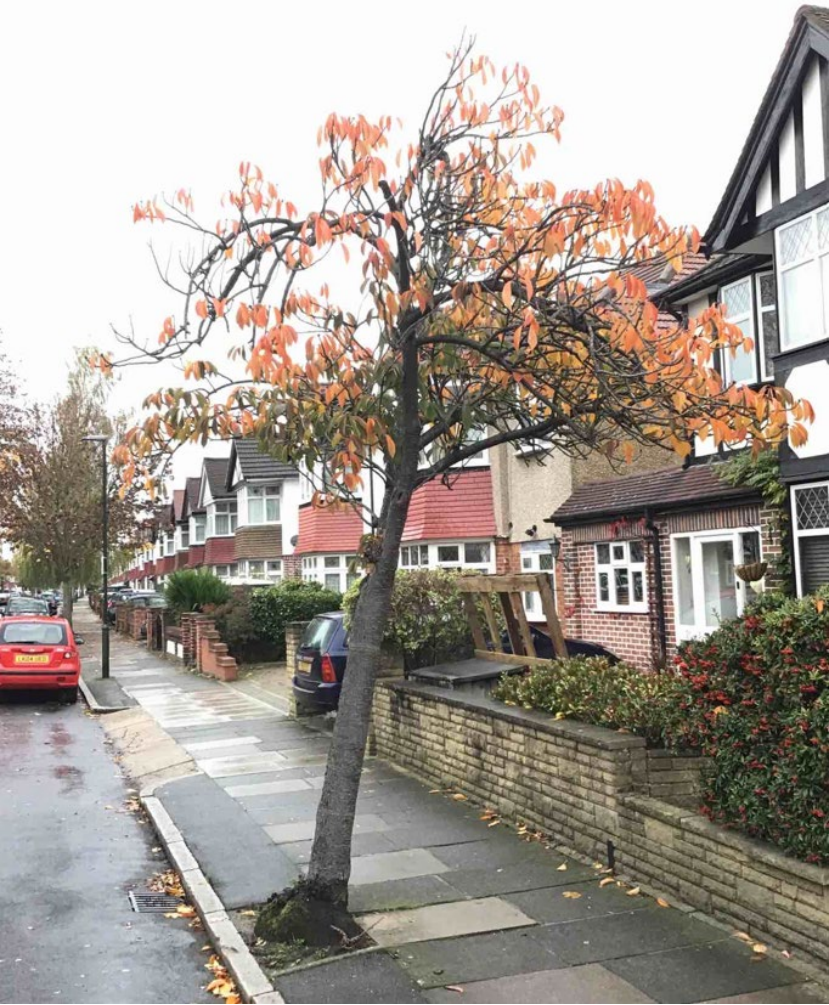
<b>Ward</b>	Heathfield
<b>Road</b>	Montrose Avenue
<b>Location</b>	Outside 34/36
<b>Species</b>	Kanzan Flowering Cherry Tree ( <i>Prunus Kanzan</i> )
<b>Height</b>	4.5m
<b>Physiological Condition</b>	Good
<b>Structural Condition</b>	Good
<b>Inspection findings/reason for exemption</b>	This tree is excessively leaning across the footway causing an unreasonable obstruction. Removal is required to manage the unacceptable risk of pedestrian injury and facilitate replanting

**Images shows tree in street scene with leaning trunk.**

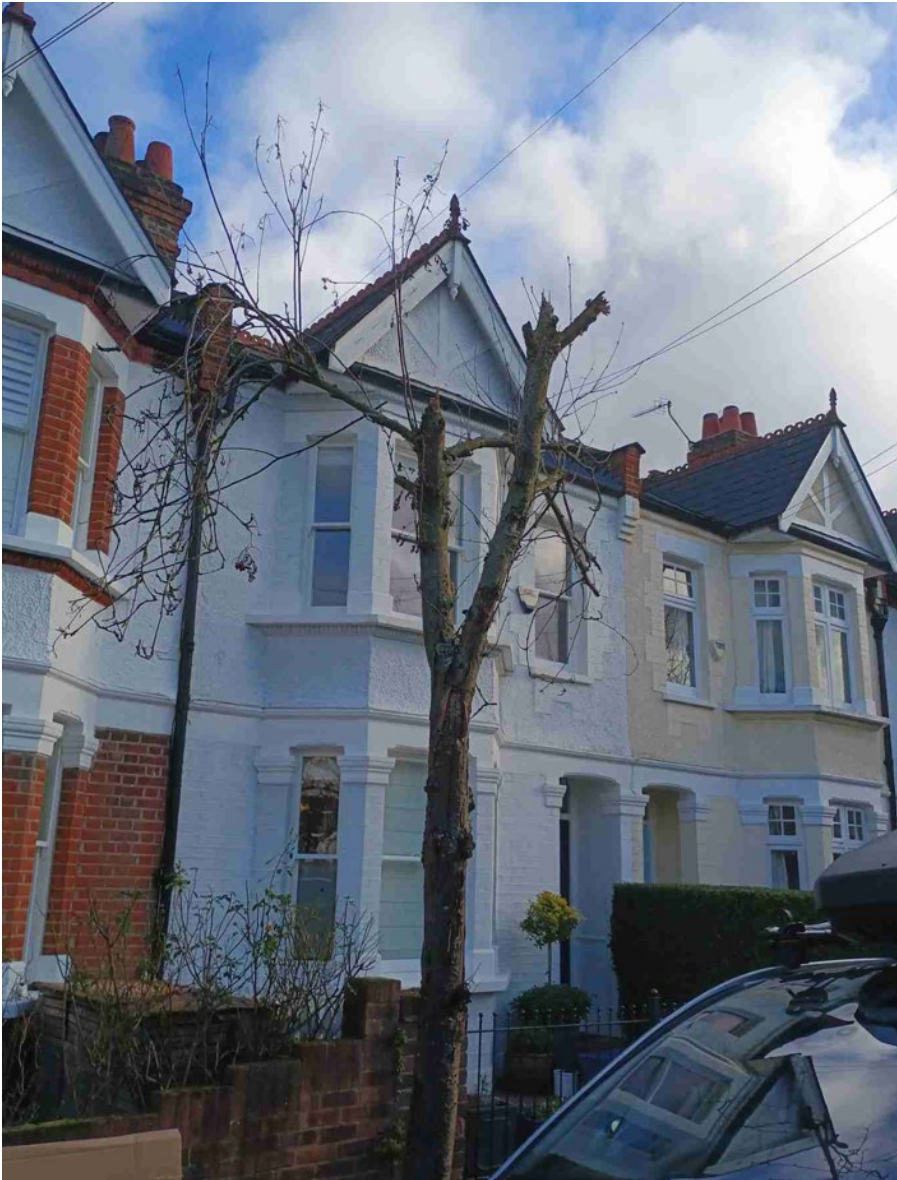
Ward	Mortlake and Barnes Common
Road	Grosvenor Gardens
Location	Outside 40
Species	Rowan ( <i>Sorbus aucuparia</i> )
Height	5.0m
Physiological Condition	Poor
Structural Condition	Poor
Inspection findings/reason for exemption	This tree is moribund; removal is required to prevent natural failure, manage risk, and facilitate replanting

**Image shows moribund tree in street scene.**

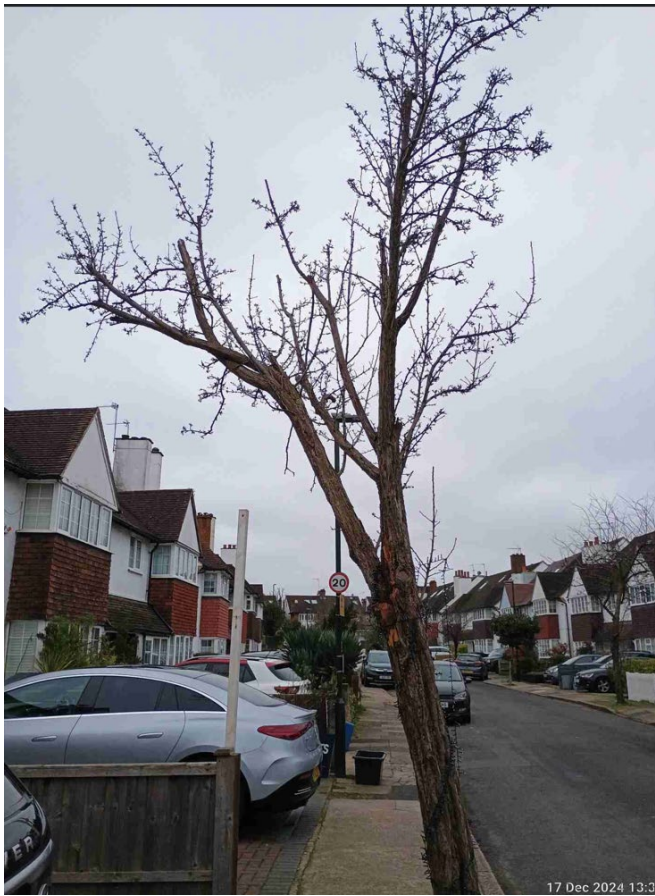
<b>Ward</b>	North Richmond
<b>Road</b>	Rothesay Avenue
<b>Location</b>	Outside 22/24
<b>Species</b>	Common hawthorn ( <i>Crataegus monogyna</i> )
<b>Height</b>	5.0m
<b>Physiological Condition</b>	Poor
<b>Structural Condition</b>	Poor
<b>Inspection findings/reason for exemption</b>	A fungal fruiting body of the decay fungi Ganoderma sp. is present at the stem base. Colonisation by this fungus causes a white rot of the stem and root system that can cause entire trees to collapse through fracture or windthrow. A recent stem failure and crown dieback indicates that the tree is under considerable physiological stress and has advanced decay to trunk. Removal is required to prevent further natural failure, manage risk, and facilitate replanting

**Image shows tree in street scene.**

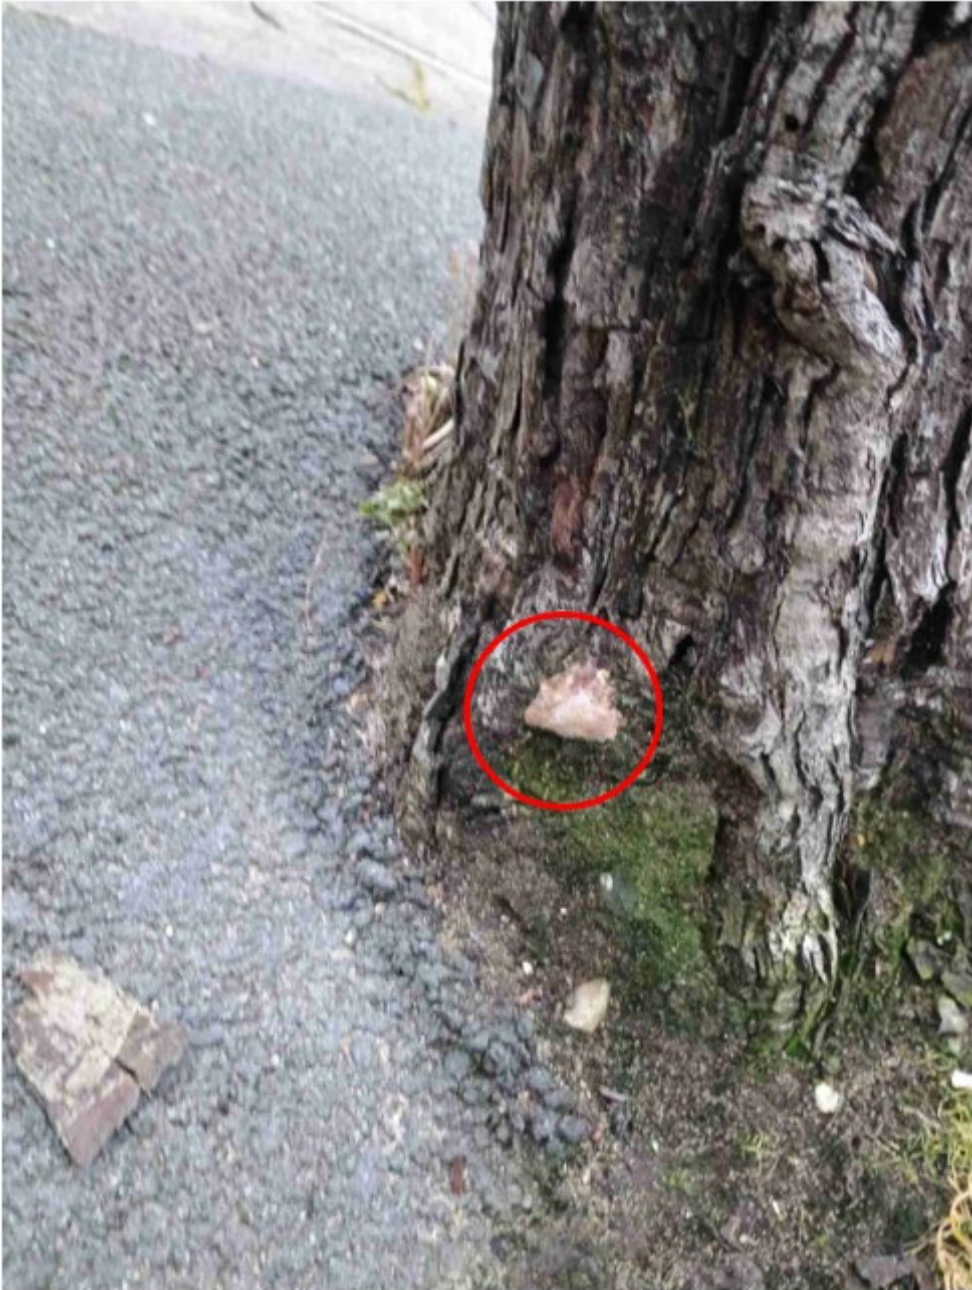
***Image shows fungal fruiting body circled in red.***

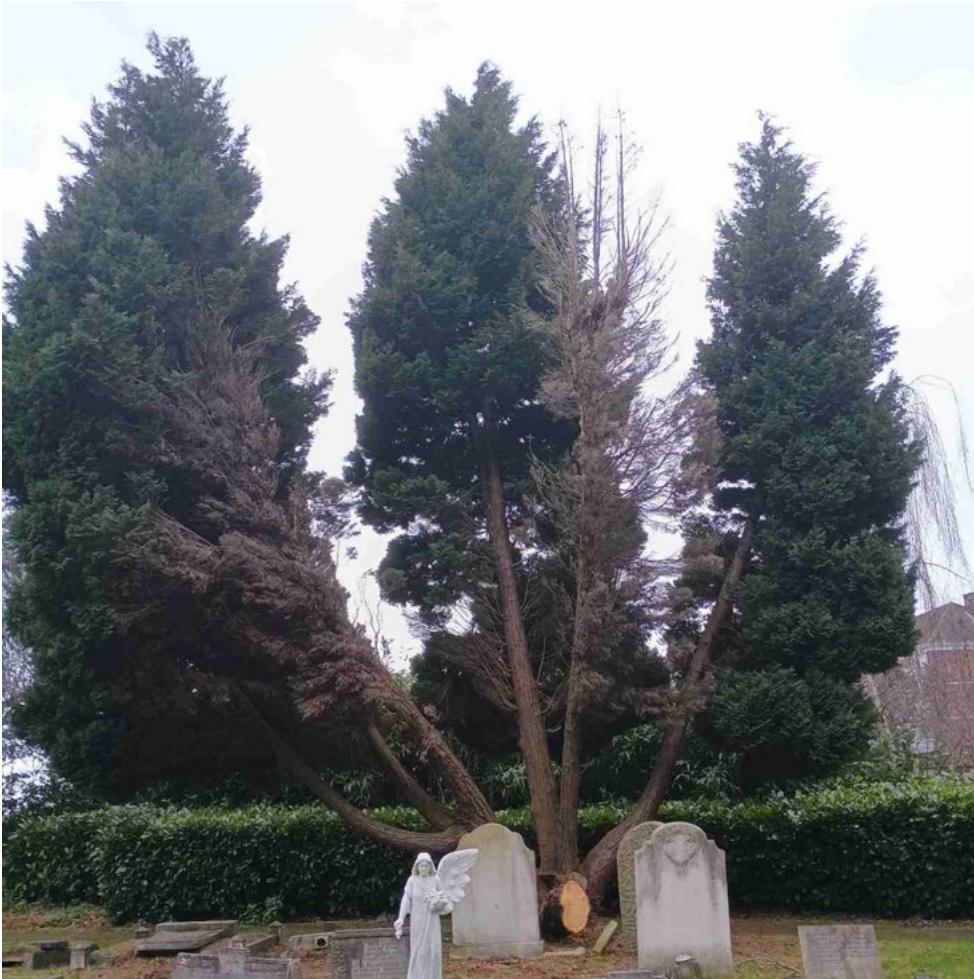
Ward	South Richmond
Road	Lower Grove Road
Location	East sheen cemetery - ///money.taps.export
Species	Conifer ( <i>Cupressus</i> sp.)
Height	11.0m
Physiological Condition	Poor
Structural Condition	Poor
Inspection findings/reason for exemption	This tree state of physical decline with a failed union at the base of stem and exposing the remaining crown. Removal is required to prevent further natural failure, manage risk, and facilitate replanting.

**Image shows moribund tree in cemetery scene.**

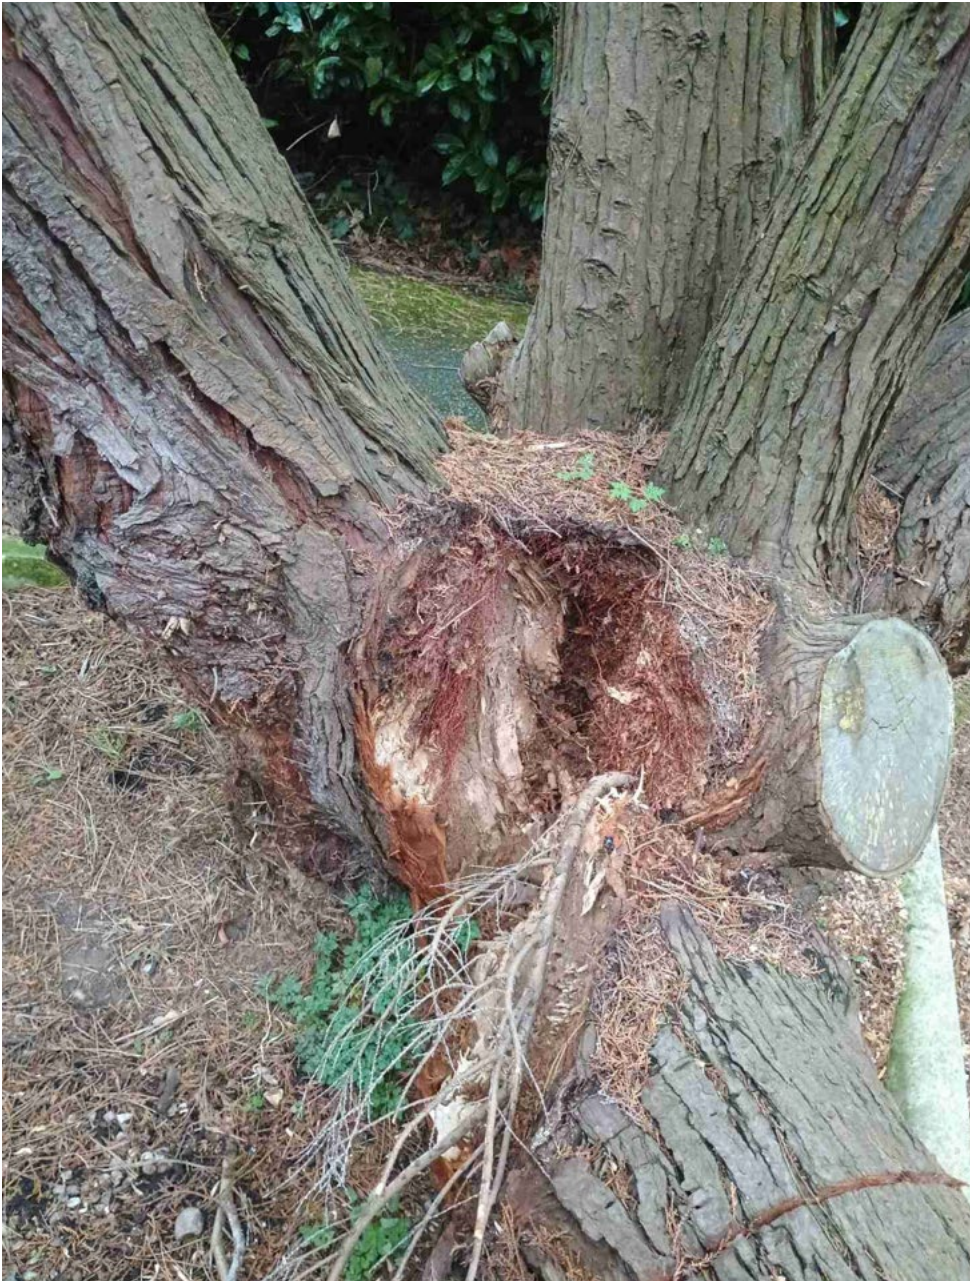
***Image shows failed union at base of trunk.***

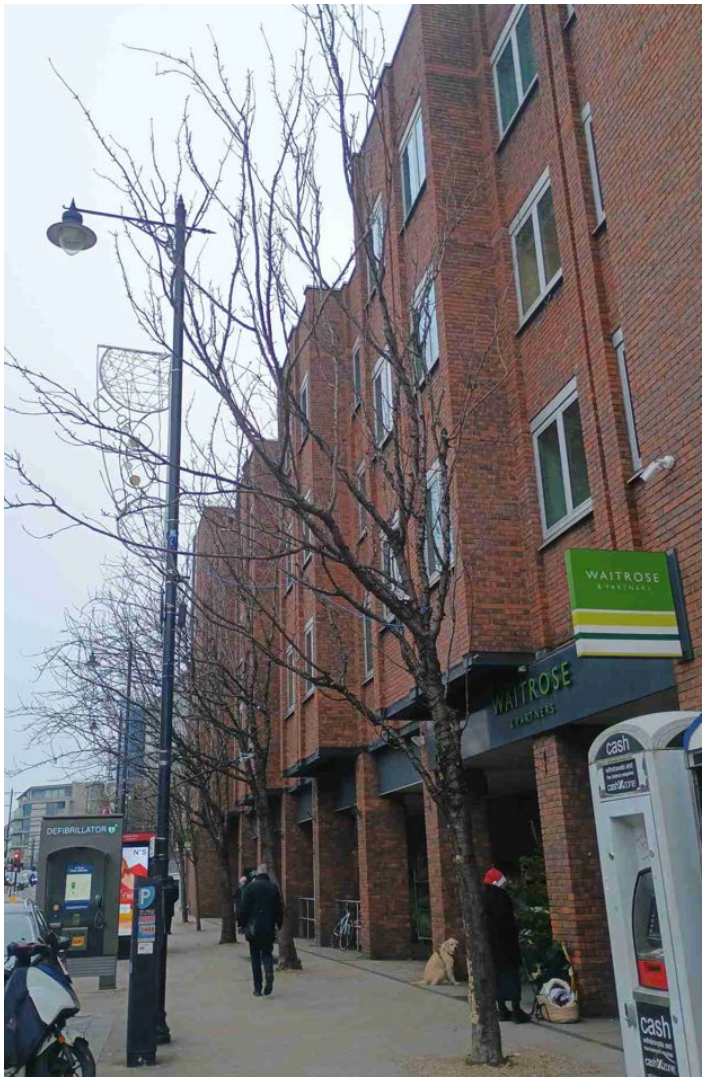
Ward	Twickenham Riverside
Road	London Road
Location	Opposite 47/49
Species	Tibetan cherry ( <i>Prunus serrula 'Tibetica'</i> )
Height	12.0m
Physiological Condition	Poor
Structural Condition	Poor
Inspection findings/reason for exemption	Fungal fruiting bodies of the cushion fungus ( <i>Phellinus pomaceus</i> ) are present on the main stem of this tree. This fungus causes a crumbly white rot that commonly causes this species of tree to snap. Removal is required to prevent natural failure, manage risk, and facilitate replanting.

Image shows tree in street scene.

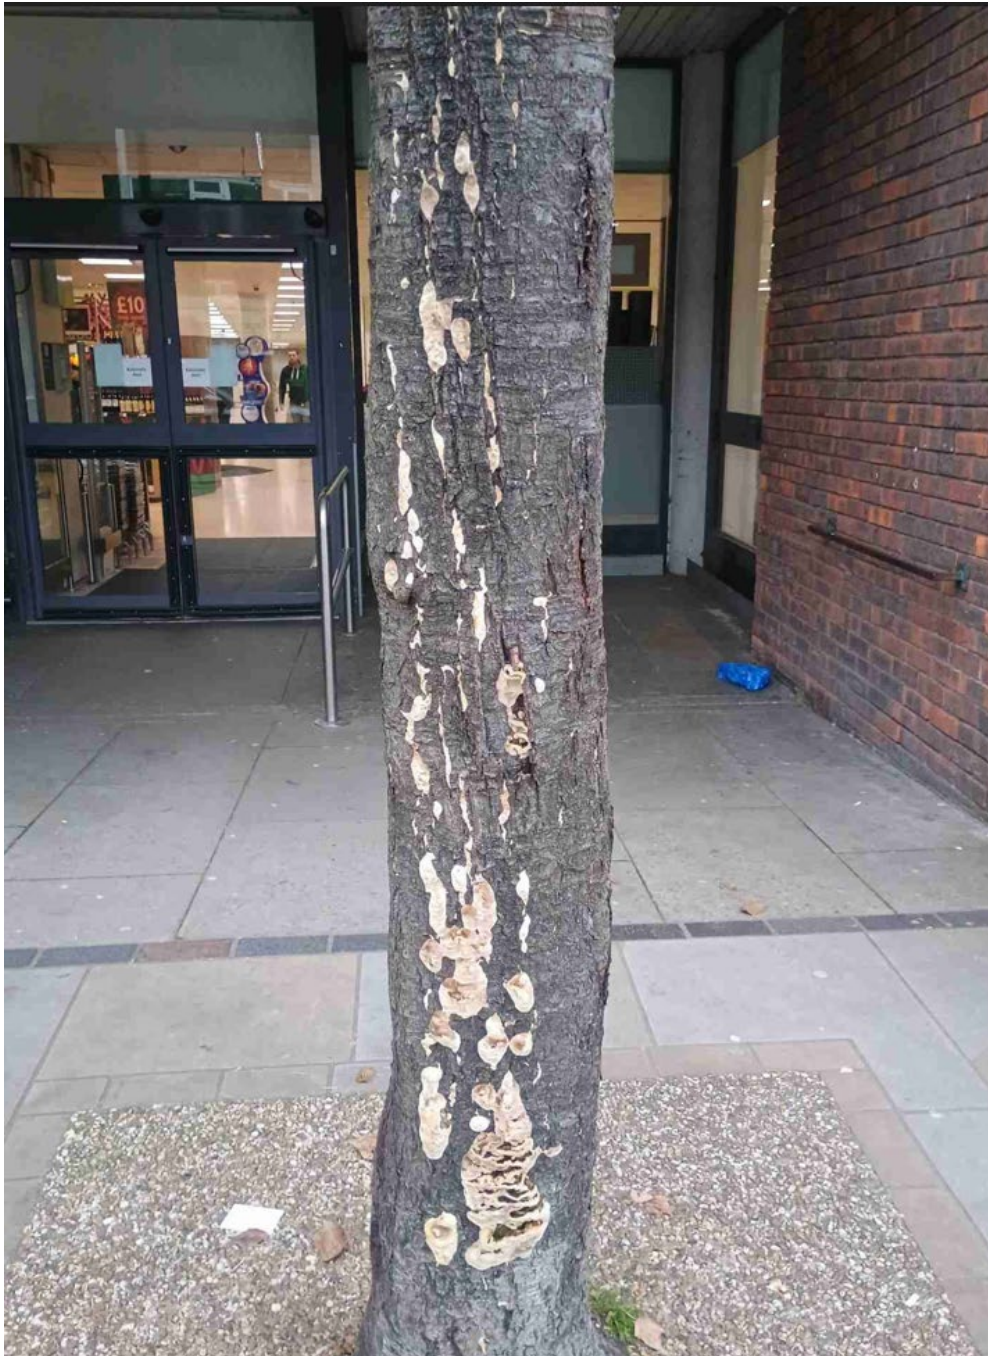
***Image shows fungal fruiting bodies on trunk.***

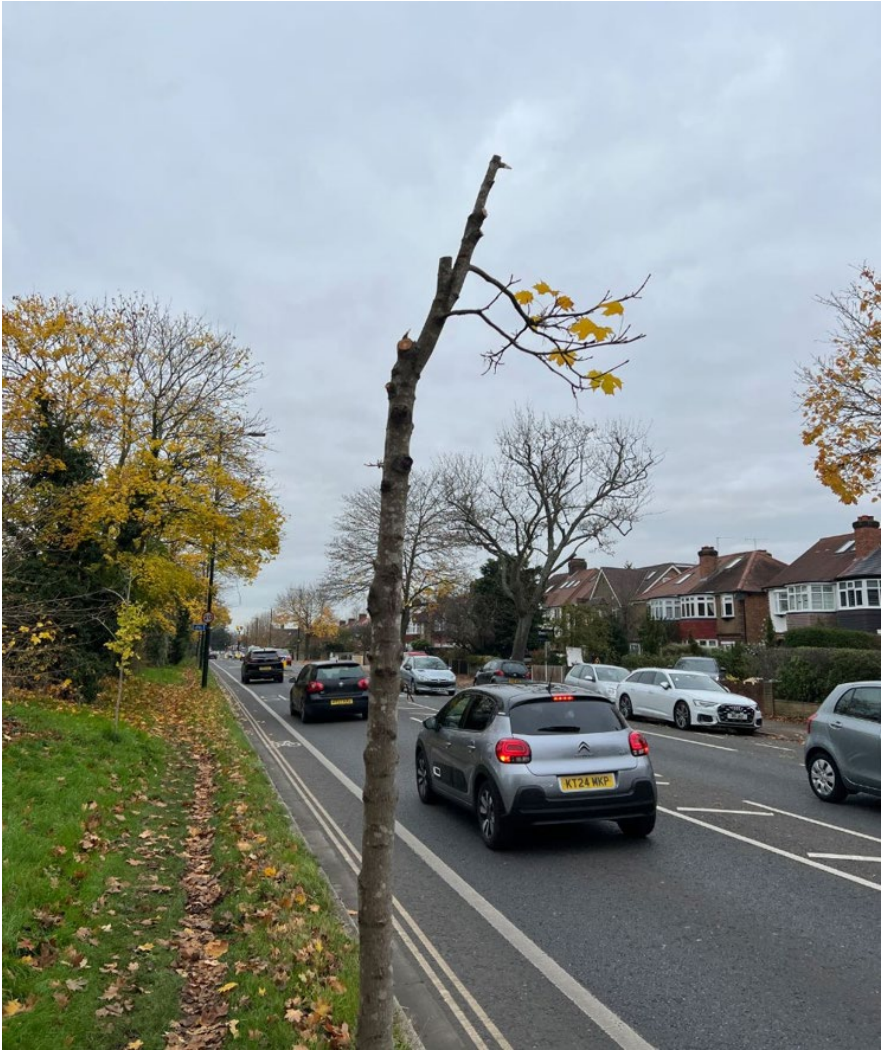
Ward	West Twickenham
Road	Sixth Cross Road
Location	Opposite 92
Species	Norway Maple ( <i>Acer platanoides</i> )
Height	3.0m
Physiological Condition	Poor
Structural Condition	Fair
Inspection findings/reason for exemption	This tree has been vandalised – unauthorised pruning has been undertaken resulting in the removal of the young trees crown. This will prevent the tree from forming a useful specimen. Removal is required to facilitate replanting.

**Images show vandalised tree in street scene.**

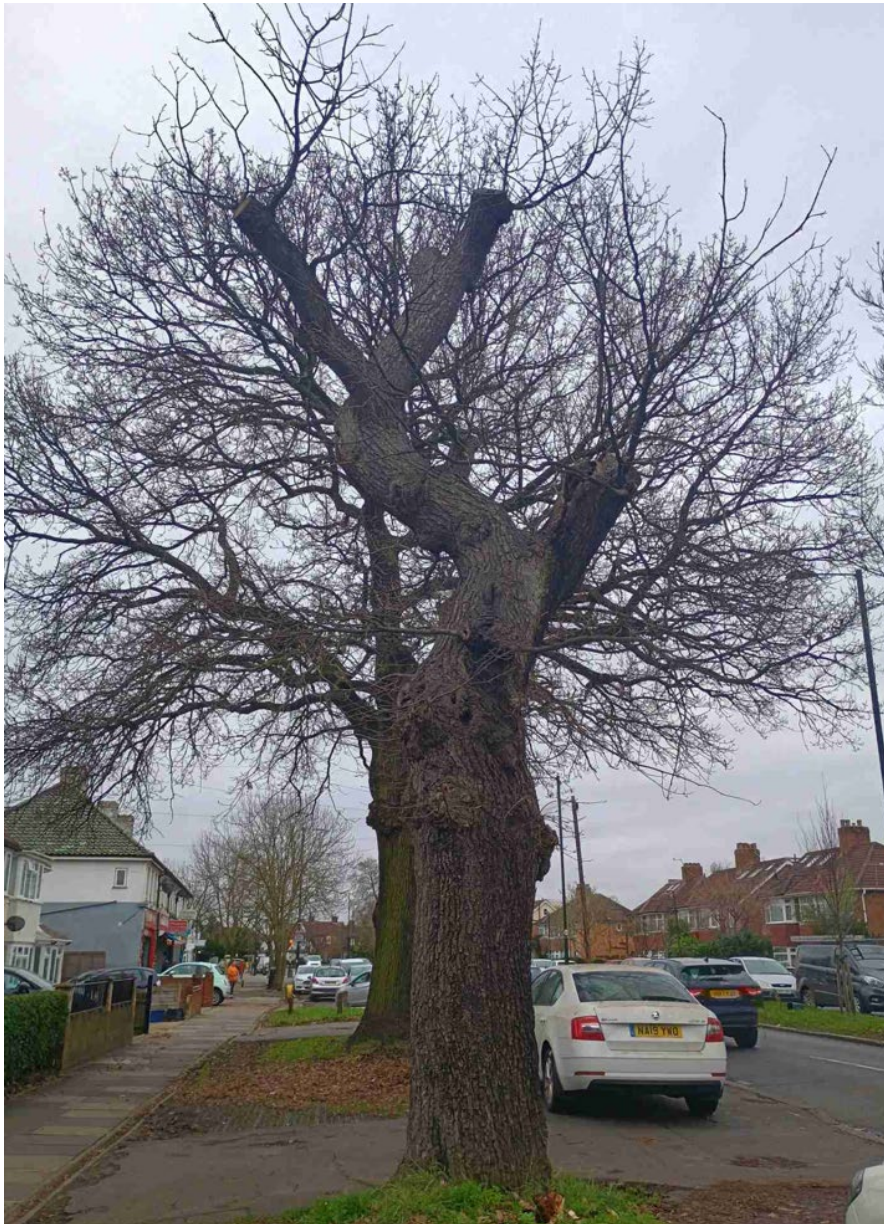
<b>Ward</b>	Whitton
<b>Road</b>	Nelson Road
<b>Location</b>	Outside 332
<b>Species</b>	Common Oak ( <i>Quercus robur</i> )
<b>Height</b>	9.5m
<b>Physiological Condition</b>	Poor
<b>Structural Condition</b>	Poor
<b>Inspection findings/reason for exemption</b>	<p>Fungal fruiting bodies of the decay pathogens <i>Meripilus giganteus</i> and <i>Laetiporus sulphureus</i> are present on this tree. <i>Meripilus giganteus</i> which is populating the base of the trunk, causing white and soft rot that degrades lignin and cellulose in the structural roots and butt, significantly weakening the tree's foundation and increasing the risk of complete failure. <i>Laetiporus sulphureus</i> is present in the crown, causing brown rot that rapidly breaks down cellulose and weakens the wood, heightening the likelihood of branch or whole tree failure through brittle fracture.</p> <p>Despite ongoing efforts to safeguard this tree, it has shown a history of structural and physiological decline, including a recent fungal collapse onto a vehicle. A resonance test has revealed severe decay in the lower stem, with crown dieback correlating to the fungal pathogens present. Given its deteriorating condition and proximity to private housing and a busy road, removal is necessary to prevent natural failure, manage risk, and facilitate replanting.</p>

***Images shows moribund tree in street scene.***

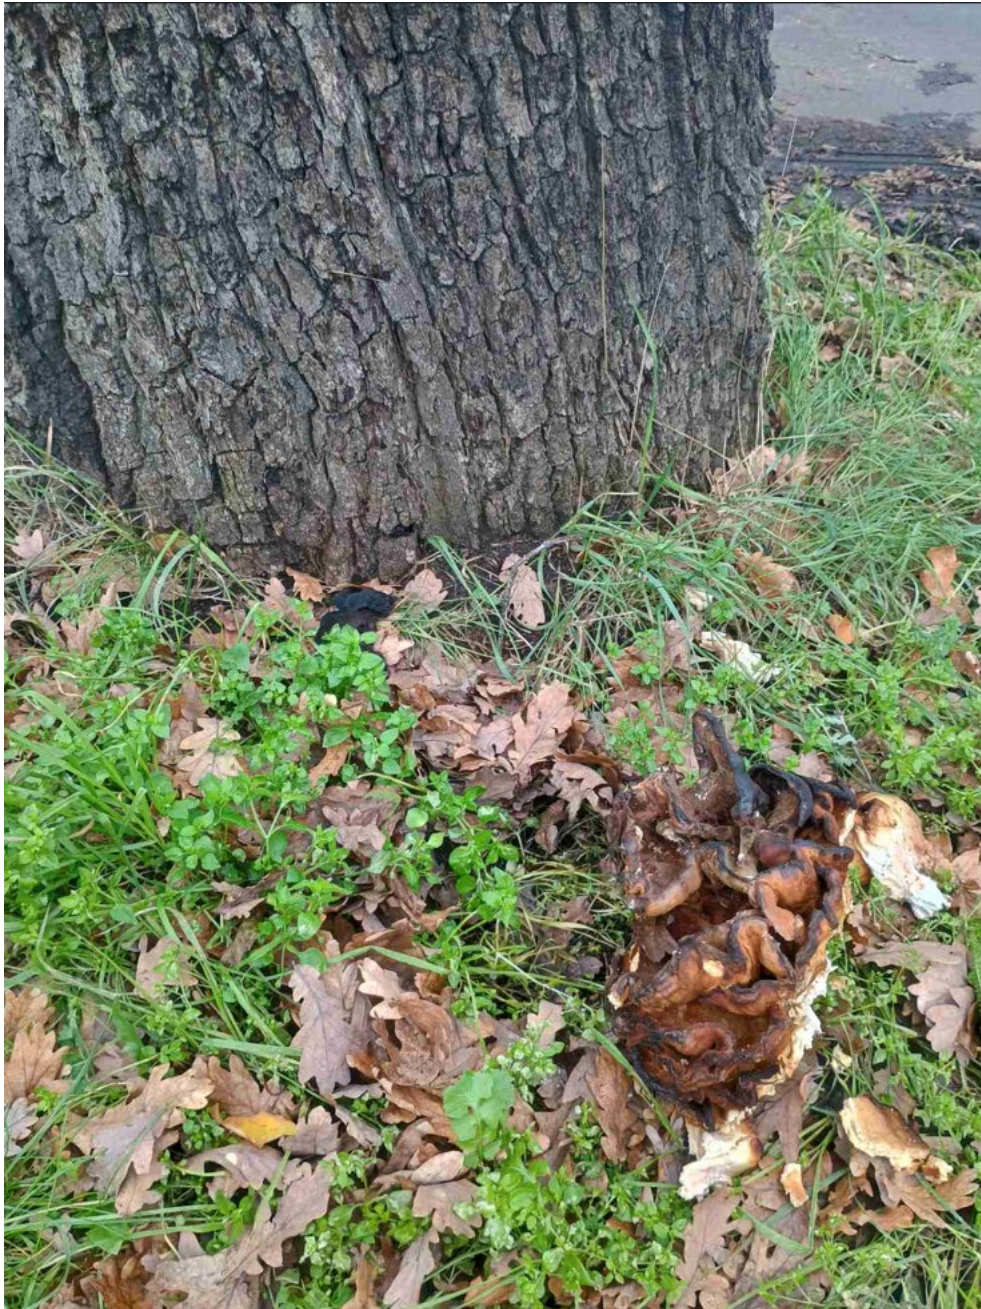
***Images shows fungal fruiting bodies growing at base of trunk.***
