December 2024 - Reactive Tree Works Programme

Introduction

Dated 16.12.2024

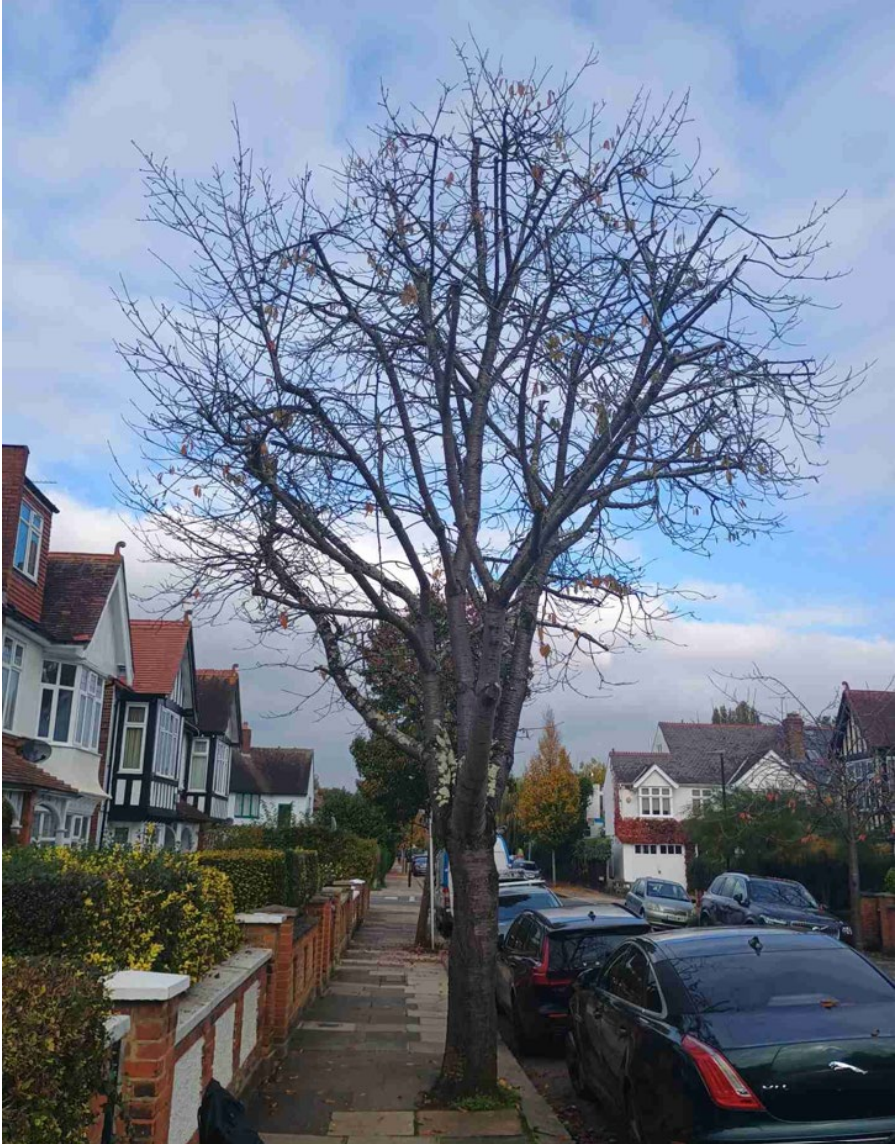
Ward	Barnes
Road	Madrid Road
Location	Outside 95
Species	Cherry (<i>Prunus sp.</i>)
Height	8.0m
Physiological Condition	Poor
Structural Condition	Poor
Inspection findings/reason for exemption	Fungal fruiting bodies of the decay fungi <i>Armillaria sp.</i> are present at the base of this tree. Colonisation by this fungus causes a white rot of the roots and butt that can cause entire tree failure. Crown dieback could correlate with the parasite present. Removal is required to prevent natural failure, manage risk, and facilitate replanting

Image shows tree in street scene

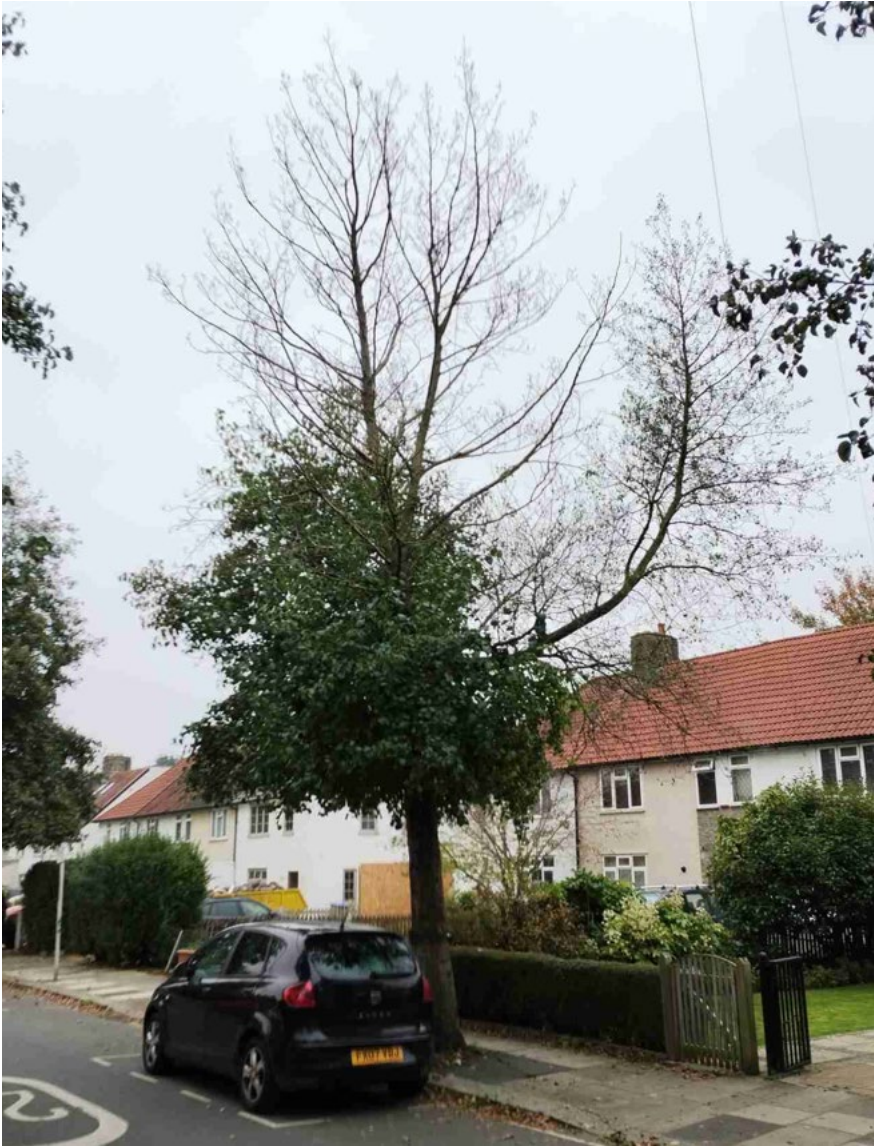
Ward	Barnes
Road	Barnes Avenue
Location	Outside 41
Species	Italian Alder (<i>Alnus cordata</i>)
Height	12.5m
Physiological Condition	Poor
Structural Condition	Poor
Inspection findings/reason for exemption	This tree is moribund with over 70% of the crown being dead. Removal is required to prevent natural failure, manage risk, and facilitate replanting

Image shows moribund tree in street scene.

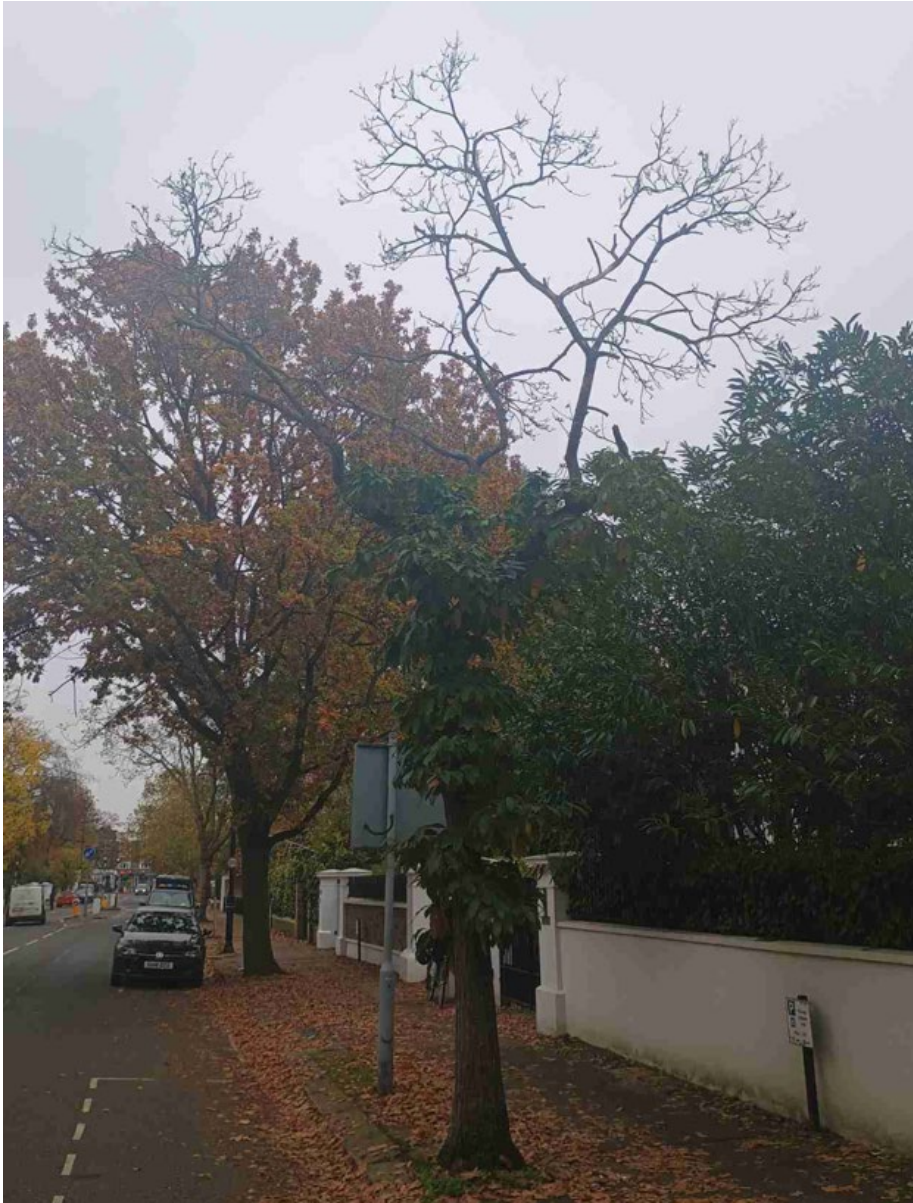
Ward	Barnes
Road	Lonsdale Road
Location	Outside 25
Species	Sweet Chestnut (<i>Castanea sativa</i>)
Height	8.0m
Physiological Condition	Poor
Structural Condition	Fair
Inspection findings/reason for exemption	This tree is moribund with over 80% of the crown being dead. Removal is required to prevent natural failure, manage risk, and facilitate replanting

Image shows moribund tree in street scene.

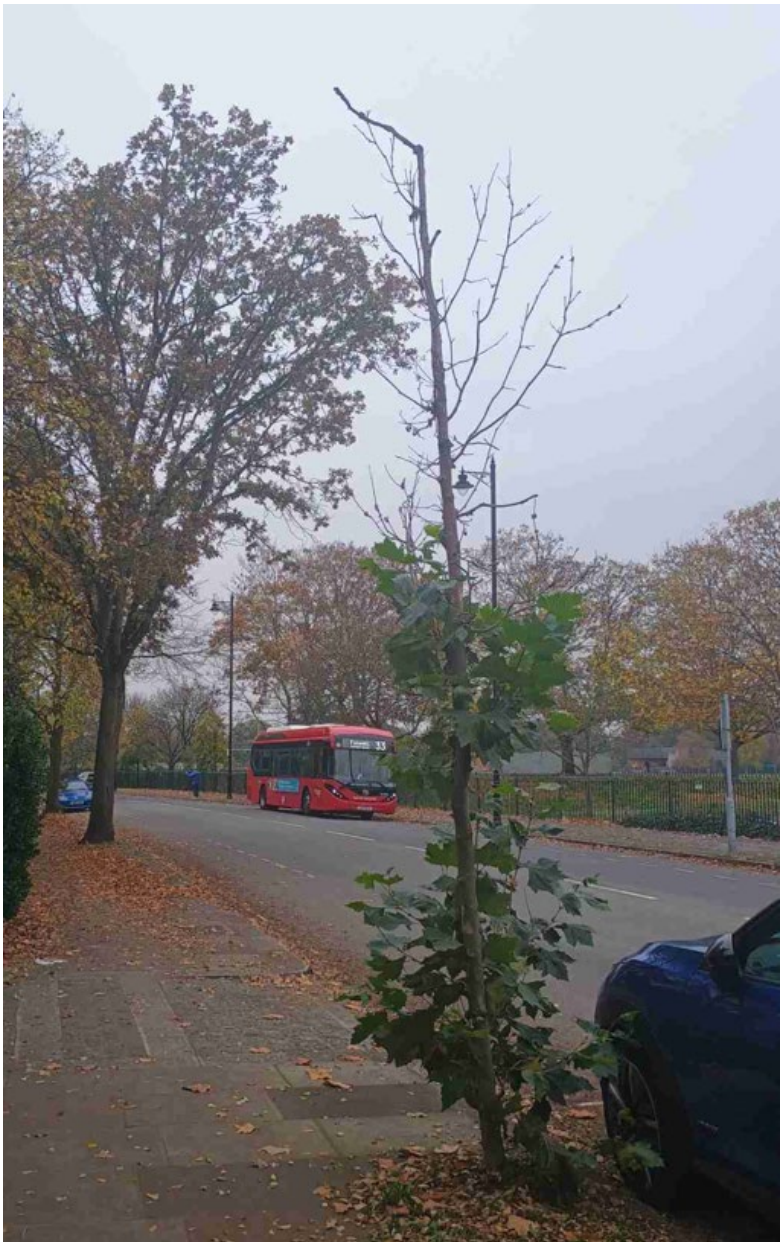
Ward	Barnes
Road	Lonsdale Road
Location	Outside 19
Species	London Plane (<i>Platanus x hispanica</i>)
Height	4.5m
Physiological Condition	Fair
Structural Condition	Poor
Inspection findings/reason for exemption	This tree is moribund with over 80% of the crown being dead. Removal is required to prevent natural failure, manage risk, and facilitate replanting

Image shows moribund tree in street scene.

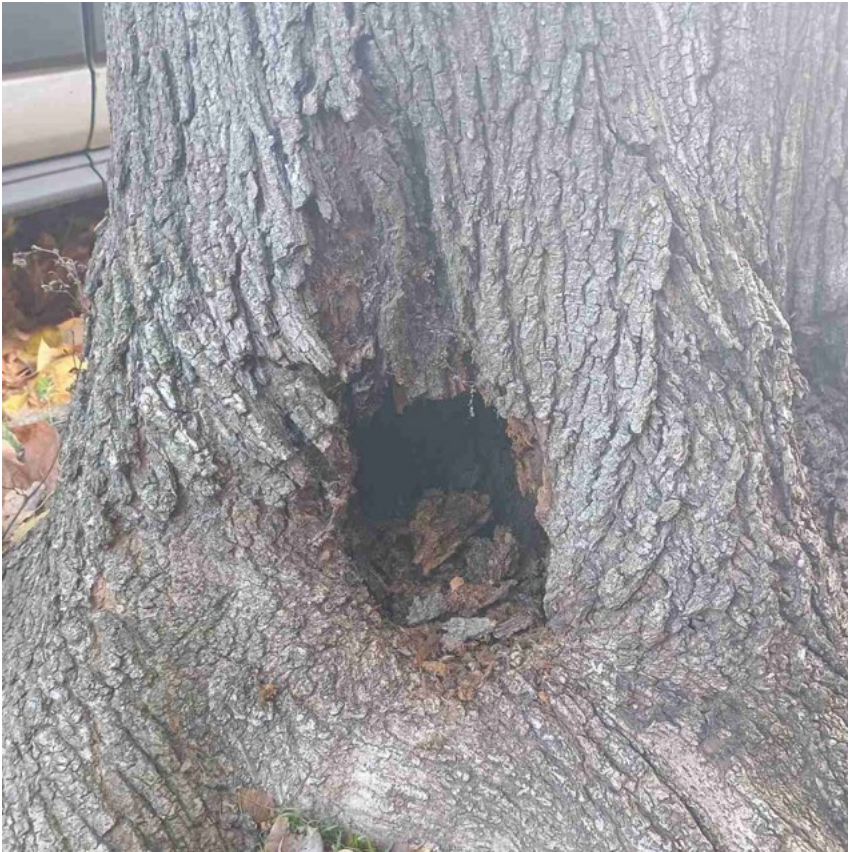
Ward	Barnes
Road	Glebe Road
Location	Opposite 51
Species	Norway Maples (<i>Acer platanoides</i>)
Height	13.0m
Physiological Condition	Fair
Structural Condition	Poor
Inspection findings/reason for exemption	This tree has a cavity at the base of trunk. Investigation with a probe revealed an unacceptable degree of decay inside the cavity. Removal is required to prevent natural failure, manage risk, and facilitate replanting.

Image shows cavity at base of stem.

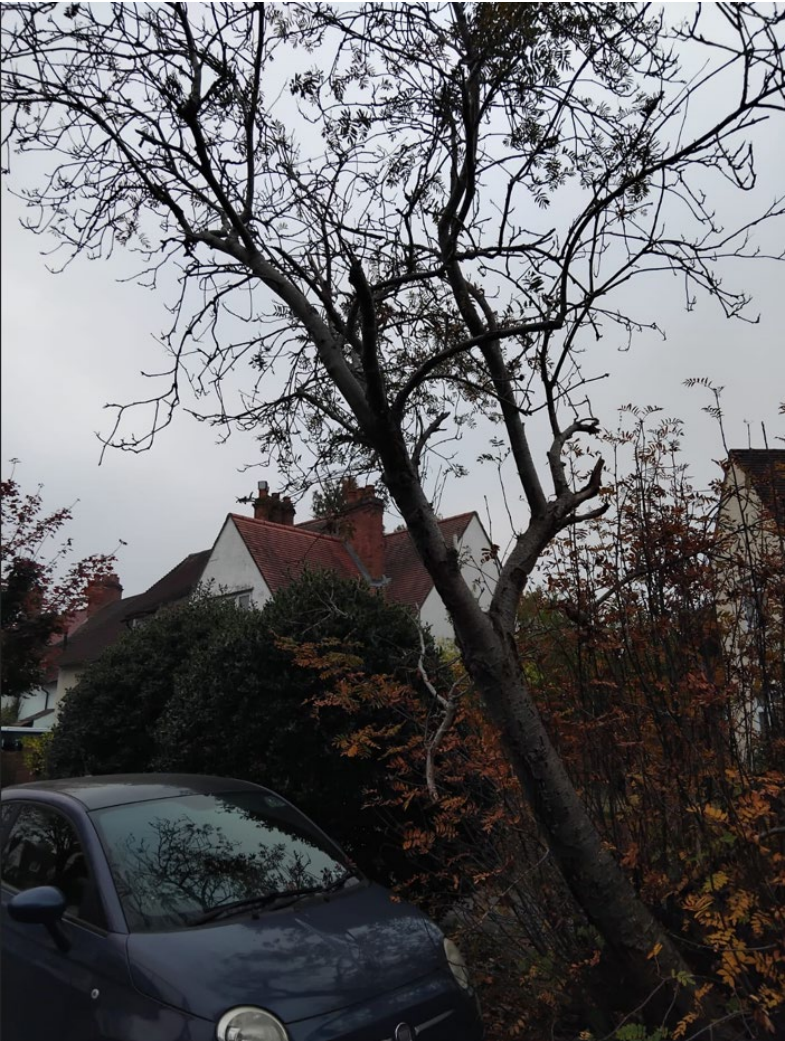
Ward	Fulwell and Hampton Hill
Road	Mays Road
Location	Outside 17 driveway
Species	Rowan (<i>Sorbus aucuparia</i>)
Height	6.0m
Physiological Condition	Poor
Structural Condition	Poor
Inspection findings/reason for exemption	A fungal fruiting body of the decay fungi <i>Ganoderma</i> sp. is present at the stem base. Colonisation by this fungus causes a white rot of the stem and root system that can cause entire trees to collapse through fracture or windthrow. Crown dieback indicates that the tree is under considerable physiological stress and likely advanced decay of the supporting root system. Removal is required to prevent natural failure and manage risk.

Image shows tree in street scene.

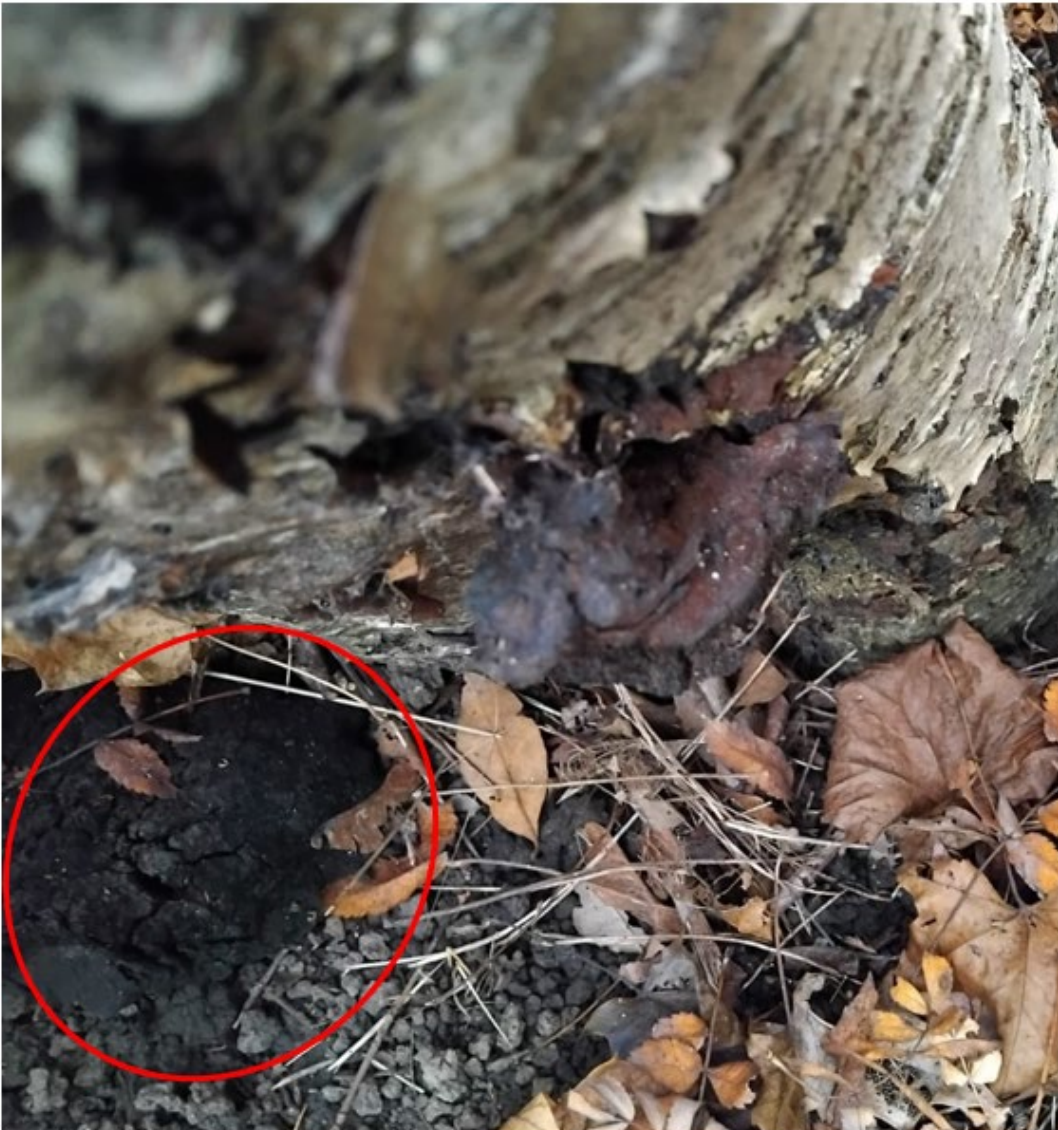
Image shows fruiting body circled.

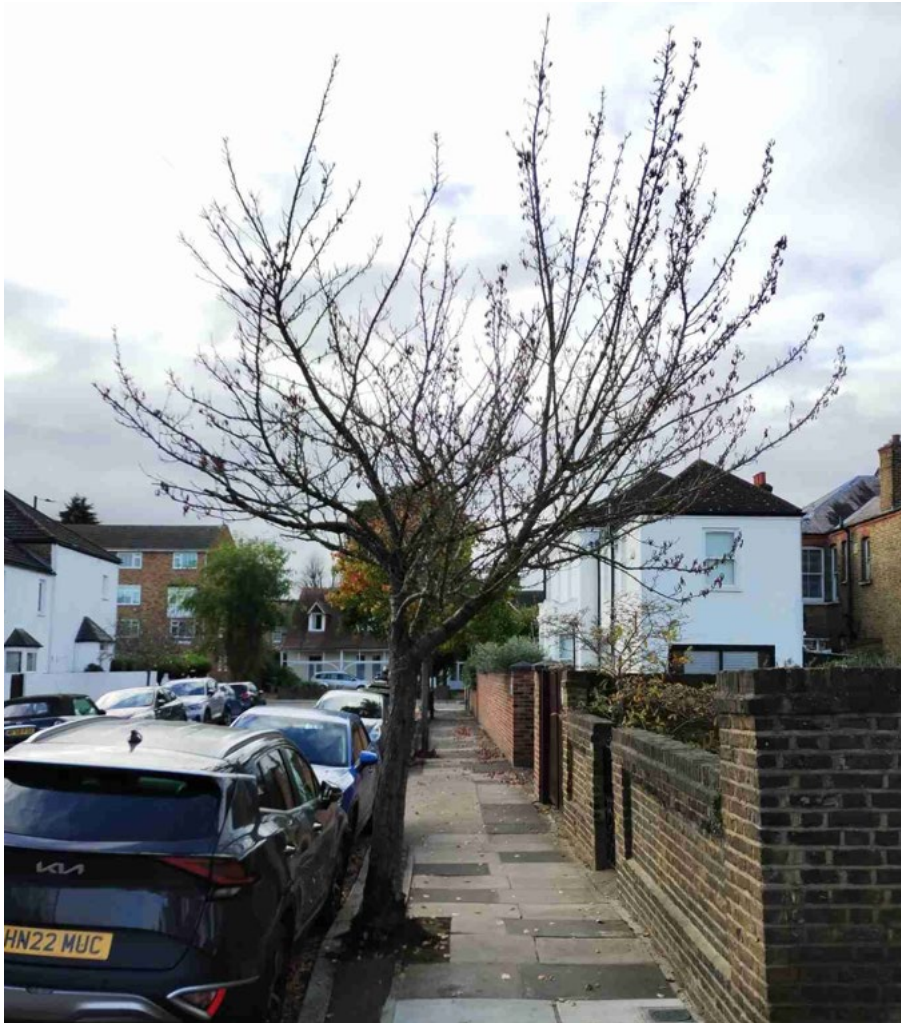
Ward	Hampton Wick and South Teddington
Road	St Winifreds Road
Location	Outside 1A
Species	Cherry (<i>Prunus sp.</i>)
Height	6.5m
Physiological Condition	Poor
Structural Condition	Poor
Inspection findings/reason for exemption	Fungal fruiting bodies of the decay fungi <i>Armillaria sp.</i> are present at the base of this tree. Colonisation by this fungus causes a white rot of the roots and butt that can cause entire tree failure. Crown dieback could correlate with the parasite present. Removal is required to prevent natural failure, manage risk, and facilitate replanting

Image shows tree in street scene.

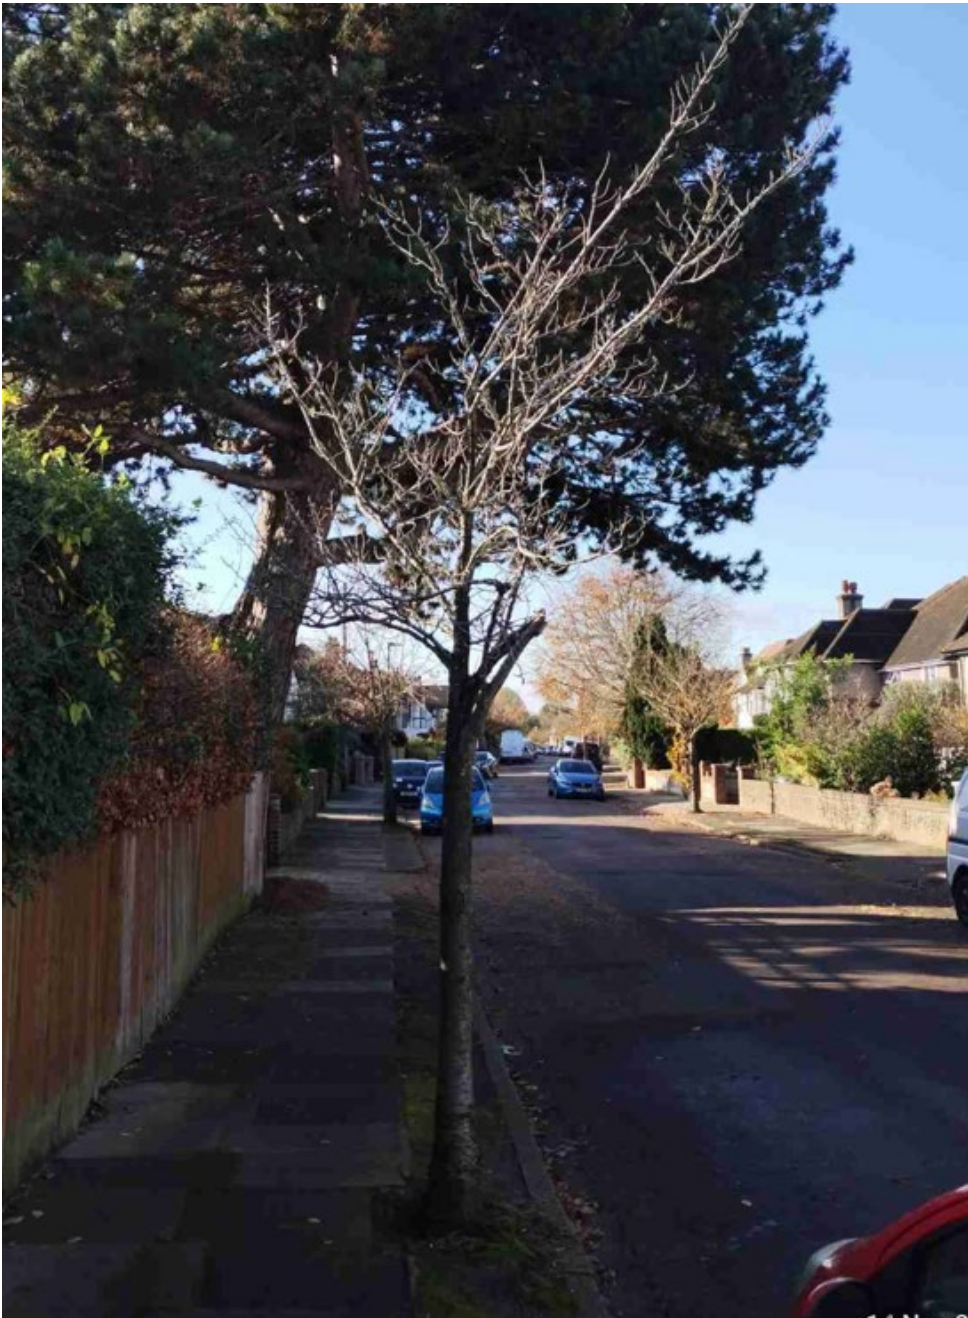
Ward	Hampton Wick and South Teddington
Road	St Winifreds Road
Location	Adjacent to 78 Broom Road rear garden
Species	Wild Cherry (<i>Prunus avium</i>)
Height	4.5m
Physiological Condition	Dead
Structural Condition	Dead
Inspection findings/reason for exemption	This tree is dead; removal is required to prevent natural failure, manage risk, and facilitate replanting

Image shows dead tree in street scene.

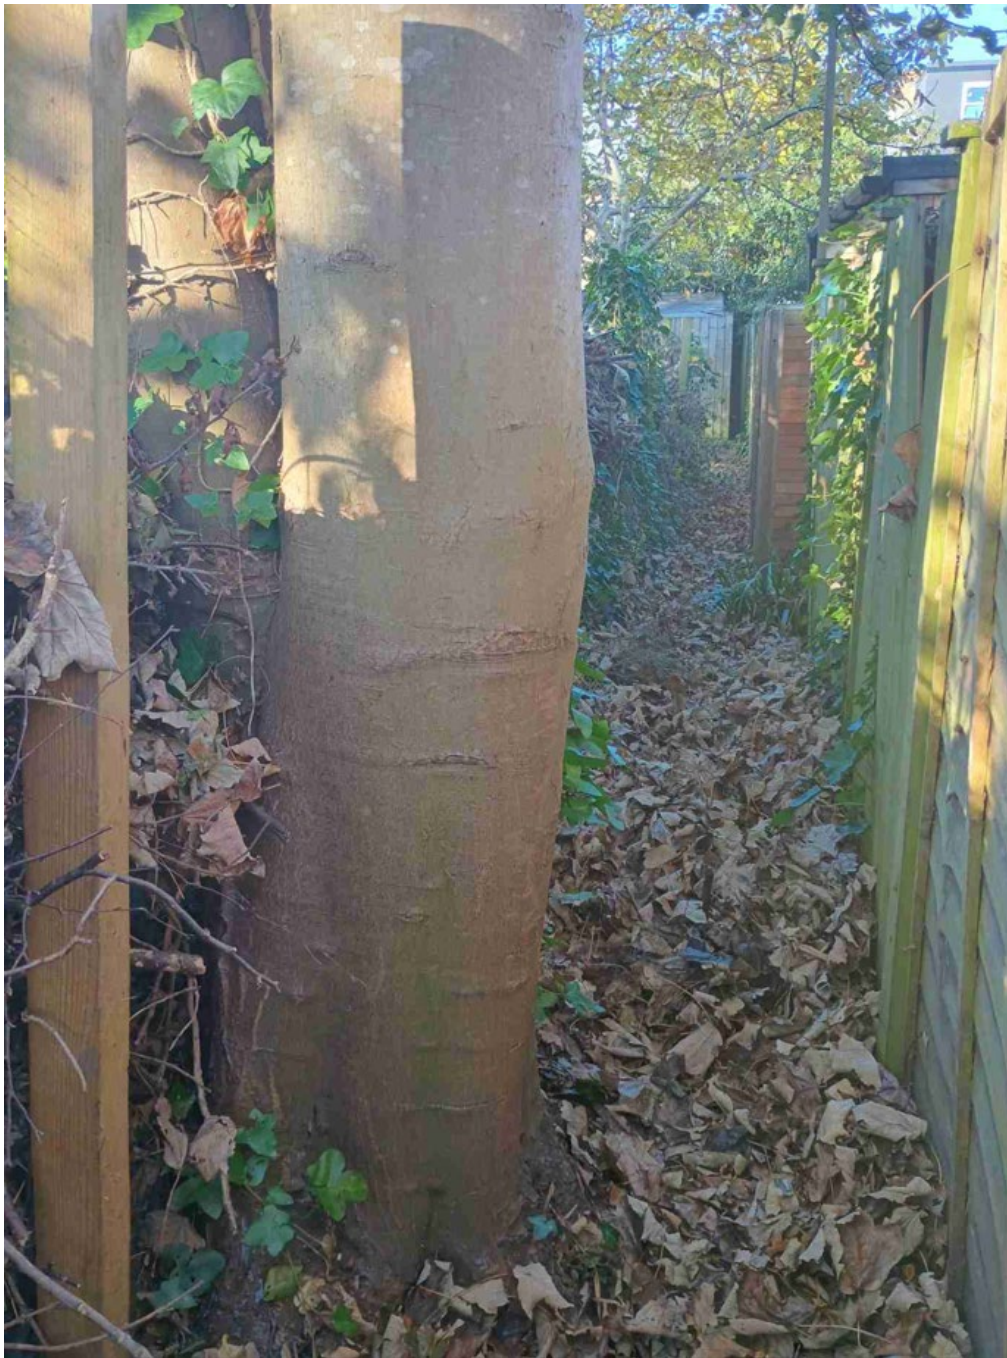
Ward	Hampton Wick and South Teddington
Road	School House Lane
Location	In alleyway between open space and to the rear of houses- ///buns.roof.broke
Species	Sycamore (<i>Acer pseudoplatanus</i>)
Height	12.0m
Physiological Condition	Good
Structural Condition	Good
Inspection findings/reason for exemption	This tree is causing an unreasonable obstruction to a passage with a designated right of way, which the council is obligated to keep clear. The only viable solution in this situation is to remove the tree to restore unobstructed access to the path.

Image shows trunk blocking right of way.

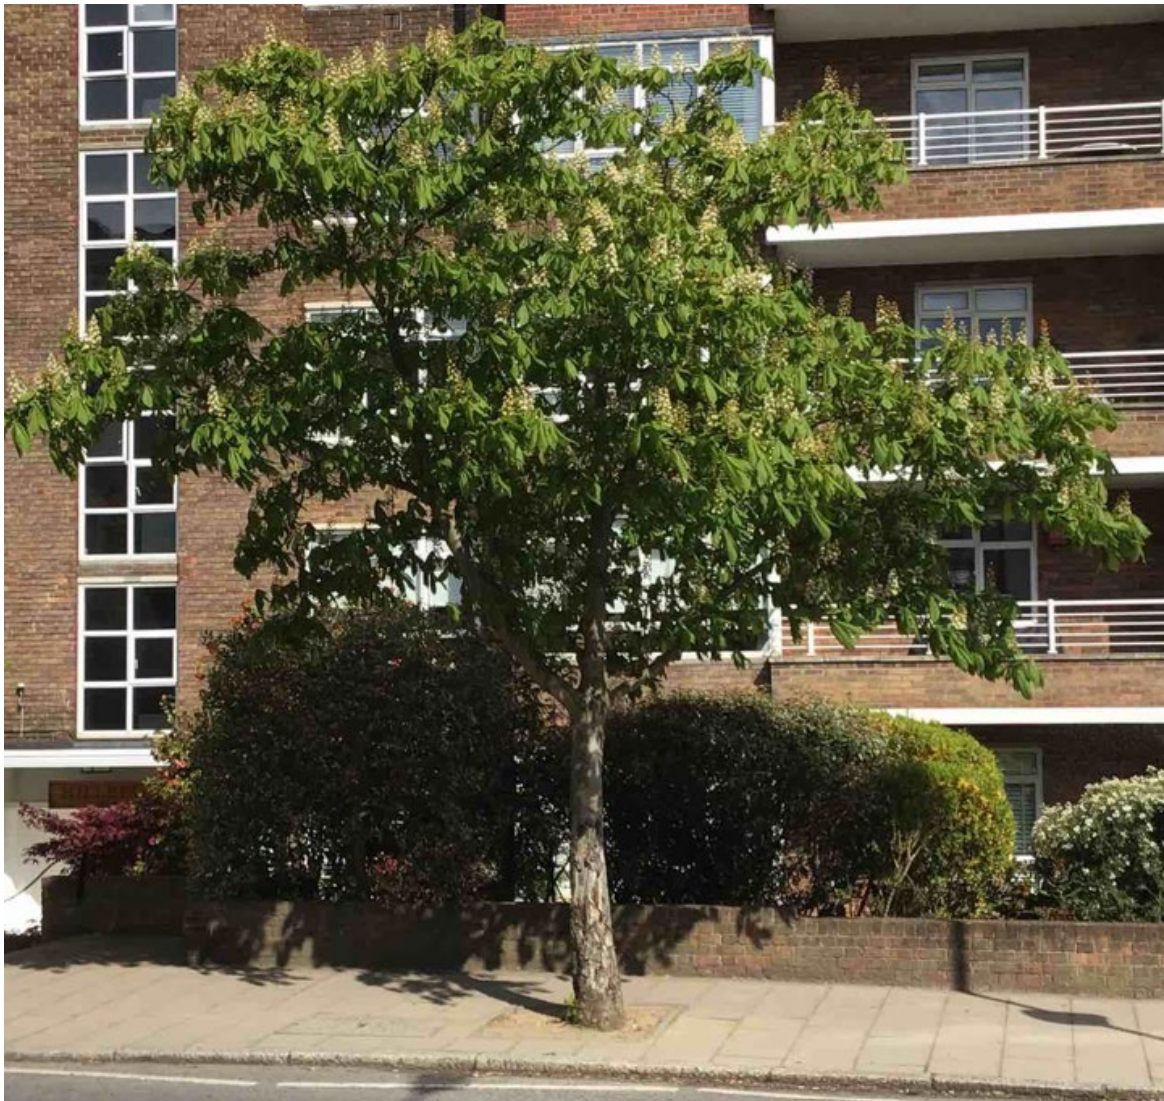
Ward	South Richmond
Road	Friars Stile Road
Location	Opposite Terrace Lane
Species	Horse Chestnut (<i>Aesculus hippocastanum</i>)
Height	7.0m
Physiological Condition	Fair
Structural Condition	Poor
Inspection findings/reason for exemption	This is a retrospective notice of this tree being felled, as our contractor noted an unacceptable amount of bark necrosis and stem decay which would lead to dysfunction of the vascular system, and which would course the tree to decline and stem failure. Removal was required to prevent natural failure, manage risk, and facilitate replanting.

Image shows tree in street scene.

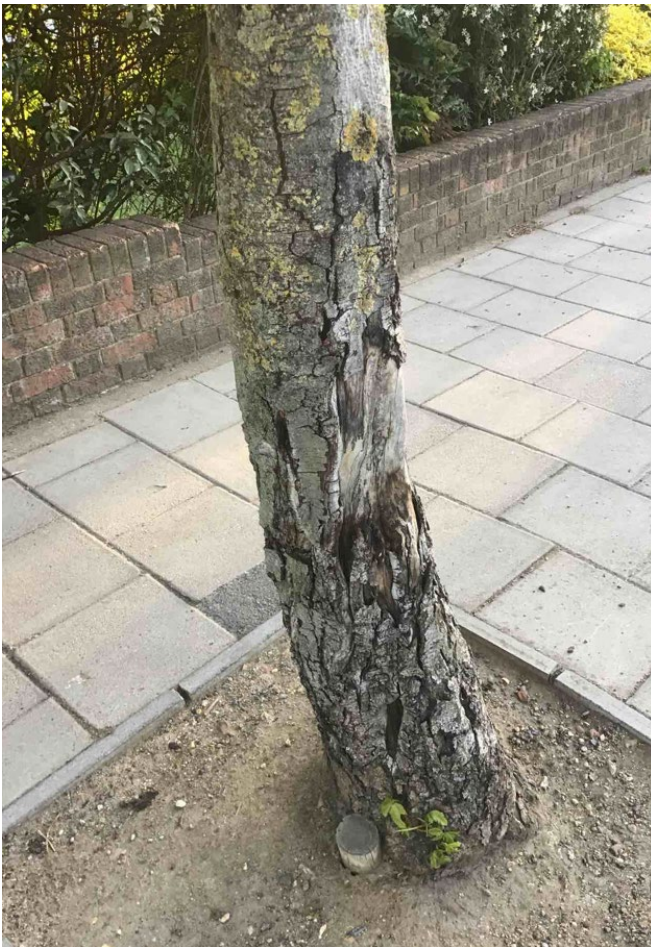
Image shows bleeding bark cankering with associated necroses on trunk.

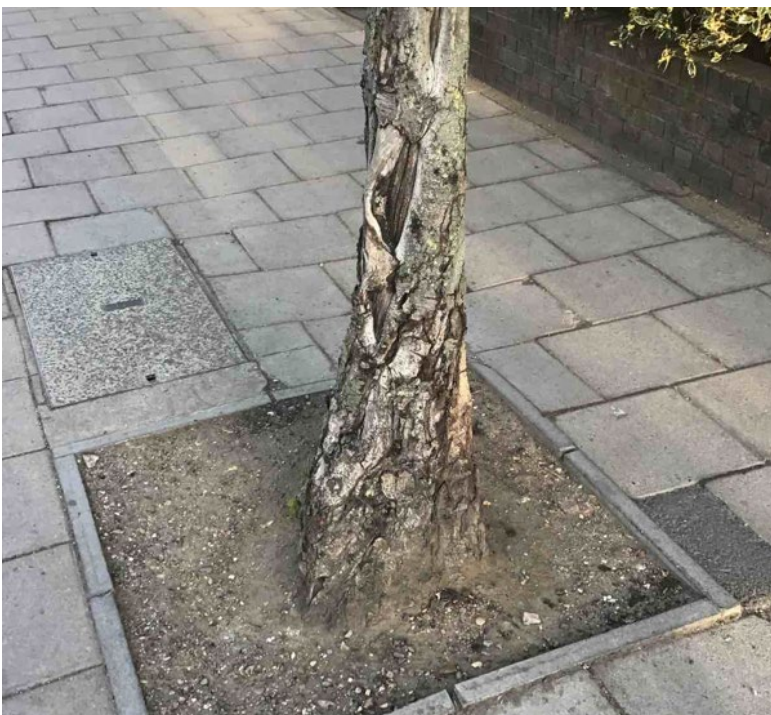
Image shows bleeding bark cankering with associated necroses on trunk.

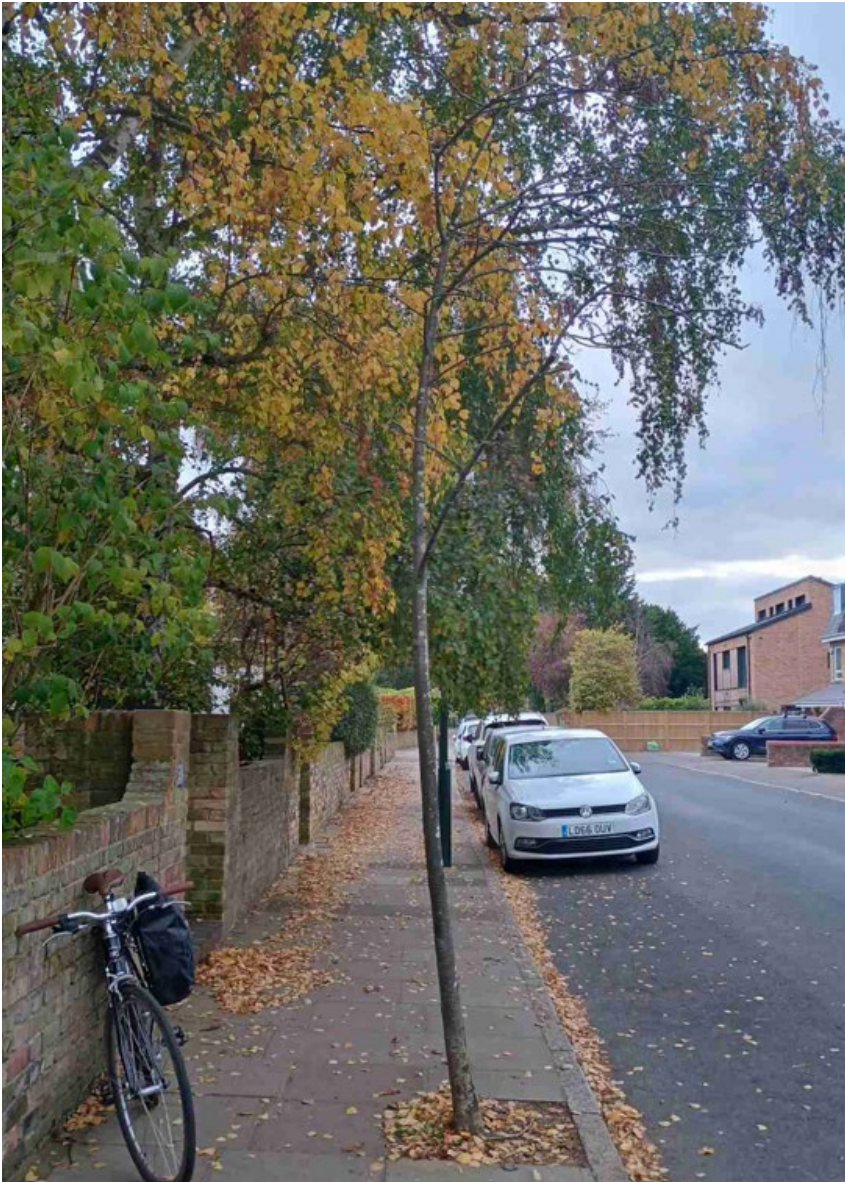
Ward	South Twickenham
Road	Popes Avenue
Location	Outside 59
Species	Rowan (<i>Sorbus aucuparia</i>)
Height	5.0m
Physiological Condition	Dead
Structural Condition	Dead
Inspection findings/reason for exemption	This tree is dead; removal is required to prevent natural failure, manage risk, and facilitate replanting

Image shows dead tree in street scene.
