November 2024 - Reactive Tree Works Programme

A survey of trees in the Barnes ward are currently being undertaken; this is being conducted by specialist arboricultural officers as part of the scheduled 4 yearly detailed inspection regime that has been devised for all Council highway and parks trees.

Recent reactive inspections have identified the need for 40 individual tree work operations to take place. This work will now be issued to the Council's Arborist Contractor KPS, for completion over the winter period.

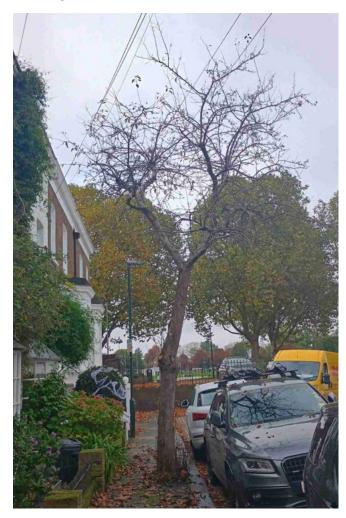
Ward	Barnes
Road	Lillian Road
Location	Outside 3
Species	Apple (Malus sp.)
Height	7.5m
Physiological Condition	Poor
Structural Condition	Poor
	A fungal fruiting body of the decay fungi <i>Ganoderma</i> sp. is present at the stem base. Colonisation by this fungus causes a white rot of the stem and root system that can cause entire trees to collapse through fracture or windthrow. A resonance test and revealed an unacceptable degree of decay in the trunk of this tree. Crown dieback indicates that the tree is under considerable physiological stress and likely advanced decay of
Inspection findings/reason	the supporting root system. Removal is required to prevent
for exemption	natural failure, manage risk, and facilitate replanting

Image shows moribund tree in street scene

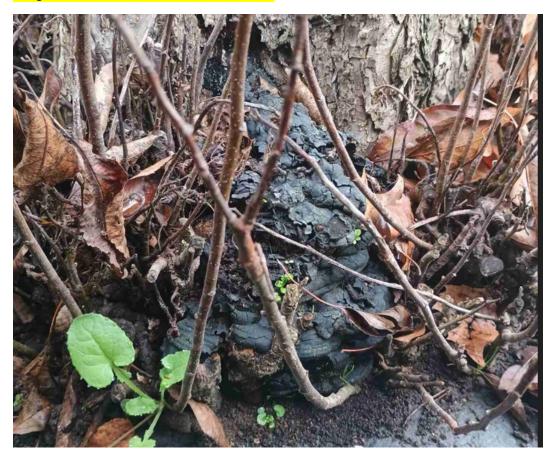
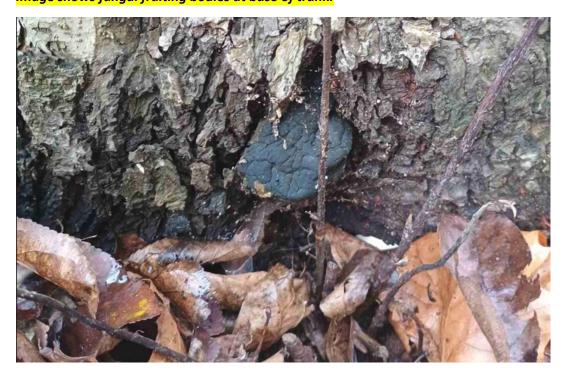
Image shows fungal fruiting bodies at base of trunk.

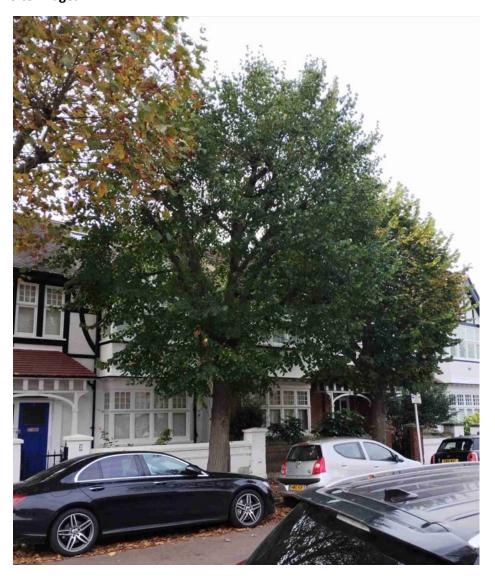
Ward	Barnes
Road	Ferry Road
Location	Outside 3
Species	Common Lime (Tilia x europaea)
Height	11.0m
Physiological Condition	Fair
Structural Condition	Poor
	A fungal fruiting body of the decay fungi Ganoderma sp. is
	present at the stem base. Colonisation by this fungus causes a
	white rot of the stem and root system that can cause entire
	trees to collapse through fracture or windthrow. A resonance
	test and probing revealed an unacceptable degree of decay in
Inspection findings/reason	the trunk of this tree. Removal is required to prevent natural
for exemption	failure, manage risk, and facilitate replanting

Image shows tree in street scene

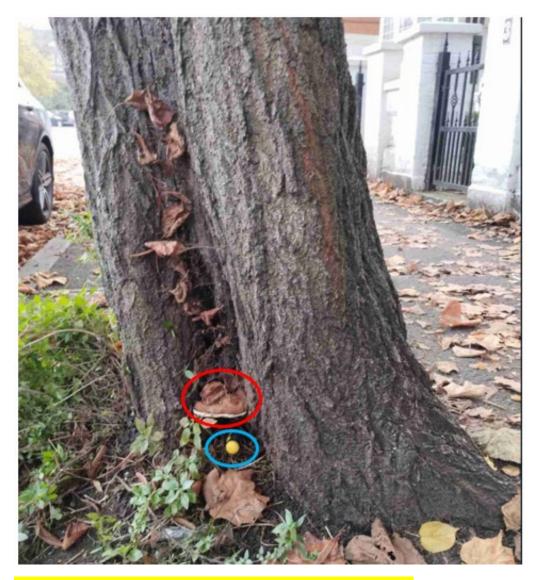
Image shows fruiting body circled in red and probe circled in blue.

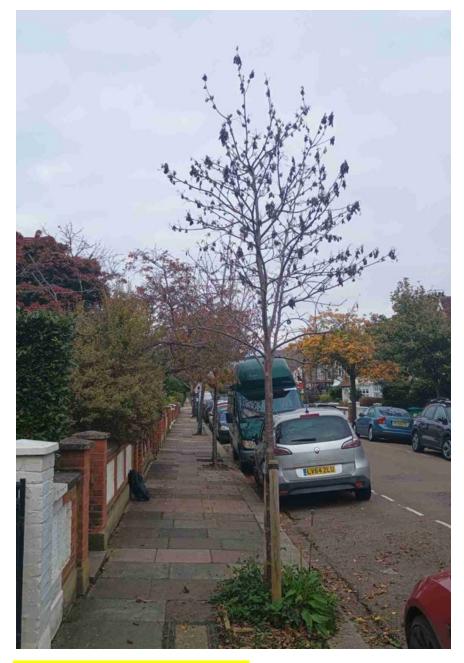
Ward	Barnes
Road	Madrid Road
Location	Outside 83
Species	Swedish Whitebeam (Sorbus intermedia)
Height	4.0m
Physiological Condition	Dead
Structural Condition	Dead
Inspection findings/reason	This tree is dead; removal is required to prevent natural failure,
for exemption	manage risk and facilitate replanting

Image shows dead tree in street scene.

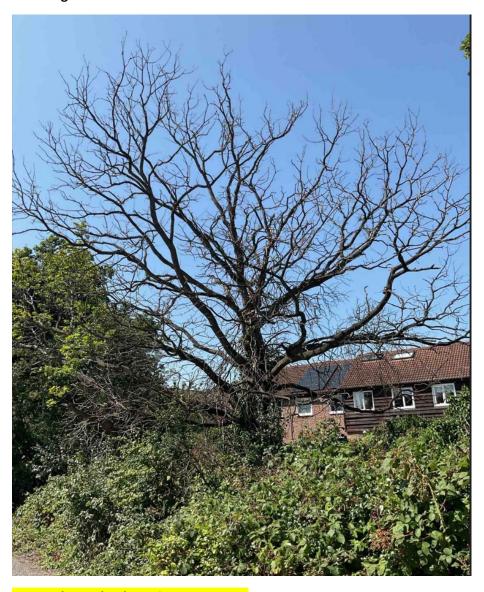
Ward	Hampton North
Road	Old Farm Road
Location	Opposite Holotory
Species	Common Oak (Quercus robur)
Height	12.0m
Physiological Condition	Dead
Structural Condition	Dead
	This tree is dead; removal is required to prevent natural failure
Inspection findings/reason	and manage risk. A 1.5m high stump will be left for ecological
for exemption	purposes.

Image shows dead tree in street scene.

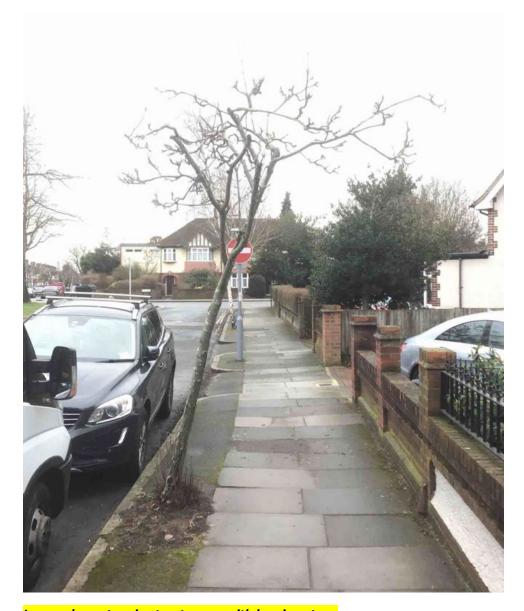
Ward	Heathfield
Road	Montrose Avenue
Location	Outside 3/5
Species	Rowan (Sorbus aucuparia)
Height	3.5m
Physiological Condition	Fair
Structural Condition	Poor
	This tree has a progressive lean due to partial root failure.
Inspection findings/reason	Removal is required to prevent natural failure, manage risk, and
for exemption	facilitate replanting

Image shows tree in street scene with leaning stem.

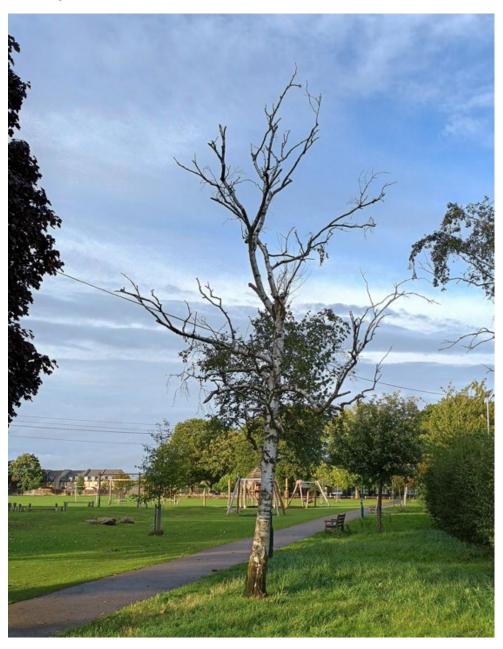
Ward	Heathfield
Road	Powder Mill Lane
Location	Heathfield Recreation Ground-///risen.atomic.plus
Species	Silver Birch (Betula pendula)
Height	10.0m
Physiological Condition	Poor
Structural Condition	Poor
	This tree is in a moribund state with over 90 % of the crown
Inspection findings/reason	being dead. Removal is required to prevent natural failure,
for exemption	manage risk, and facilitate replanting.

Images shows moribund tree in park scene.

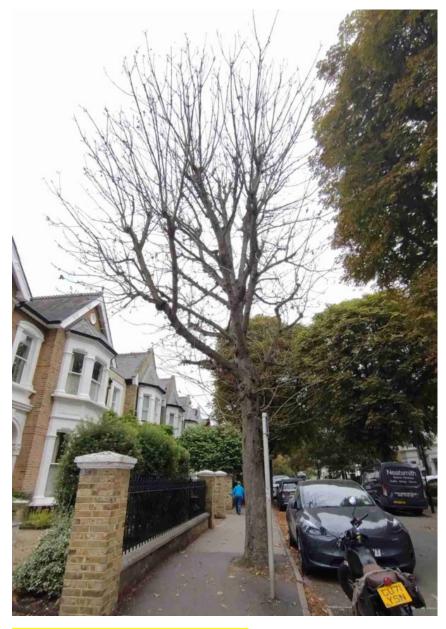
Ward	Kew
Road	Lichfield Road
Location	Outside 9
Species	Horse Chestnut (Aesculus hippocastanum)
Height	11.5m
Physiological Condition	Dead
Structural Condition	Dead
Inspection findings/reason	This tree is dead; removal is required to prevent natural failure,
for exemption	manage risk, and facilitate replanting

Image shows dead tree in street scene.

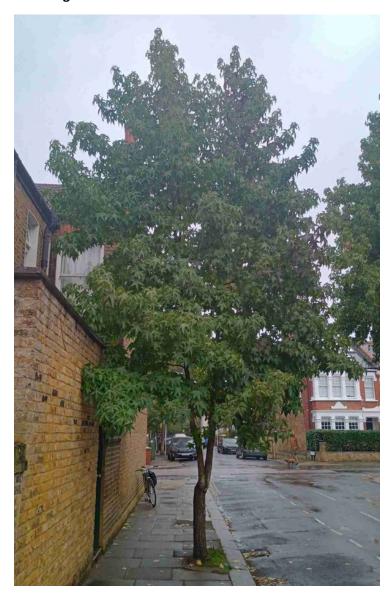
Ward	Kew
Road	Defoe Avenue
Location	Adjacent to 9 Ruskin Avenue main building
Species	Sweet Gum (<i>Liquidambar styraciflua</i>)
Height	8.0m
Physiological Condition	Good
Structural Condition	Poor
	This tree has major stem failure due to a wide mouthed bark included union. This feature is a weak form of branch union that has caused the stem to fail. This tree now presents an
Inspection findings/reason	unacceptable risk of further failure and removal is required
for exemption	manage risk and facilitate replanting.

Image shows tree in street scene.

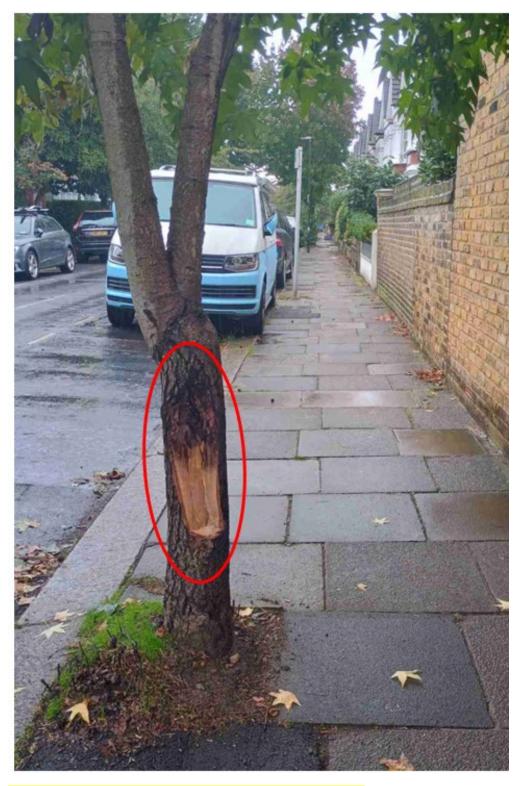
Image shows wound from failed wide mouth union circled.

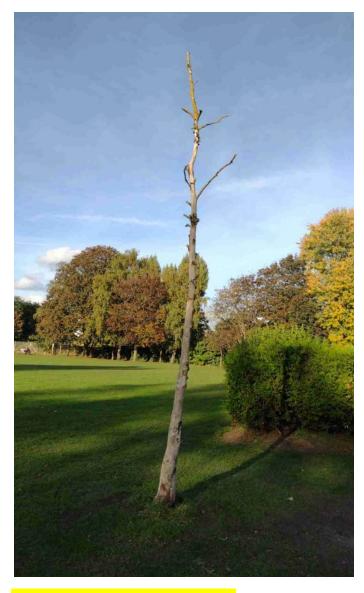
Ward	Mortlake and Barnes Common
Road	Vine Road
Location	Vine Road Rec. Ground- ///taker.hunter.covers
Species	Common Alder (Alnus glutinosa)
Height	5.0m
Physiological Condition	Dead
Structural Condition	Dead
Inspection findings/reason	This tree is dead; removal is required to prevent natural failure,
for exemption	manage risk, and facilitate replanting.

Image shows dead tree in park scene

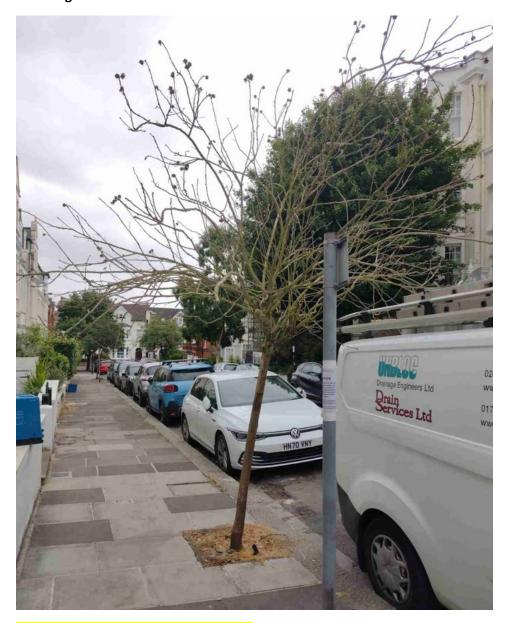
Ward	South Richmond
Road	Onslow Avenue
Location	Outside 16
Species	Rose of Sharon (Hibiscus x resi)
Height	3.5m
Physiological Condition	Dead
Structural Condition	Dead
Inspection findings/reason	This tree is dead; removal is required to prevent natural failure,
for exemption	manage risk, and facilitate replanting.

Image shows dead tree in street scene.

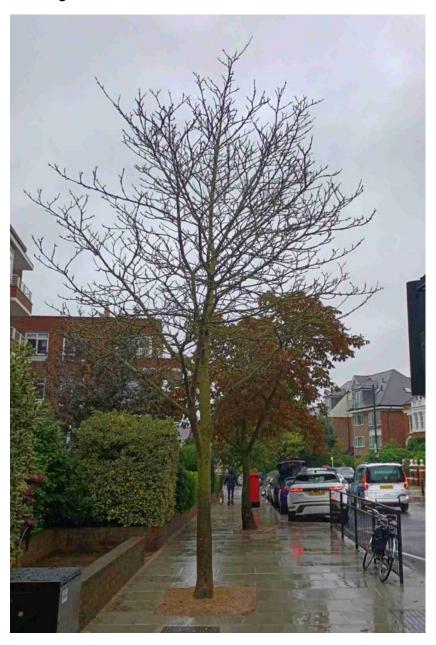
Ward	South Richmond
Road	Friars Stile Road
Location	Opposite 4
Species	Indian horse Chestnut (Aesculus indica)
Height	9.5m
Physiological Condition	Dead
Structural Condition	Dead
Inspection findings/reason	This tree is dead; removal is required to prevent natural failure,
for exemption	manage risk, and facilitate replanting

Image shows dead tree in street scene

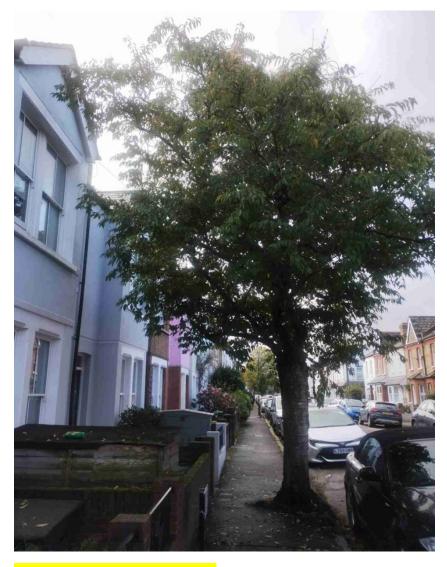
Ward	South Twickenham
Road	Gould Road
Location	Outside 5
Species	Cherry (<i>Prunus sp.</i>)
Height	8.0m
Physiological Condition	Good
Structural Condition	Good
	Tree has raised and damaged roots causing trip hazards and an unacceptable obstruction to the pavement making an impasse for Prams & wheelchairs to safely pass. With no engineering solution available to resolve this issue, we are unable to meet
Inspection findings/reason	our duties under the Equality Act 2010. For this reason, removal
for exemption	is required to manage risk and facilitate replanting.

Image shows tree in street scene.

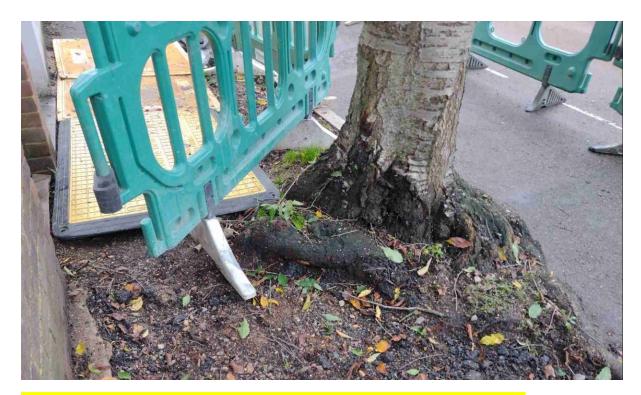
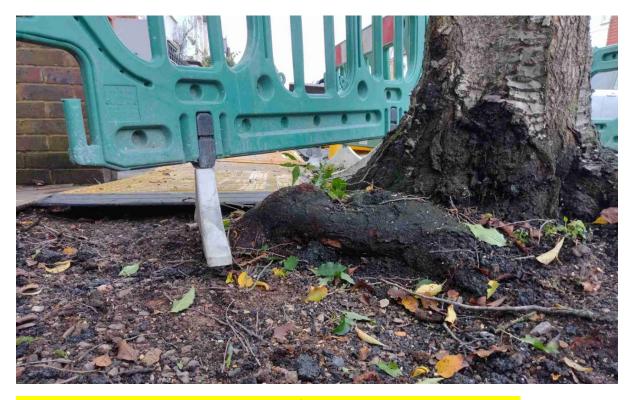
Image shows exposed damage roots at base of trunk obstructing pavement access.

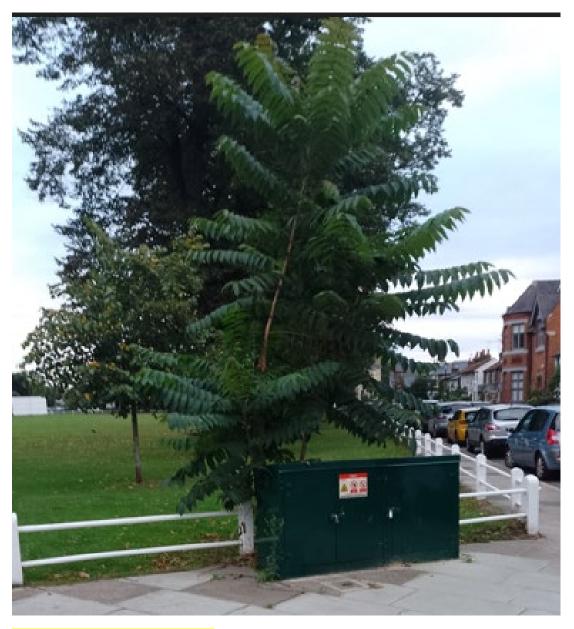
Ward	South Twickenham
Road	The Green
Location	Twickenham Green- ///snaps.ties.effort
Species	Tree of Heaven (Ailanthus altissima)
Height	5.0m
Physiological Condition	Good
Structural Condition	Good
	Tree is growing in an unsuitable location and if left to grow will
Inspection findings/reason	cause damage to services cabinet. Removal is required for this
for exemption	reason.

Image shows tree in street scene.

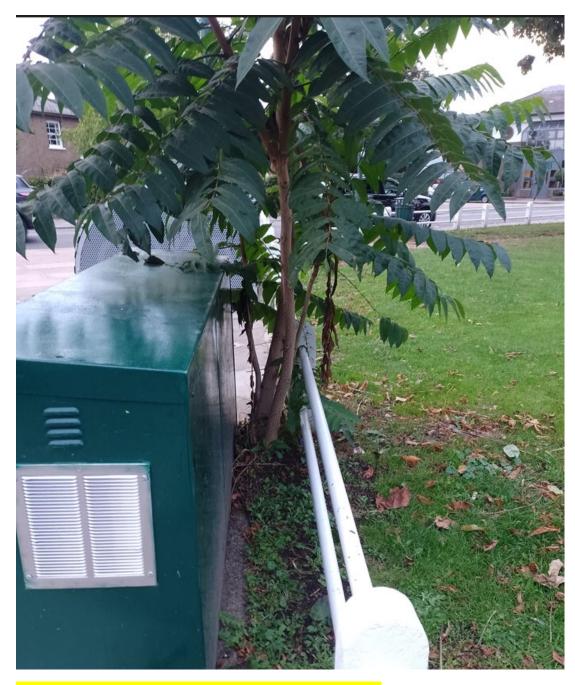
Image show's location of tree in relation to services cabinet.

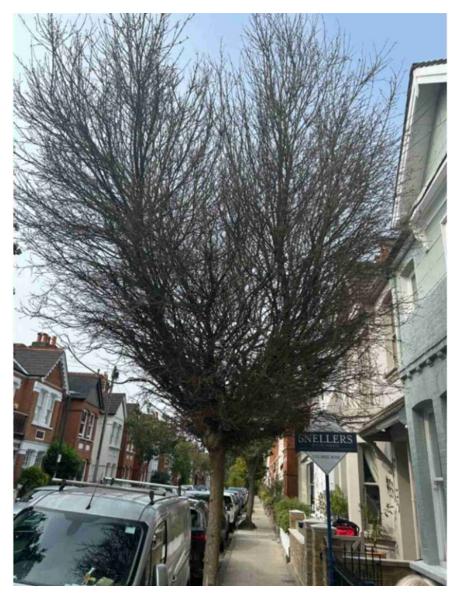
Ward	St Margarets and North Twickenham
Road	Napoleon Road
Location	Outside 11
Species	Field Maple (Acer campestre)
Height	5.5m
Physiological Condition	Dead
Structural Condition	Dead
Inspection findings/reason	This tree is dead; removal is required to prevent natural failure,
for exemption	manage risk, and facilitate replanting.

Image shows dead tree in street scene.

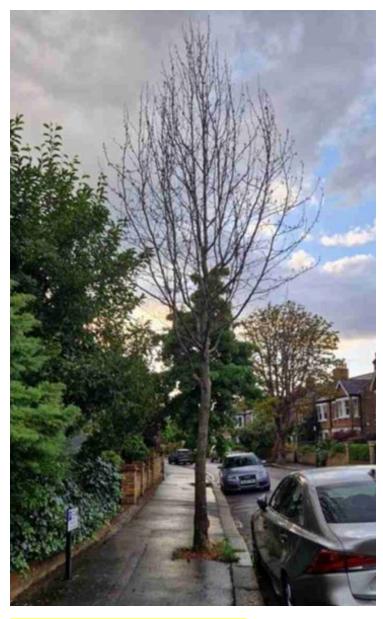
Ward	Teddington
Road	Clarence Road
Location	Outside 48
Species	Sweet Gum (<i>Liquidambar styraciflua</i>)
Height	8.0m
Physiological Condition	Dead
Structural Condition	Dead
Inspection findings/reason	This tree is Dead; removal is required to prevent natural failure,
for exemption	manage risk, and facilitate replanting

Image shows dead tree in street scene.

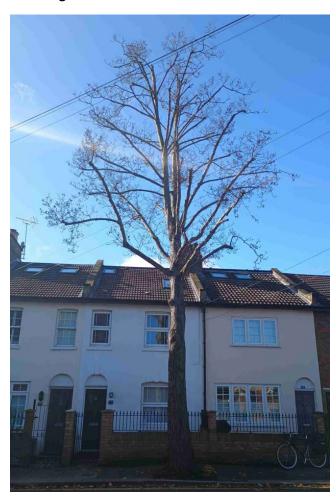
Road	Waldegrave Road
Location	Outside 17
Species	Italian alder (Alnus cordata)
Height	14.0m
Physiological Condition	Poor
Structural Condition	Poor
Inspection findings/reason for exemption	Fungal fruiting bodies of the decay fungi <i>Armillaria</i> sp. are present at the base of this tree. Colonisation by this fungus causes a white rot of the roots and butt that can cause entire tree failure. Crown dieback could correlate with the parasite present. Removal is required to prevent natural failure, manage risk, and facilitate replanting

Image shows moribund tree in street scene.

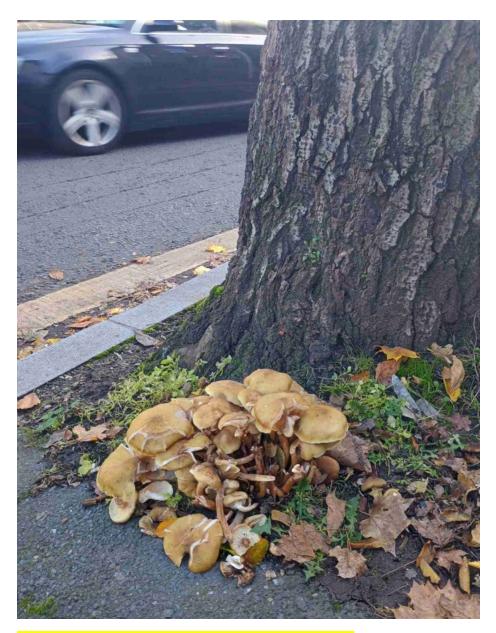
Image shows fruiting bodies at base of trunk in tree pit.

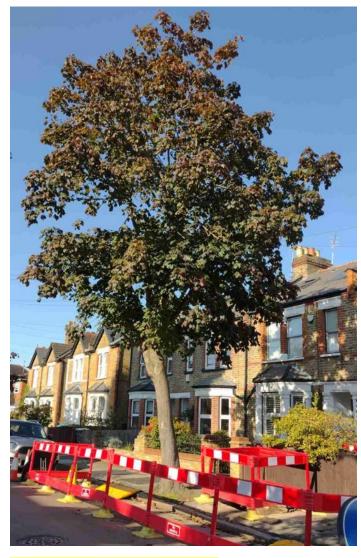
Ward	Whitton
Road	Cedar Avenue
Location	Outside 14/16
Species	Norway Maple (Acer platanoid. 'Crimson King')
Height	8.0m
Physiological Condition	Good
Structural Condition	Poor
	This tree has cracks at the main unions which are a weak point
	for failure to occur from and also extensive damage caused by
Inspection findings/reason	high sided vehicle strike. Removal is required to prevent natural
for exemption	failure and facilitate replanting.

Images shows tree in street scene.

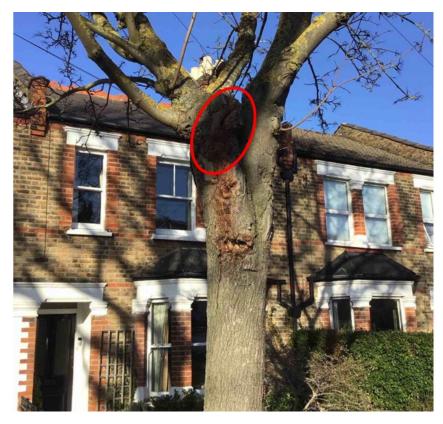
Images shows cracks at the main unions.

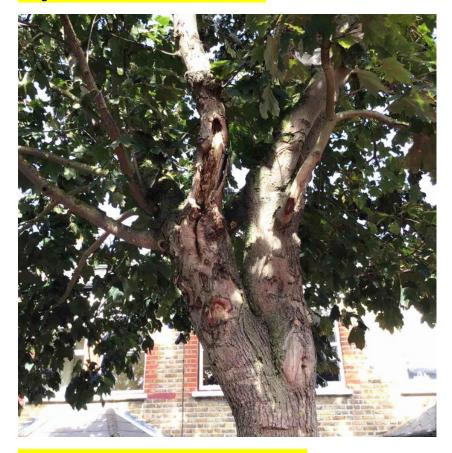
Images shows damage caused by vehicle strike.
