February 2025 - Reactive Tree Works Programme

Introduction

Dated 16.02.2025

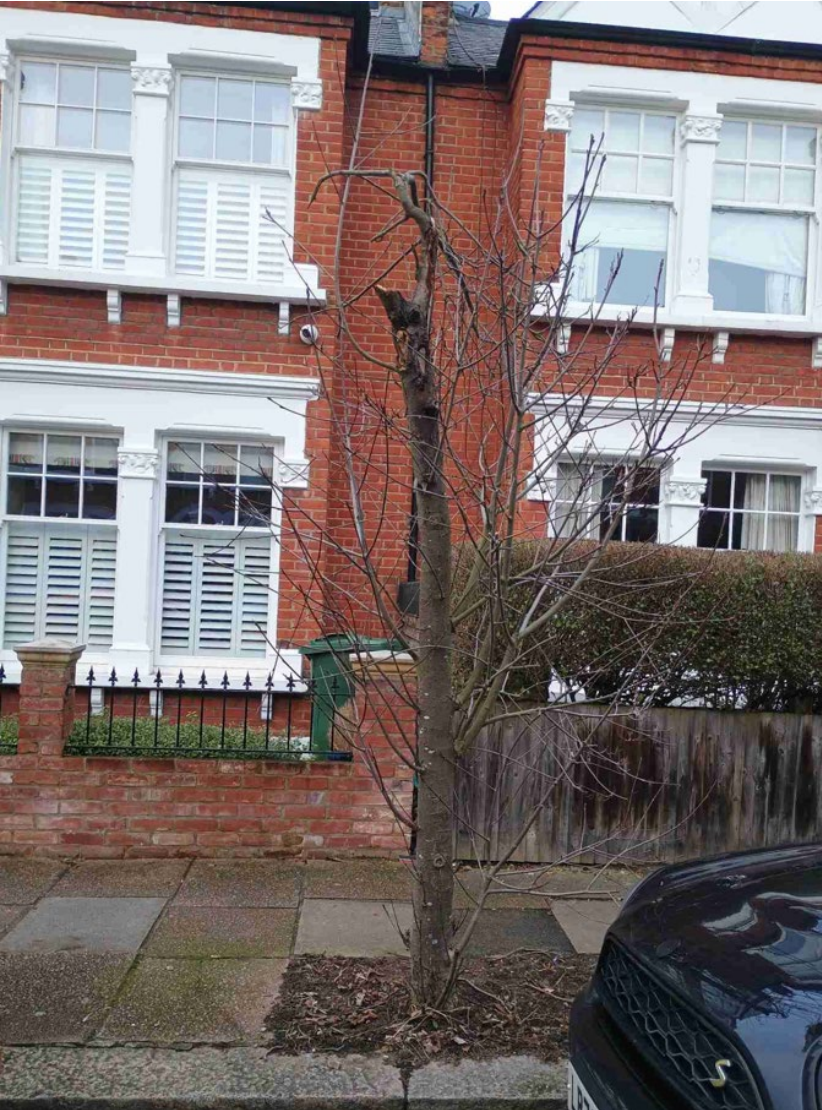
Ward	Barnes
Road	Meredyth Road
Location	Outside 19/21
Species	Swedish whitebeam (<i>Sorbus x intermedia</i>)
Height	4.0m
Physiological Condition	Poor
Structural Condition	Poor
Inspection findings/reason for exemption	This tree is in a state of physiological decline with an unacceptable amount of decay to the trunk. This has led to the loss of the trees crown through stem failure. Removal is required to prevent further natural failure, manage risk, and facilitate replanting.

Image shows tree in street scene

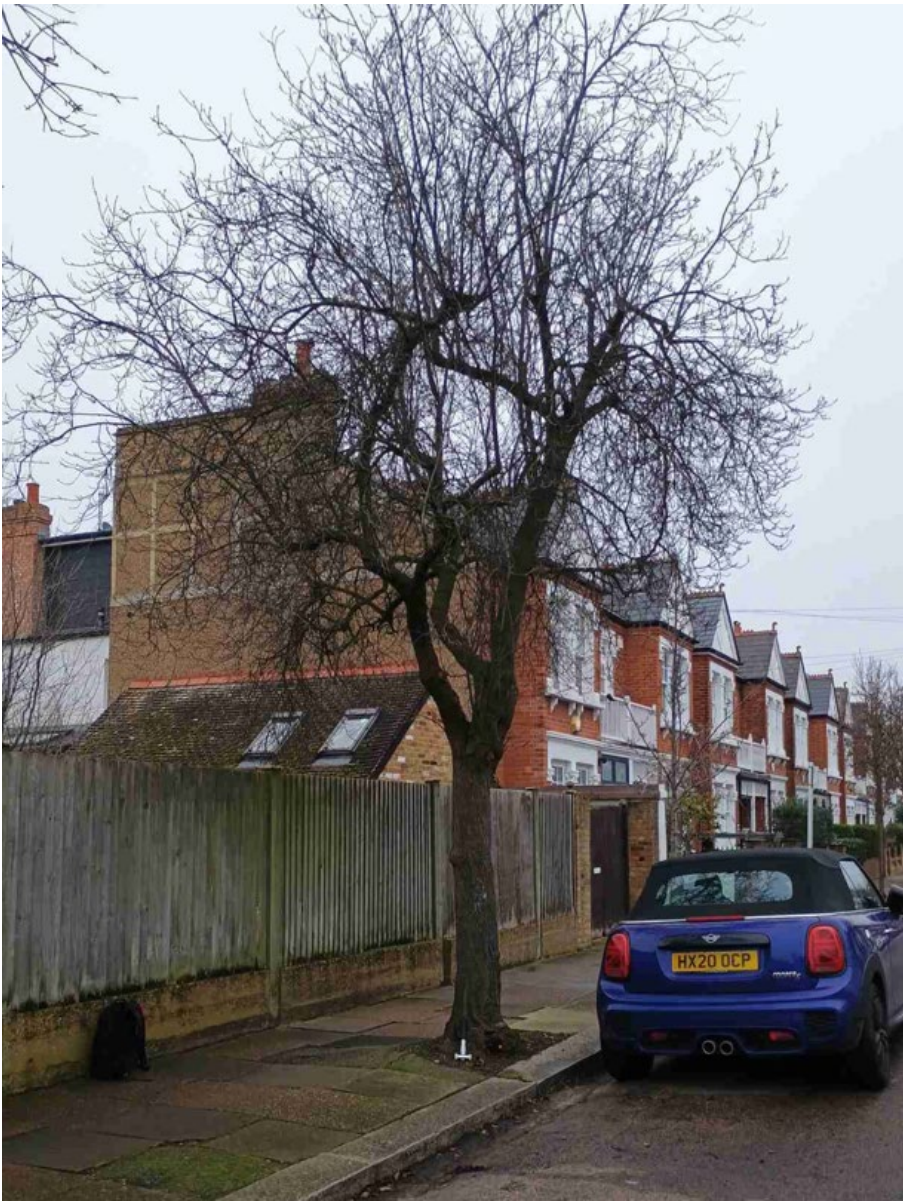
Ward	Barnes
Road	Meredyth Road
Location	Adjacent to 23 Glebe Road bottom end of rear garden
Species	Cherry Plum (<i>Prunus cerasifera</i>)
Height	8.0m
Physiological Condition	Fair
Structural Condition	Poor
Inspection findings/reason for exemption	Investigation with a probe and a resonance test with a sounding hammer has revealed an unacceptable amount of decay beyond the visible cavities on the trunk. Removal is required to prevent natural failure, manage risk, and facilitate replanting.

Image shows tree in street scene.

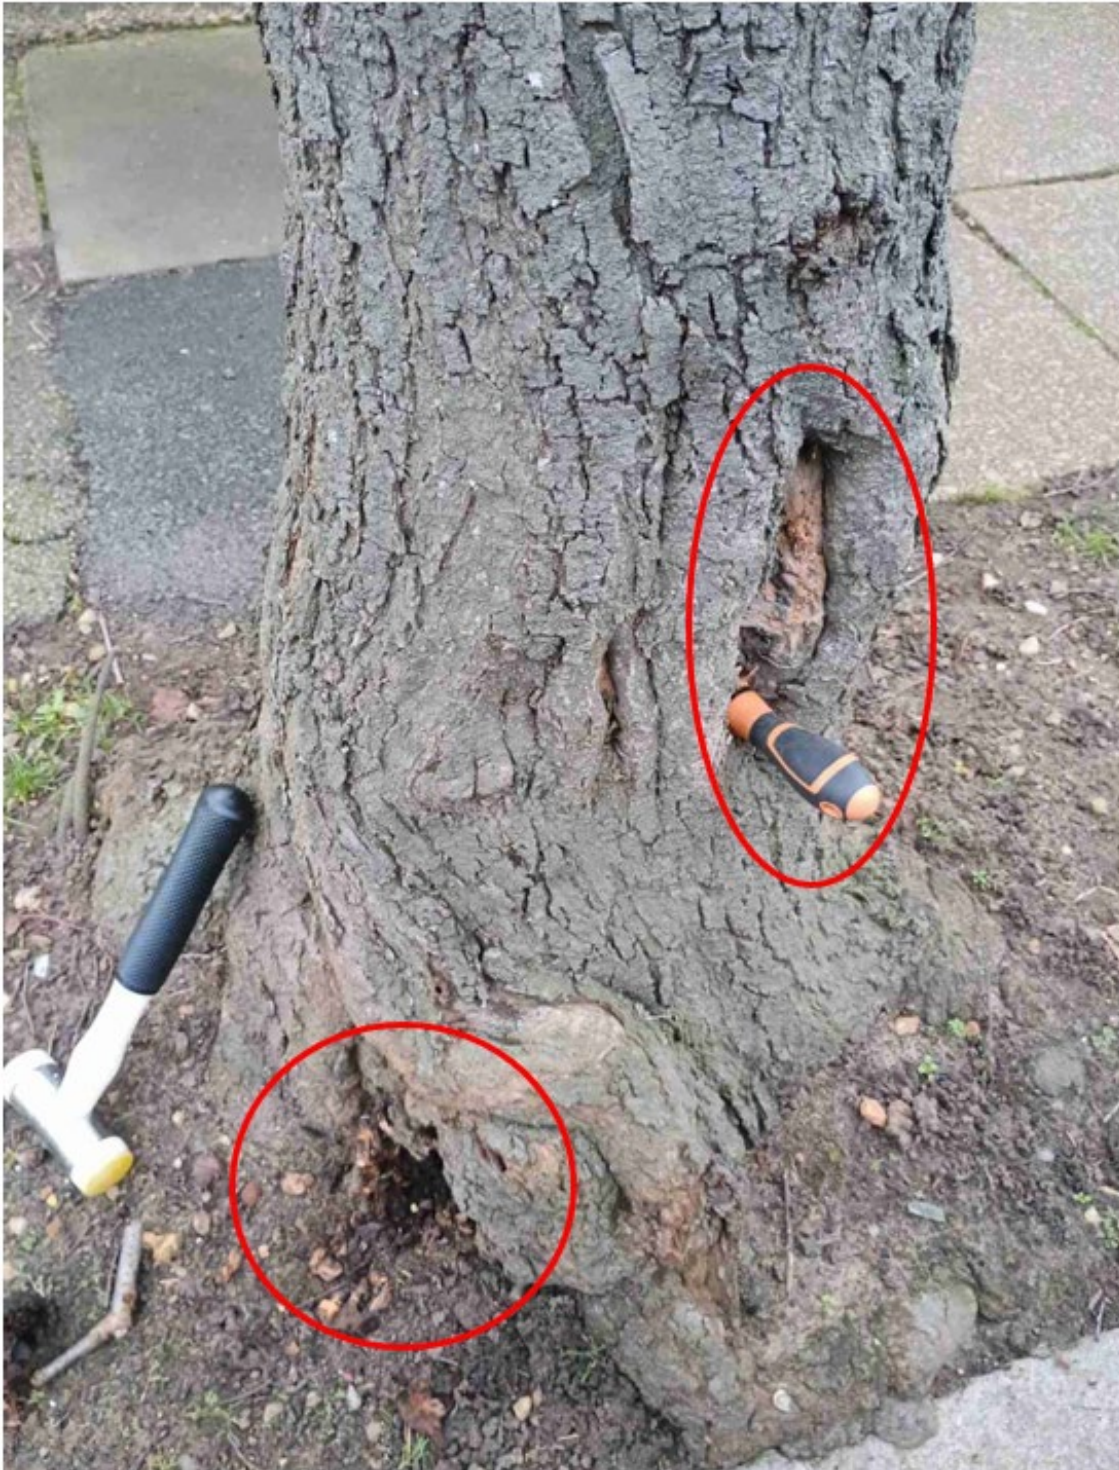
Image shows cavities with probe highlighting decay on stem circled in red.

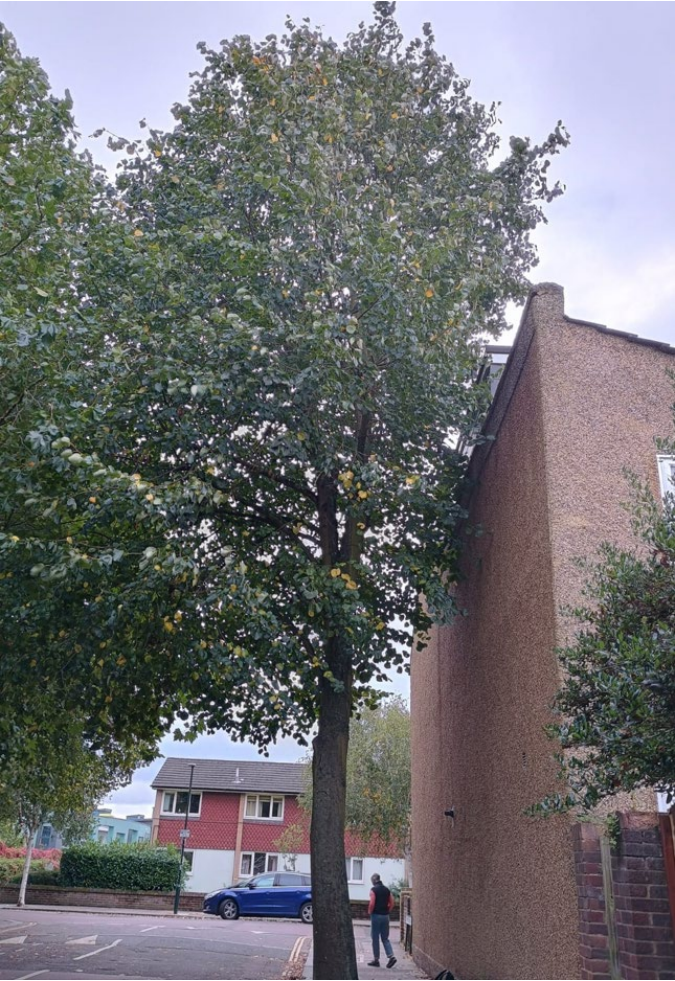
Ward	Fulwell and Hampton Hill
Road	Elmtree Road
Location	Adjacent to 41 Somerset Road
Species	Lime (<i>Tilia</i> sp.)
Height	13.0m
Physiological Condition	Good
Structural Condition	Good
Inspection findings/reason for exemption	This tree has raised and damaged roots causing trip hazards and an unacceptable obstruction to the pavement making an impasse for prams & wheelchairs to safely pass. With no engineering solution available to resolve this issue, we are unable to meet our duties under the Equality Act 2010. For this reason, removal is required to manage risk and facilitate replanting. Removal is required to manage risk and facilitate replanting.

Image shows tree in street scene.

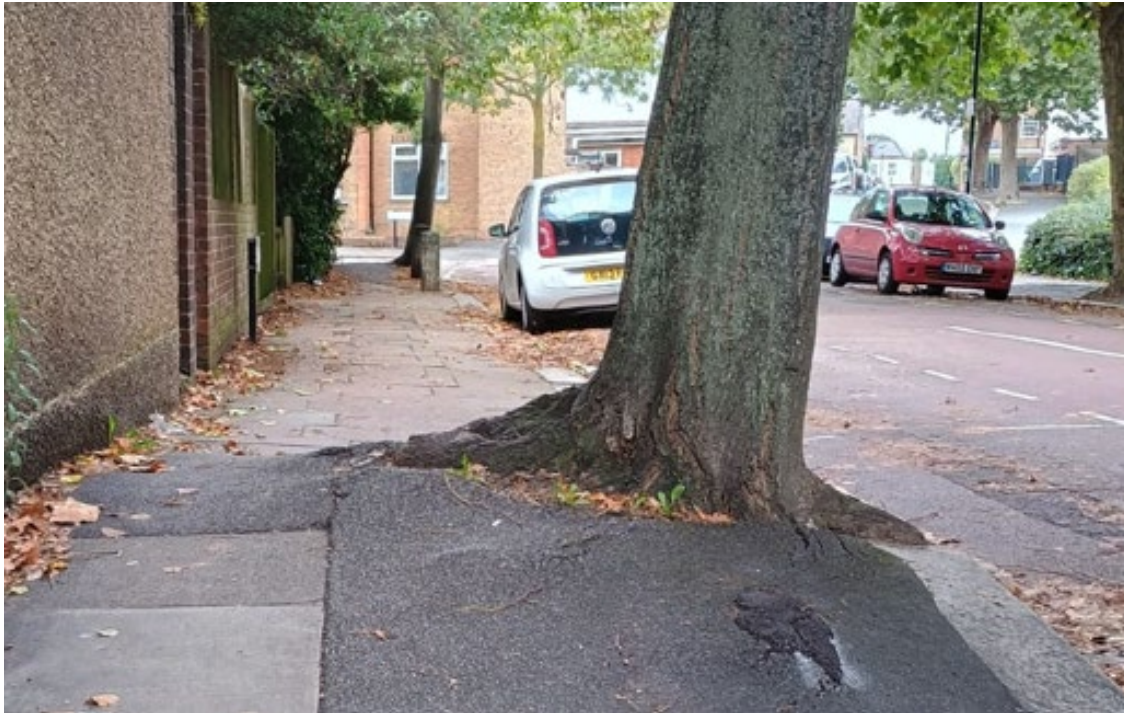
Image shows raised roots causing pavement disruption.

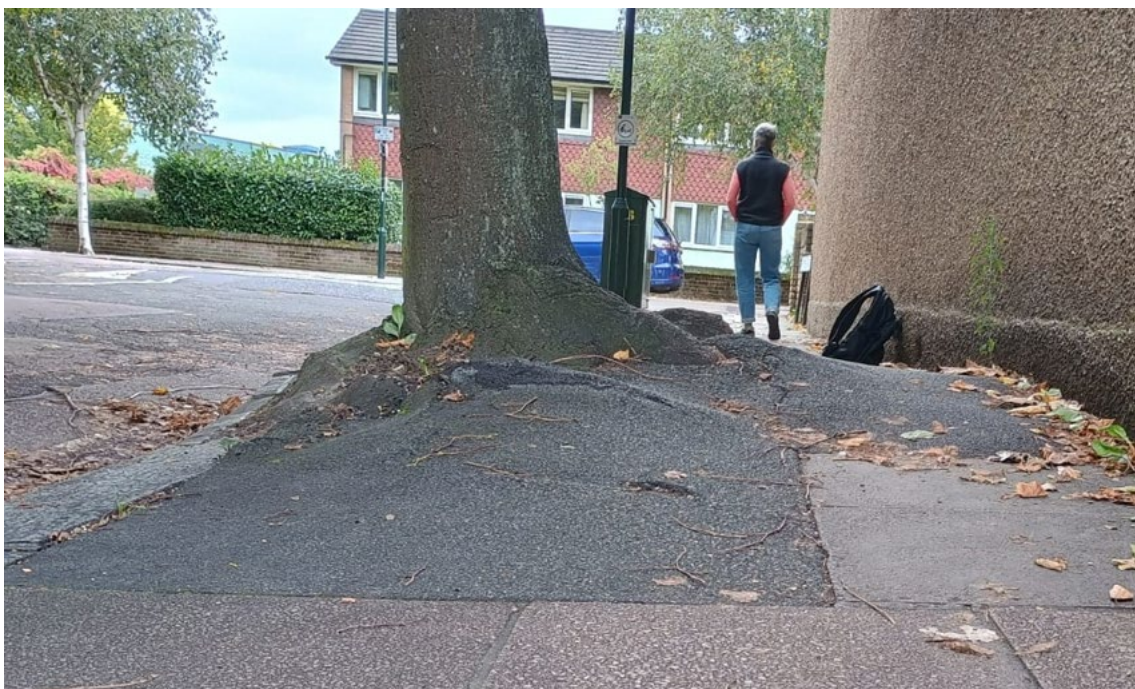
Image shows raised roots causing pavement disruption.

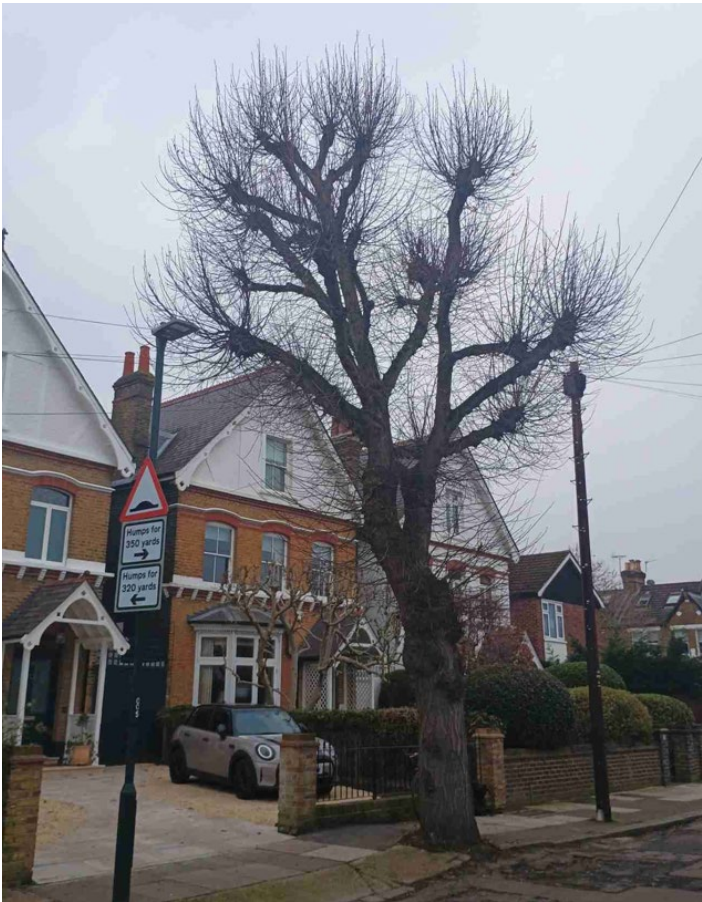
Ward	Fulwell & Hampton Hill
Road	Oxford Road
Location	Opposite 19
Species	Common lime (<i>Tilia x europaea</i>)
Height	10.5m
Physiological Condition	Fair
Structural Condition	Poor
Inspection findings/reason for exemption	A fungal fruiting body of the decay fungi <i>Ganoderma</i> sp. is present at the stem base by a cavity. Colonisation by this fungus causes a white rot of the stem and root system that can cause entire trees to collapse through fracture or windthrow. Investigation with a probe revealed an unacceptable degree of decay in the surround wood to the cavity and correlates with the fungus present. Removal is required to prevent natural failure, manage risk, and facilitate replanting.

Image shows tree in street scene

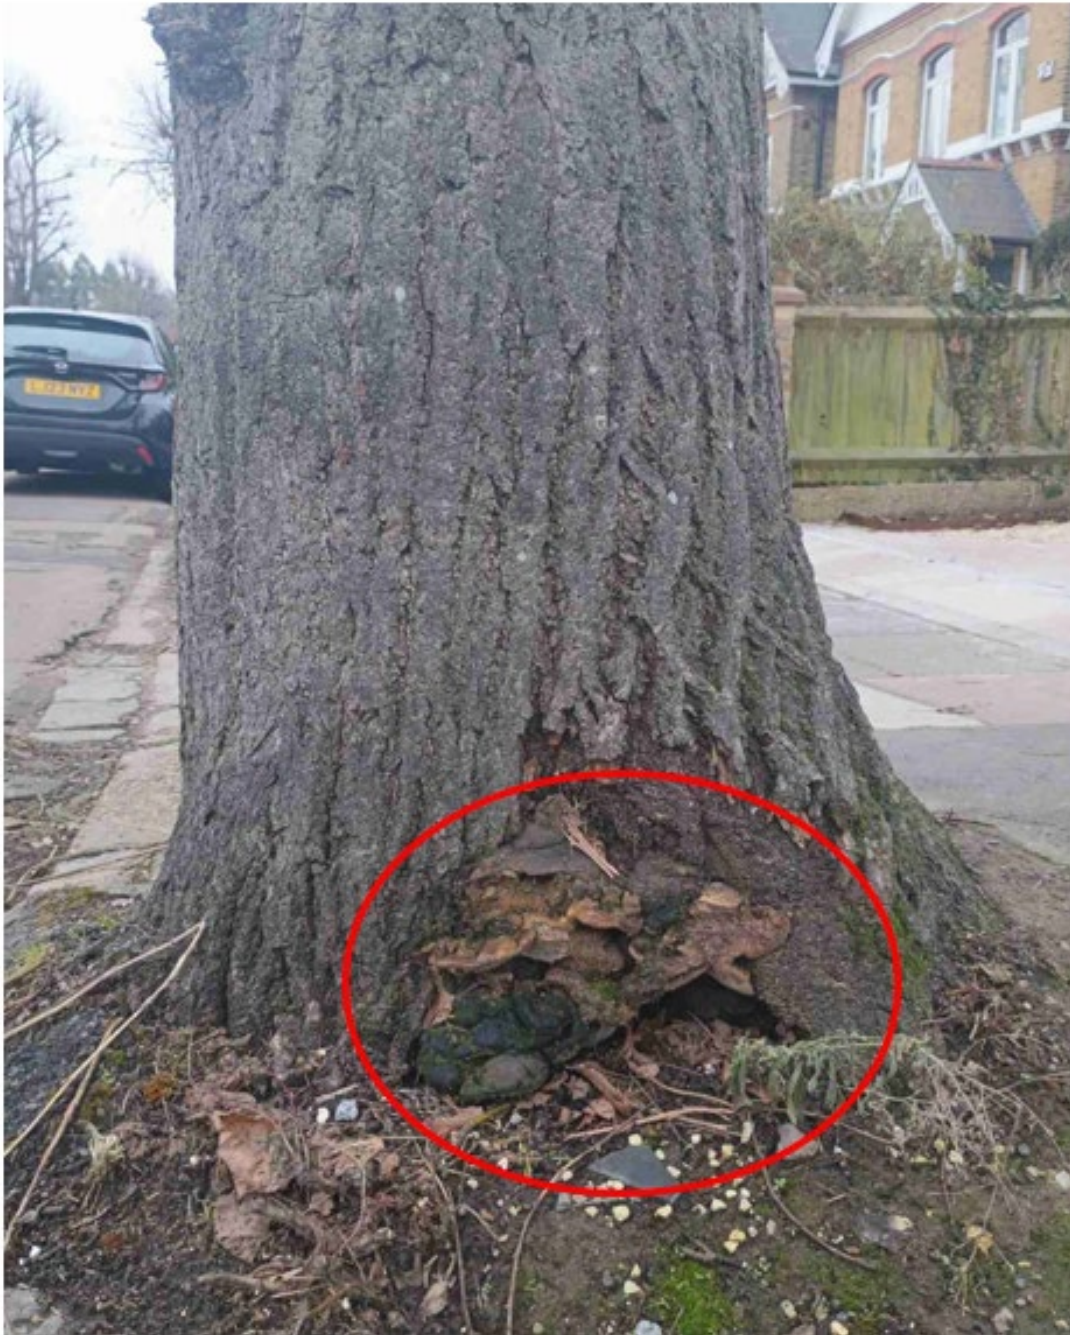
Image shows fungal fruiting body with cavity circled.

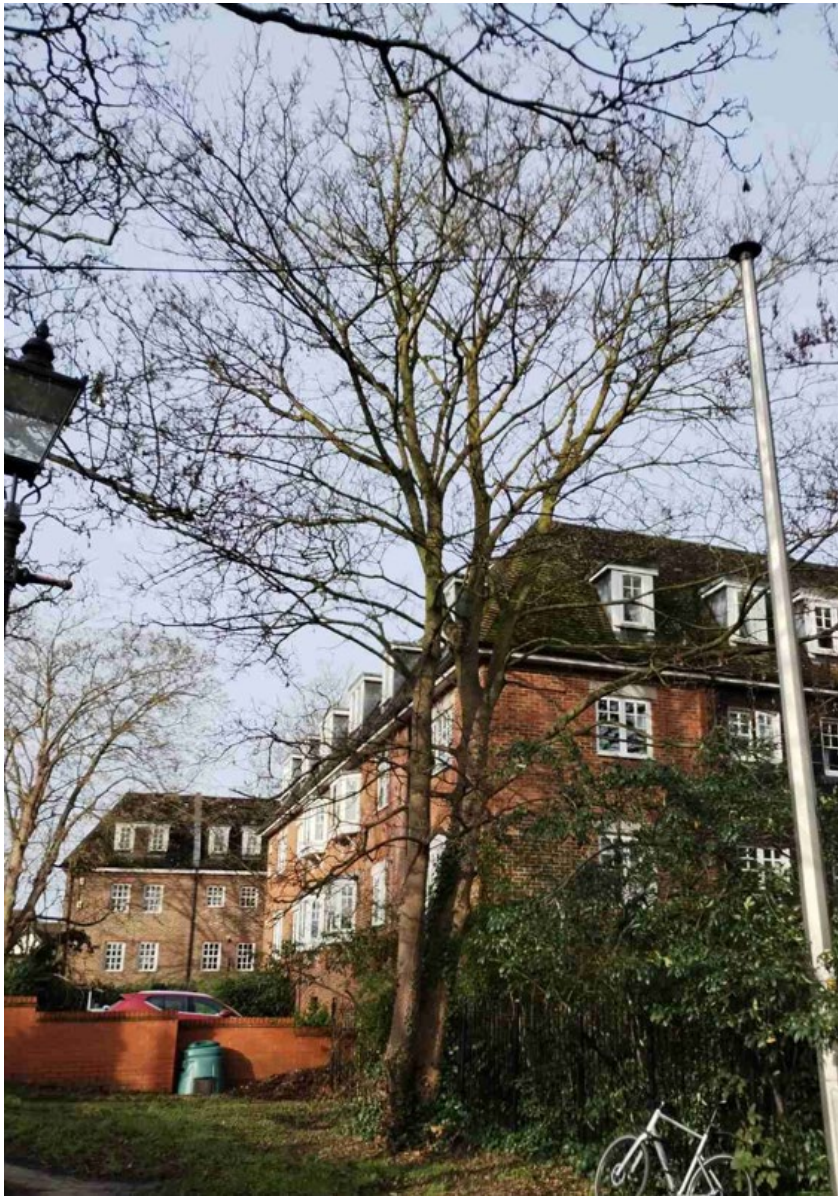
Ward	Hampton Wick and South Teddington
Road	Old Bridge Street
Location	///unit.orbit.bond
Species	Sycamore (<i>Acer pseudoplatanus</i>)
Height	16.0m
Physiological Condition	Good
Structural Condition	Good
Inspection findings/reason for exemption	This tree is growing in an unsuitable location resulting in the trunk being in contact with a privately owned fence. Removal is required to prevent damage to the fence as the trunk grows.

Image shows tree in street scene.

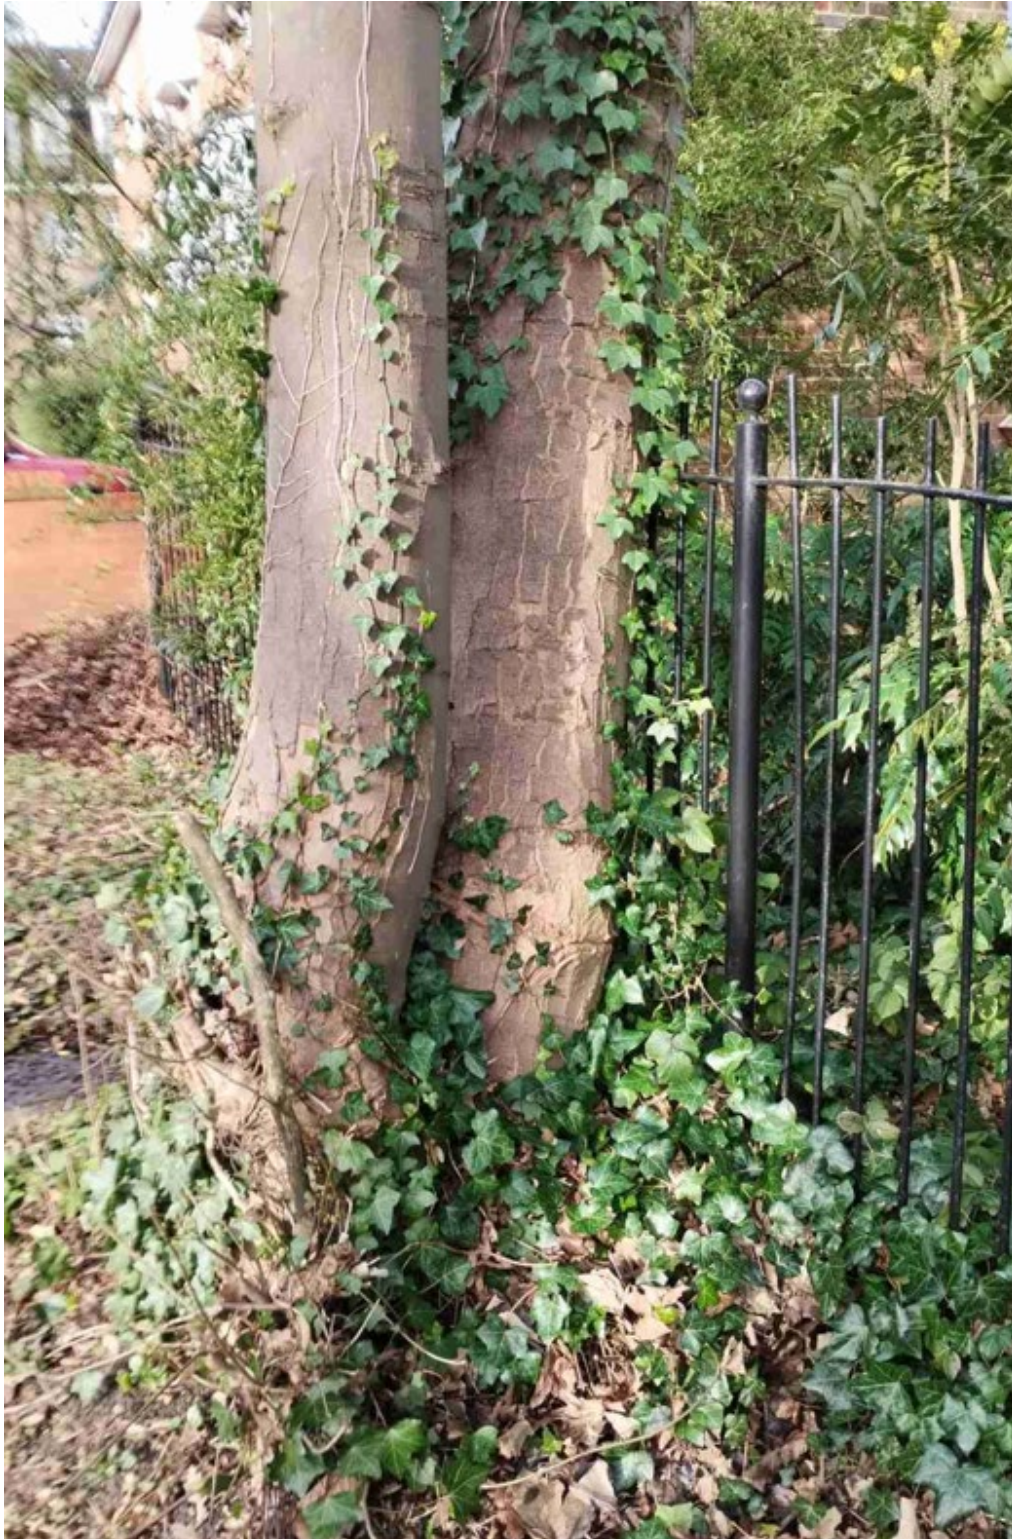
Image shows trunk in contact with fence.

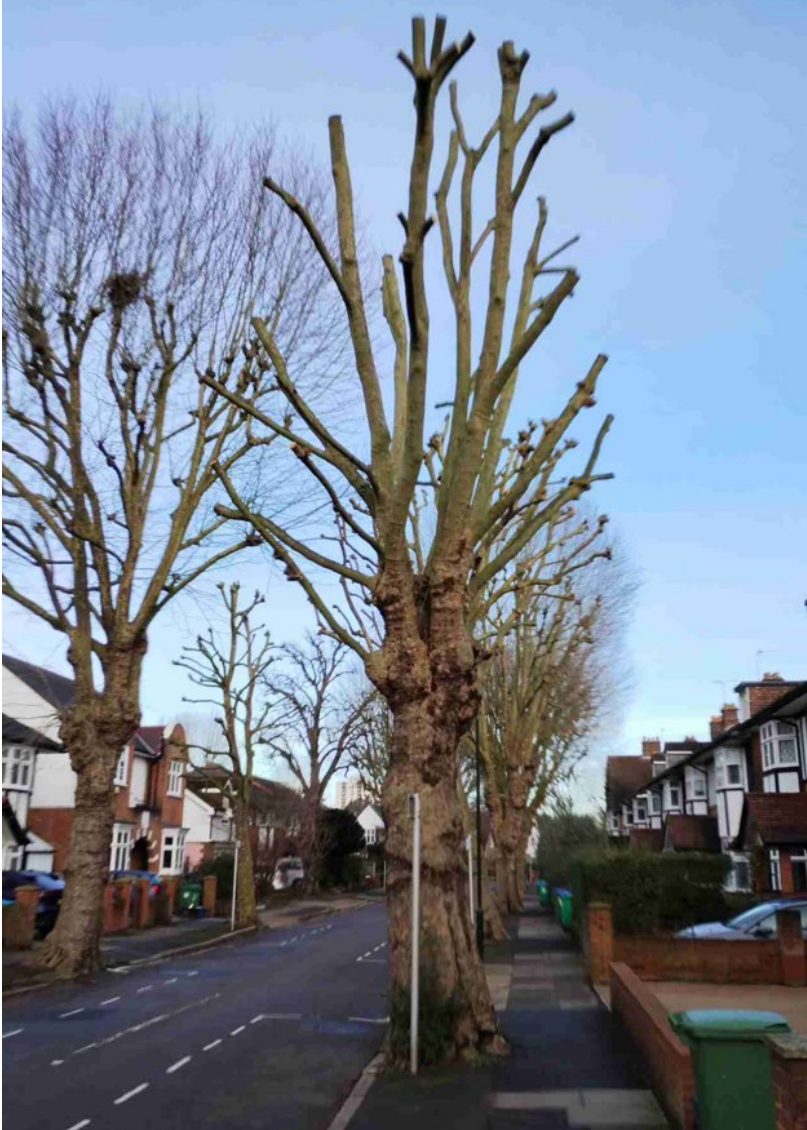
Ward	St Margarets and North Twickenham
Road	Cole Park Road
Location	Outside 36
Species	London Plane (<i>Platanus x hispanica</i>)
Height	15.0m
Physiological Condition	Fair
Structural Condition	Poor
Inspection findings/reason for exemption	Investigation with a probe and a resonance test with a sounding hammer has revealed an unacceptable amount of decay beyond the visible cavities on the trunk. Removal is required to prevent natural failure, manage risk, and facilitate replanting.

Image shows tree in street scene.

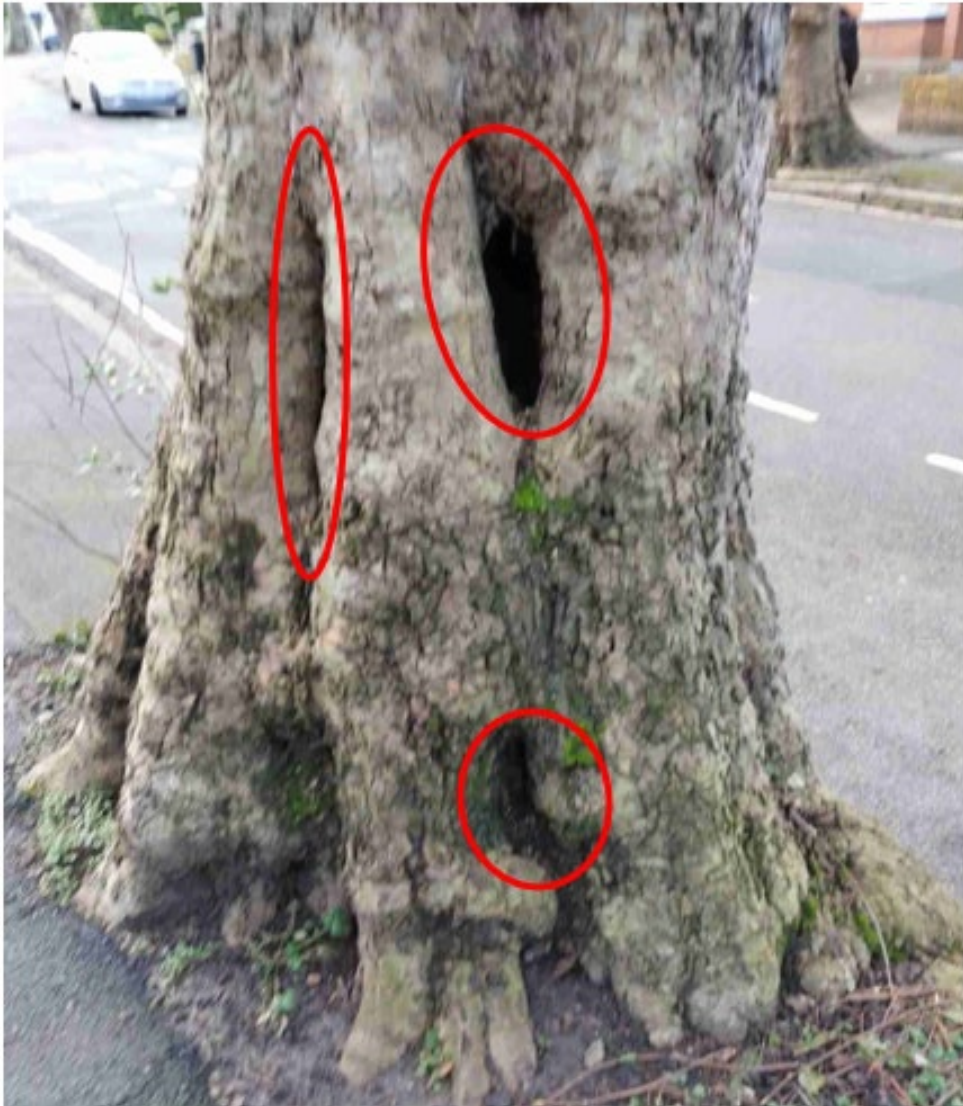
Image shows cavities on trunk circled.

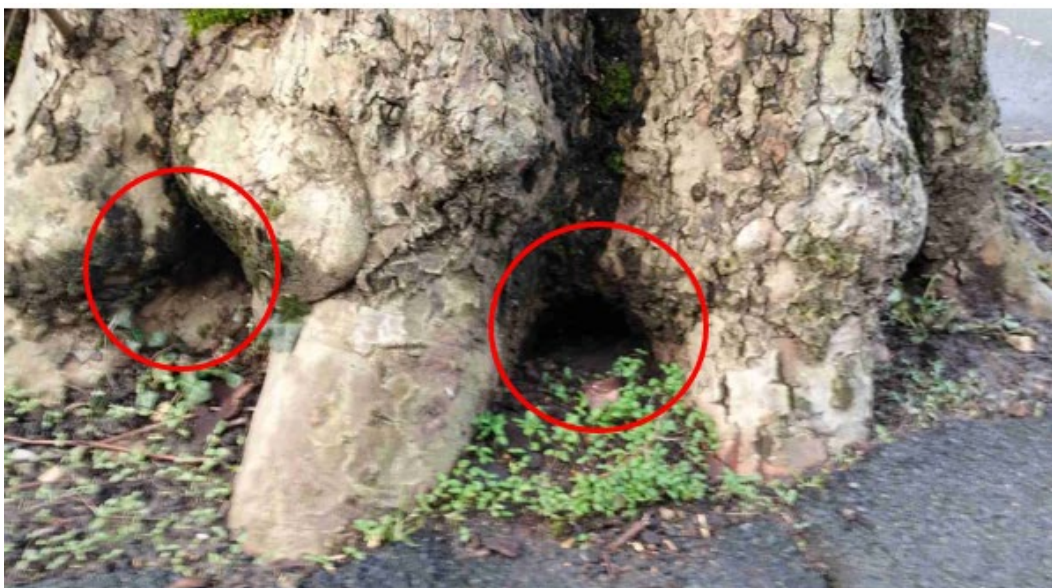
Image shows cavities on trunk circled.

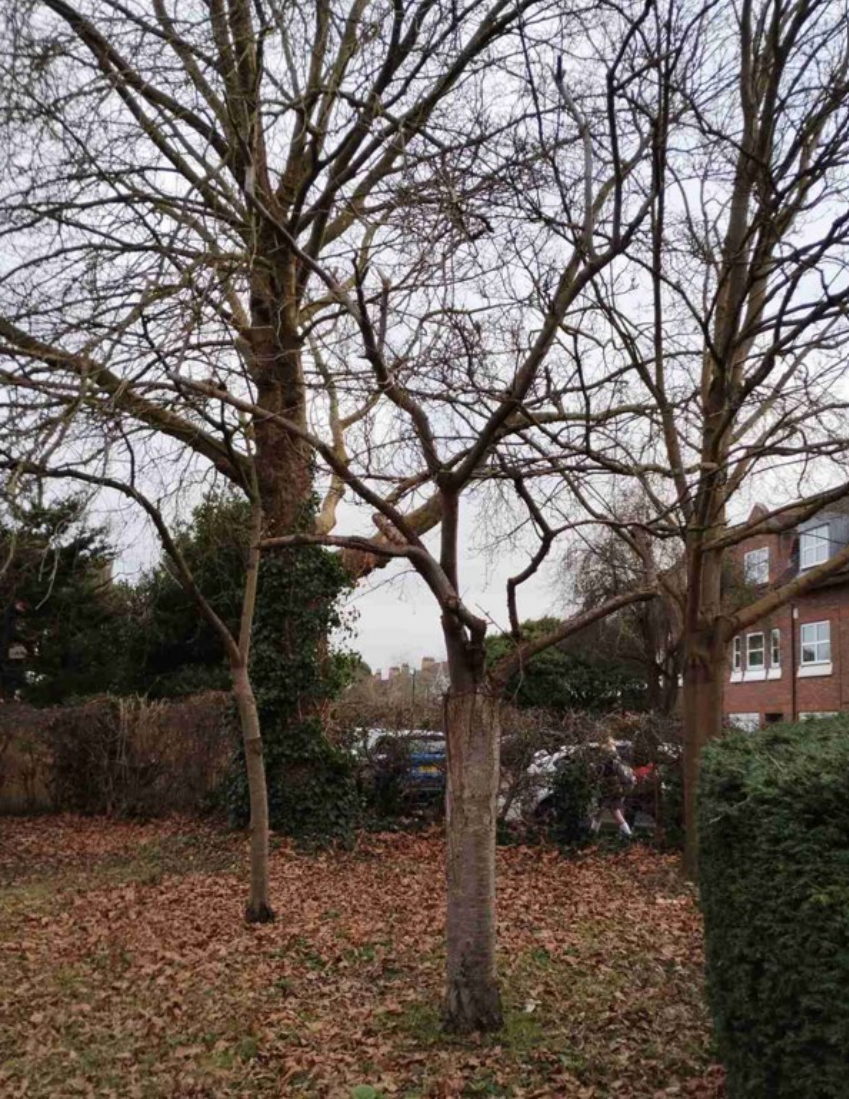
Ward	Teddington
Road	Twickenham Road
Location	Grass area adjacent to Twickenham Road- ///scared.sorry.staple
Species	Apple (<i>Malus sp.</i>)
Height	6.0m
Physiological Condition	Dead
Structural Condition	Dead
Inspection findings/reason for exemption	This tree is dead; removal is required to prevent natural failure, manage risk, and facilitate replanting

Image shows dead tree street scene.

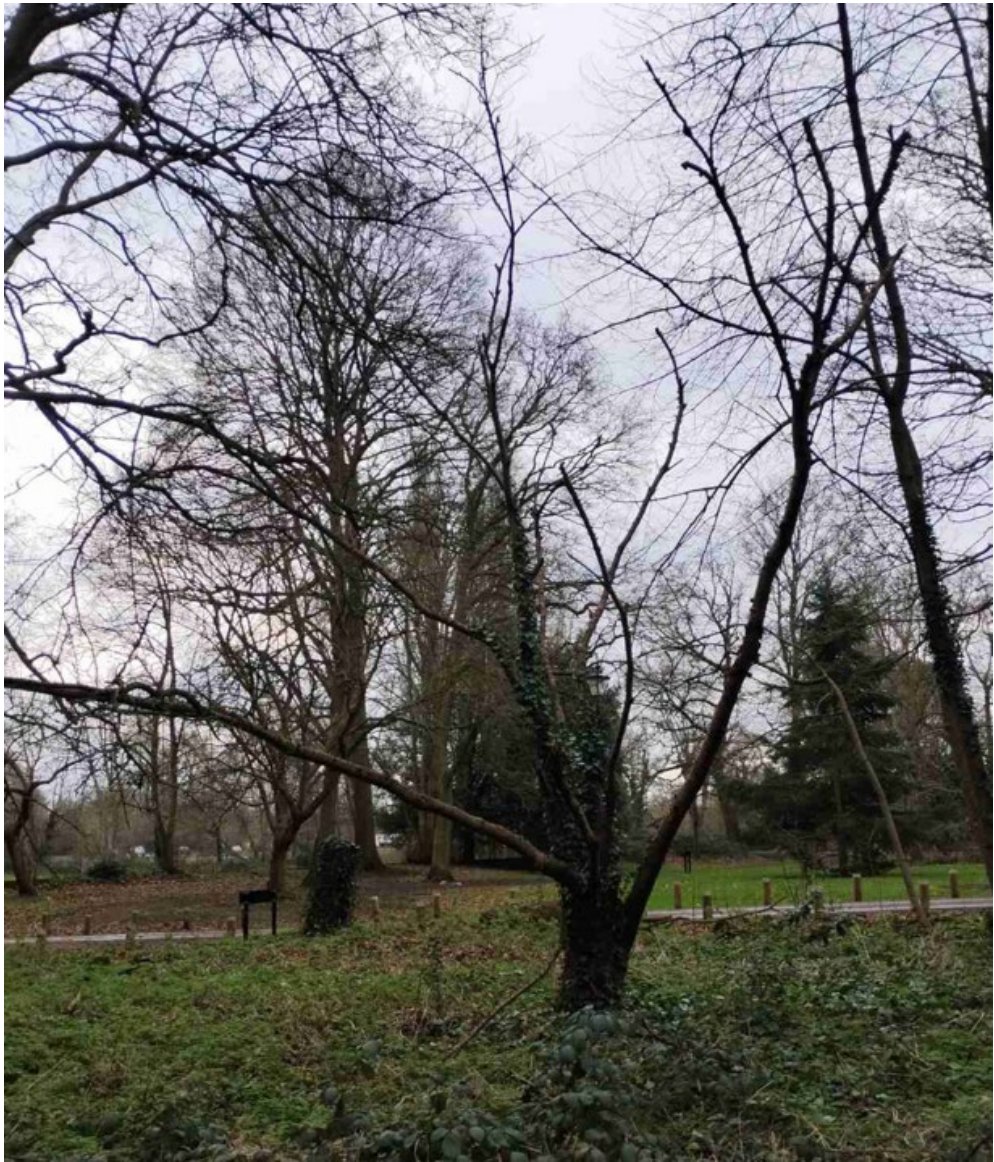
Ward	Twickenham Riverside
Road	Riverside
Location	Orleans Gallery Woods- ///eaten.sage.shop
Species	Cherry (<i>Prunus sp.</i>)
Height	8.0m
Physiological Condition	Dead
Structural Condition	Dead
Inspection findings/reason for exemption	This tree is dead; removal is required to prevent natural failure and manage risk. The stump will be left as a 2-meter-high monolith for ecological purposes.

Image shows dead tree in woodland scene.

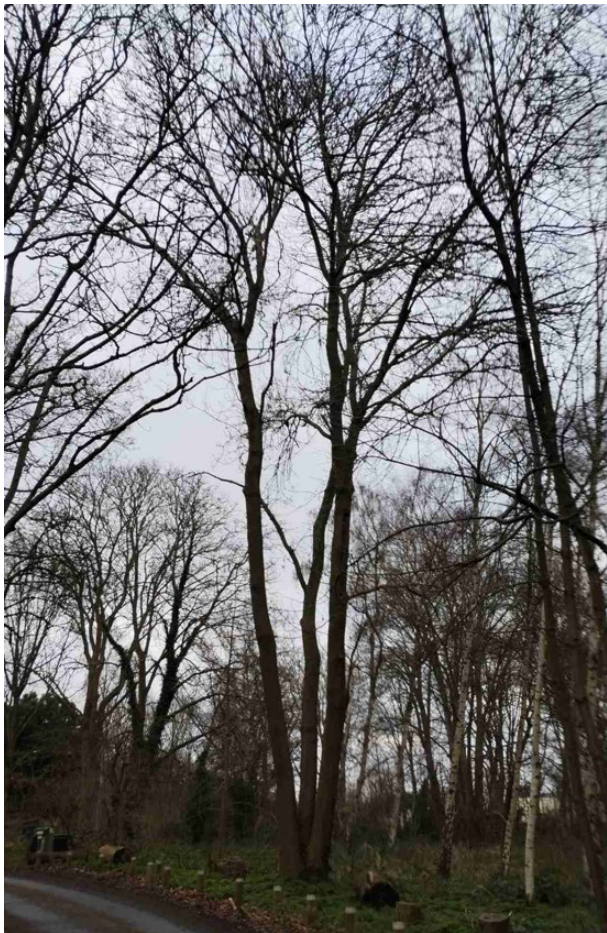
Ward	Twickenham Riverside
Road	Riverside
Location	Orleans Gallery Woods- ///lake.shirt.tries
Species	Common Ash (<i>Fraxinus excelsior</i>)
Height	22.0m
Physiological Condition	Poor
Structural Condition	Poor
Inspection findings/reason for exemption	A fungal fruiting body of the species Shaggy Polypore (<i>Inonotus hispidus</i>) is present on the main stem or trunk, this fungus causes a simultaneous white rot which can cause snapping of tree parts in this particular species. the trees crown is displaying symptoms of physiological decline associated with Ash Die Back (<i>Hymenoscyphus fraxineus</i>). This is a fungal disease specific to Ash, characterized by the progressive decline of the tree's branches and will eventually lead to the death of the tree. Removal is required to prevent natural failure and manage risk. The stump will be left as a 2-meter-high monolith for ecological purposes.

Image shows tree in woodland scene.

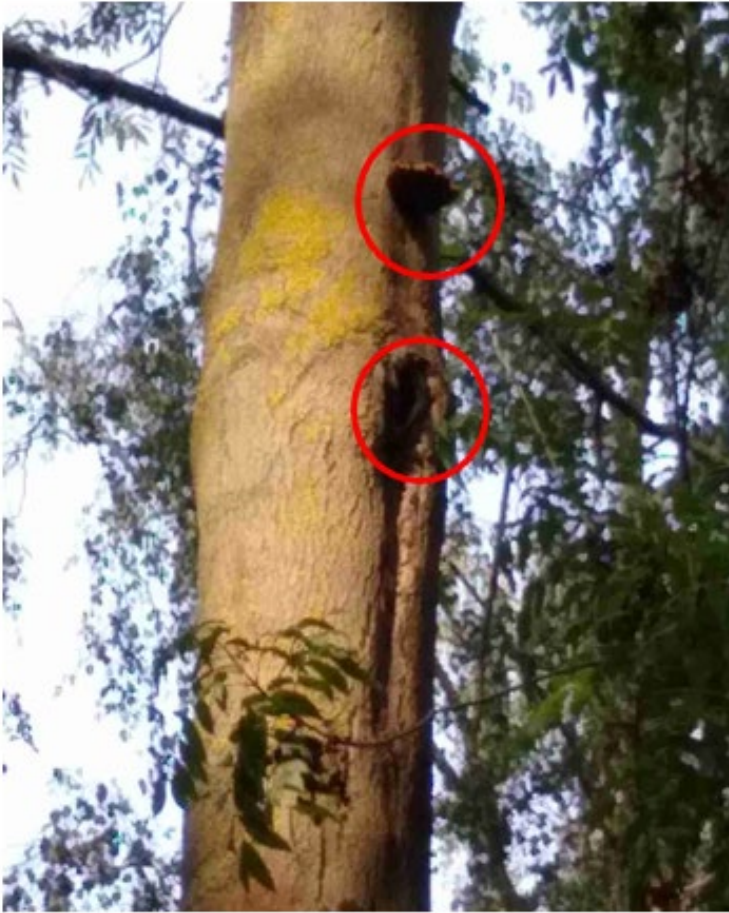
Image shows fungal fruiting bodies on trunk circled.

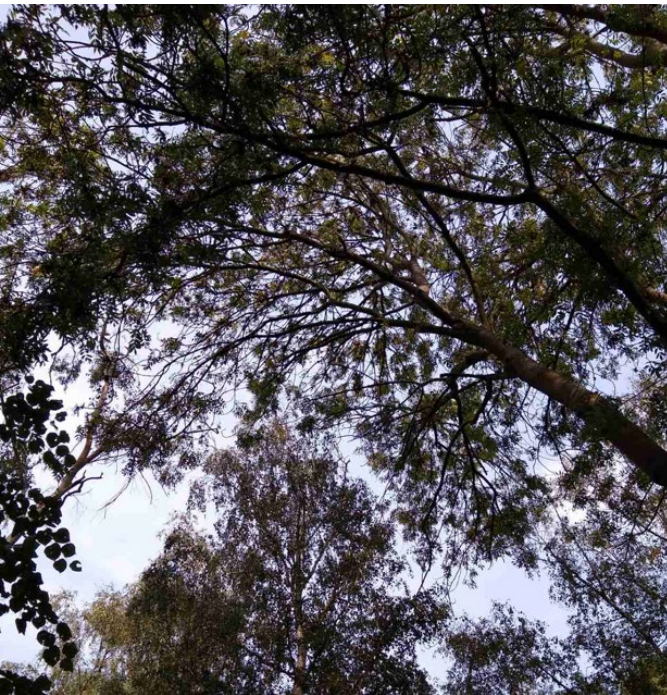
Image shows physiological decline to crown associated with Ash Die Back.
