April 2024 - Reactive Tree Works Programme

Dated 22.04.2024

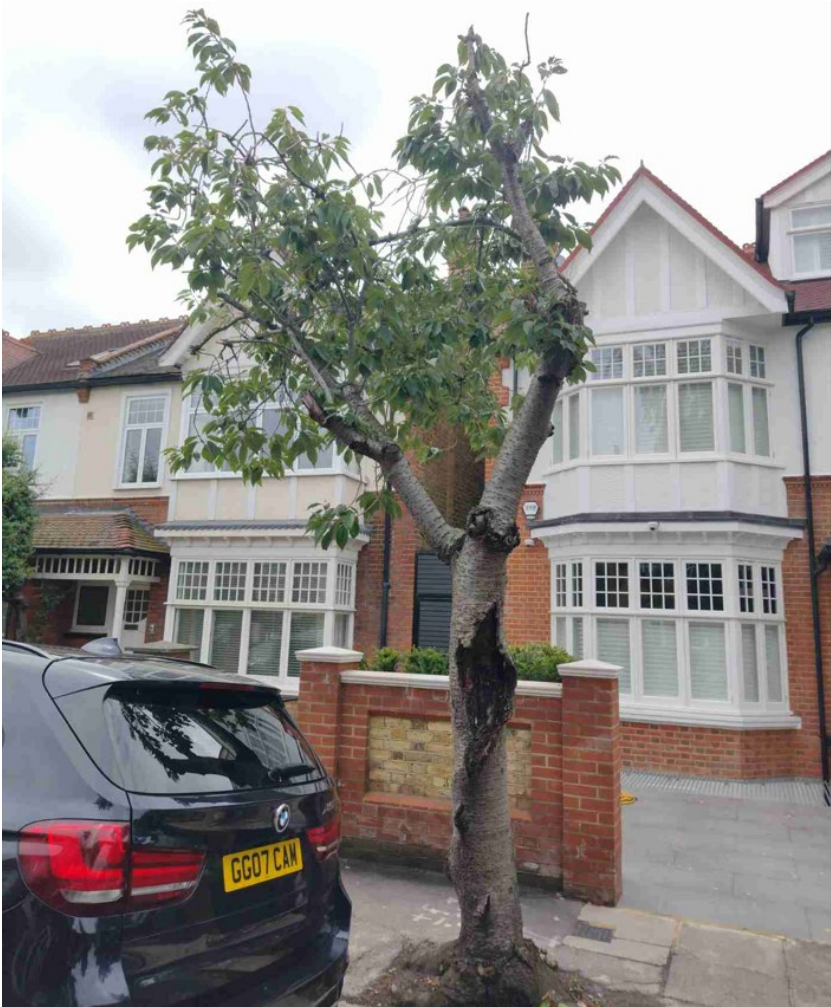
Ward	Barnes
Road	Gerard Road
Location	Outside 6
Species	Wild Cherry (<i>Prunus avium</i>)
Height	6.5m
Physiological Condition	Poor
Structural Condition	Poor
Inspection findings	Exposed damaged roots, cankering on stem with bark necrosis which has led to a bacterial infection, indicating dysfunction of the vascular system. This correlates with crown dieback and decline. Removal is required to prevent natural failure, manage risk, and facilitate replanting.

Image shows tree in street scene

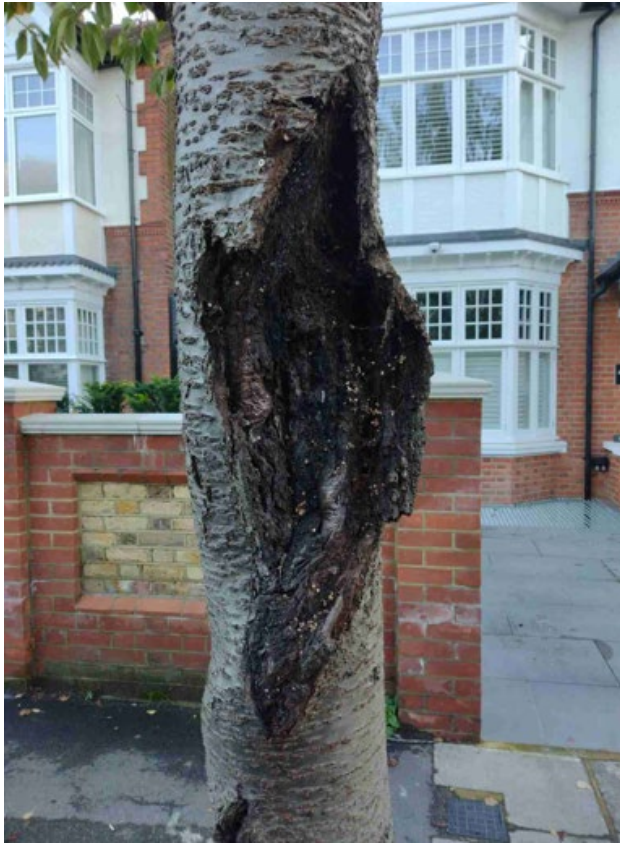
Image shows bacterial cankering on stem.

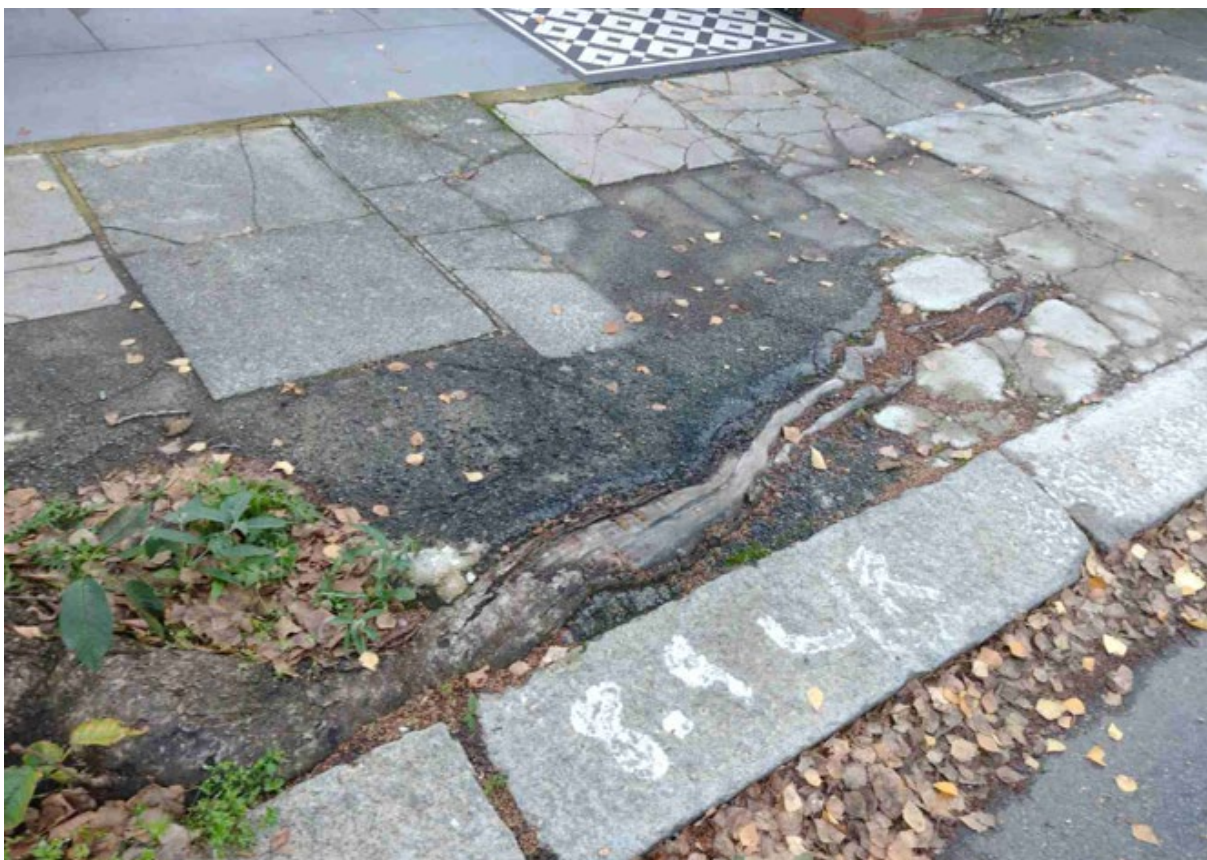
Image shows exposed damaged root.

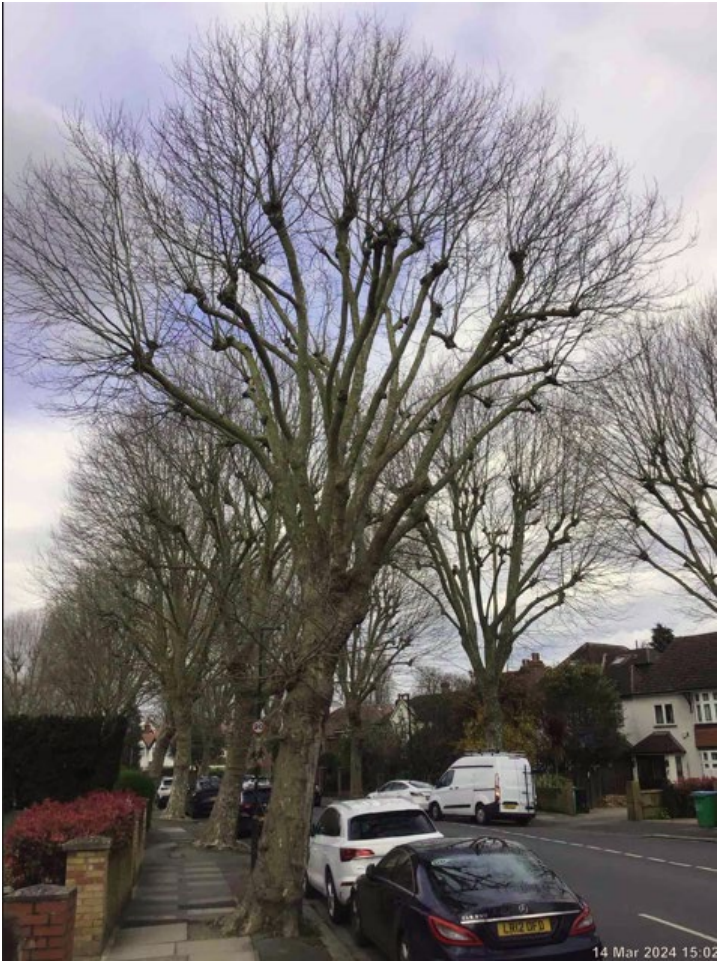
Ward	Hampton
Road	Wensleydale Road
Location	Outside 35
Species	London Plane (<i>Platanus x acerifolia</i>)
Height	16.0m
Physiological Condition	Poor
Structural Condition	Poor
Inspection findings	Fruiting bodies of the decay fungus Giant Ash Bracket (<i>Perenniporia fraxinea</i>) are present in the main union of this tree. This fungus causes a simultaneous white rot of the wood and can cause catastrophic failure of entire trees and branches. A resonance test revealed an unacceptable degree of decay in the trunk of this tree and the necrosis causing delamination to the bark on stem correlates with crown dieback and decline. Removal is required to prevent natural failure, manage risk, and facilitate replanting.

Images show tree in street scene with short regrowth compared to other trees on road.

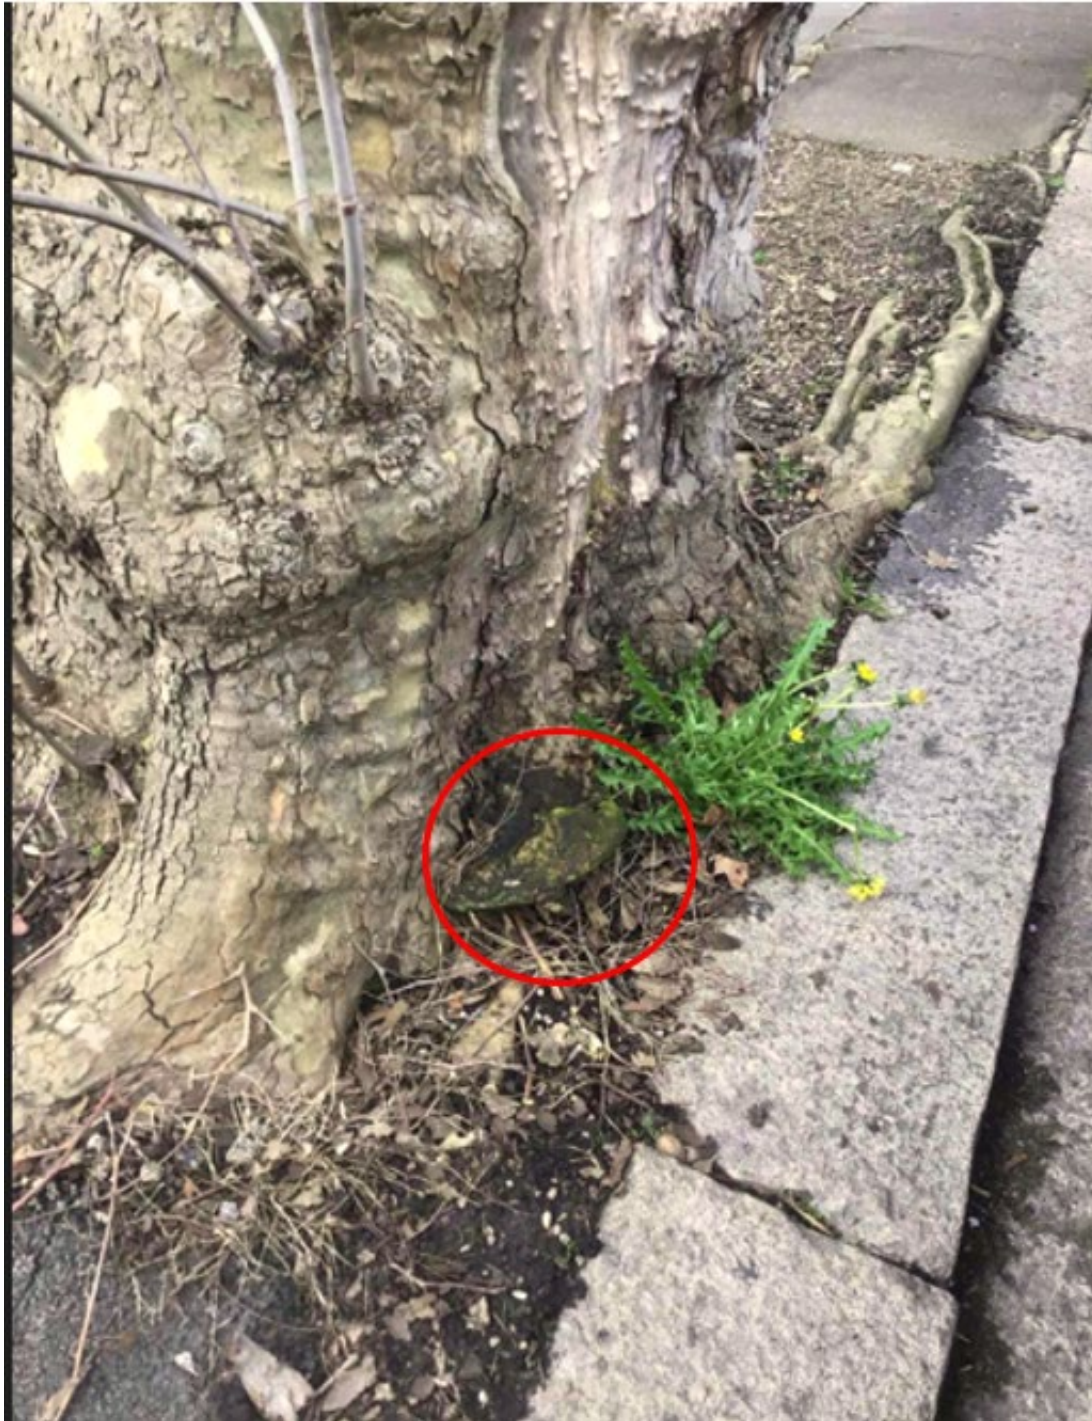
Images show fungal fruiting body circled at base of stem.

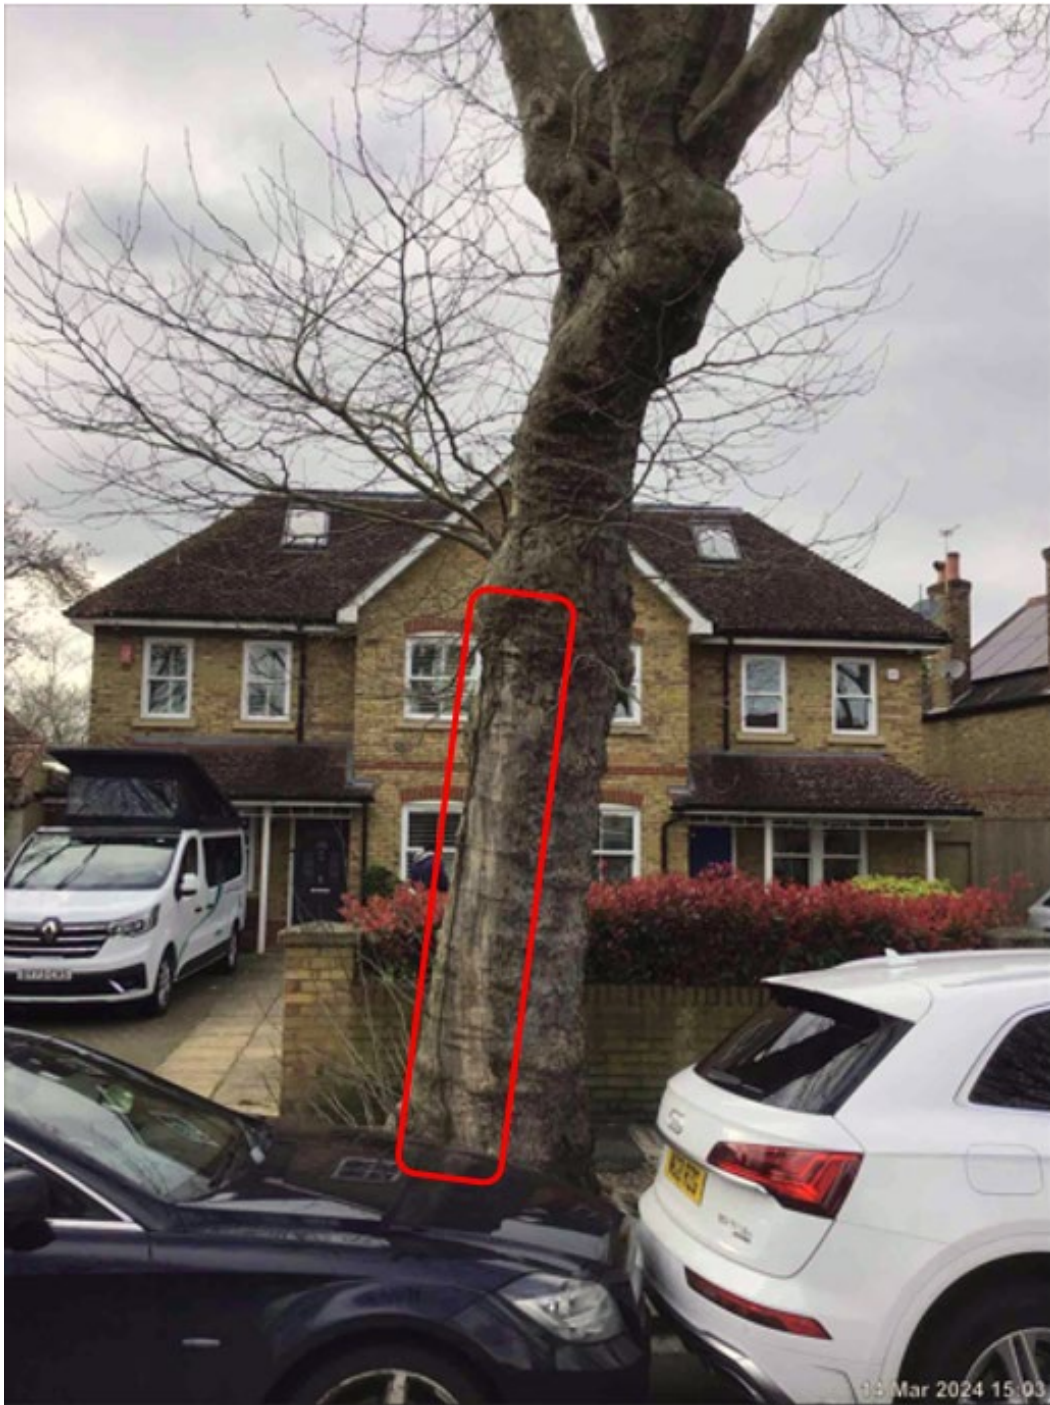
Images show necrosis of bark on stem circled.

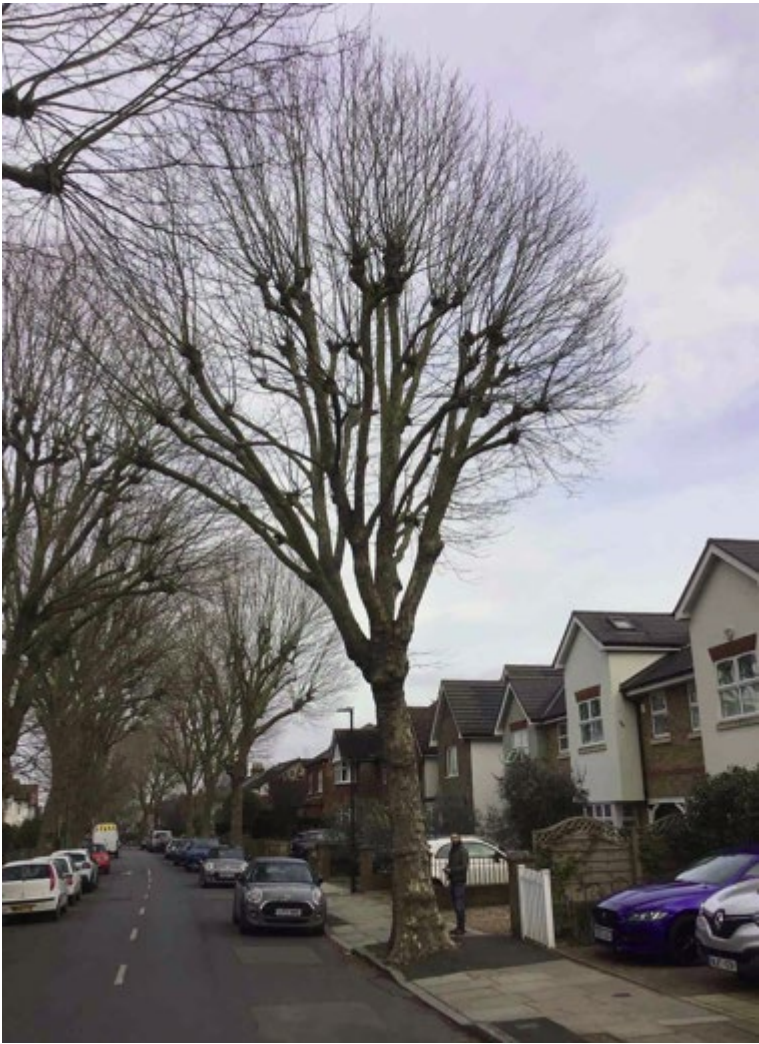
Ward	Hampton
Road	Gloucester Road
Location	Outside 68-70
Species	London Plane (<i>Platanus × acerifolia</i>)
Height	17.5m
Physiological Condition	Poor
Structural Condition	Poor
Inspection findings	Fruiting bodies of the decay fungus Giant Ash Bracket (<i>Perenniporia fraxinea</i>) are present in the main union of this tree. This fungus causes a simultaneous white rot of the wood and can cause catastrophic failure of entire trees and branches. A resonance test revealed an unacceptable degree of decay in the trunk of this tree, removal is required to prevent natural failure, manage risk, and facilitate replanting.

Images show tree in street scene.

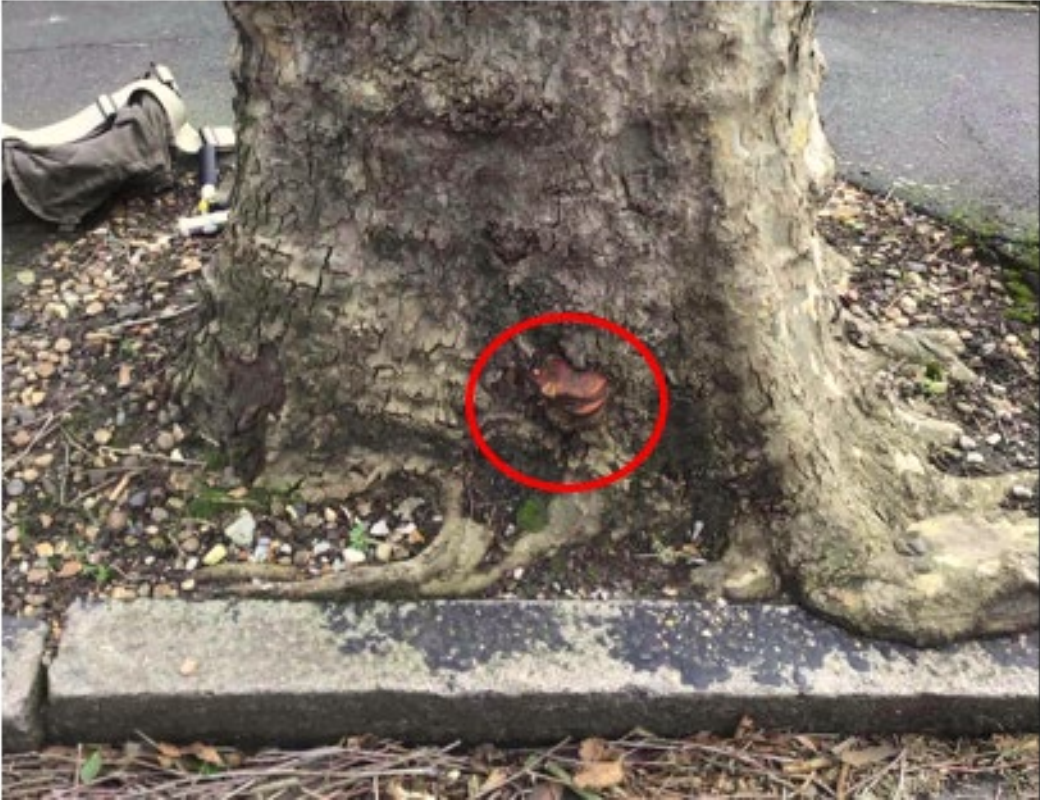
Images show fungal fruiting body circled at base of stem.

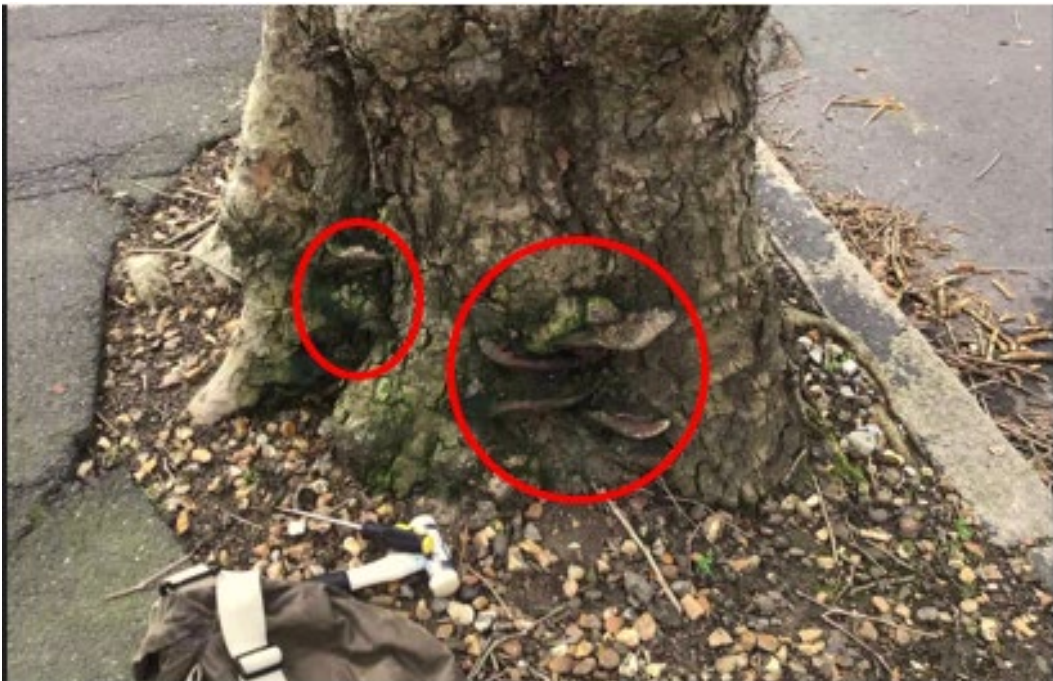
Images show fungal fruiting body circled at base of stem.

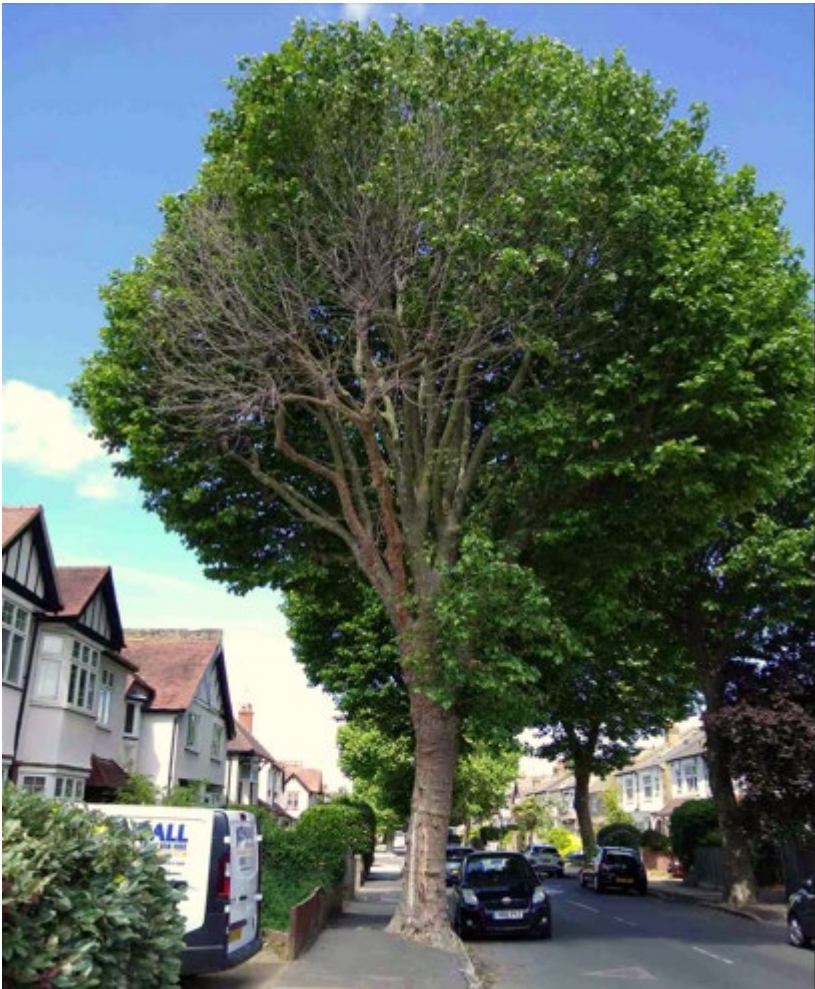
Ward	Hampton
Road	Gloucester Road
Location	Outside 75
Species	London Plane (<i>Platanus × acerifolia</i>)
Height	15.0m
Physiological Condition	Poor
Structural Condition	Poor
Inspection findings	There is major delamination of bark caused by necrosis on the stem of this tree indicating dysfunction of the vascular system. This is causing the tree to be in a state of physiological decline with dead branches in crown that are liable to collapse. The tree presents an unacceptable risk of failure and there are no suitable pruning solutions. Removal is required to prevent natural failure, manage risk, and facilitate replanting.

Images show tree in street scene.

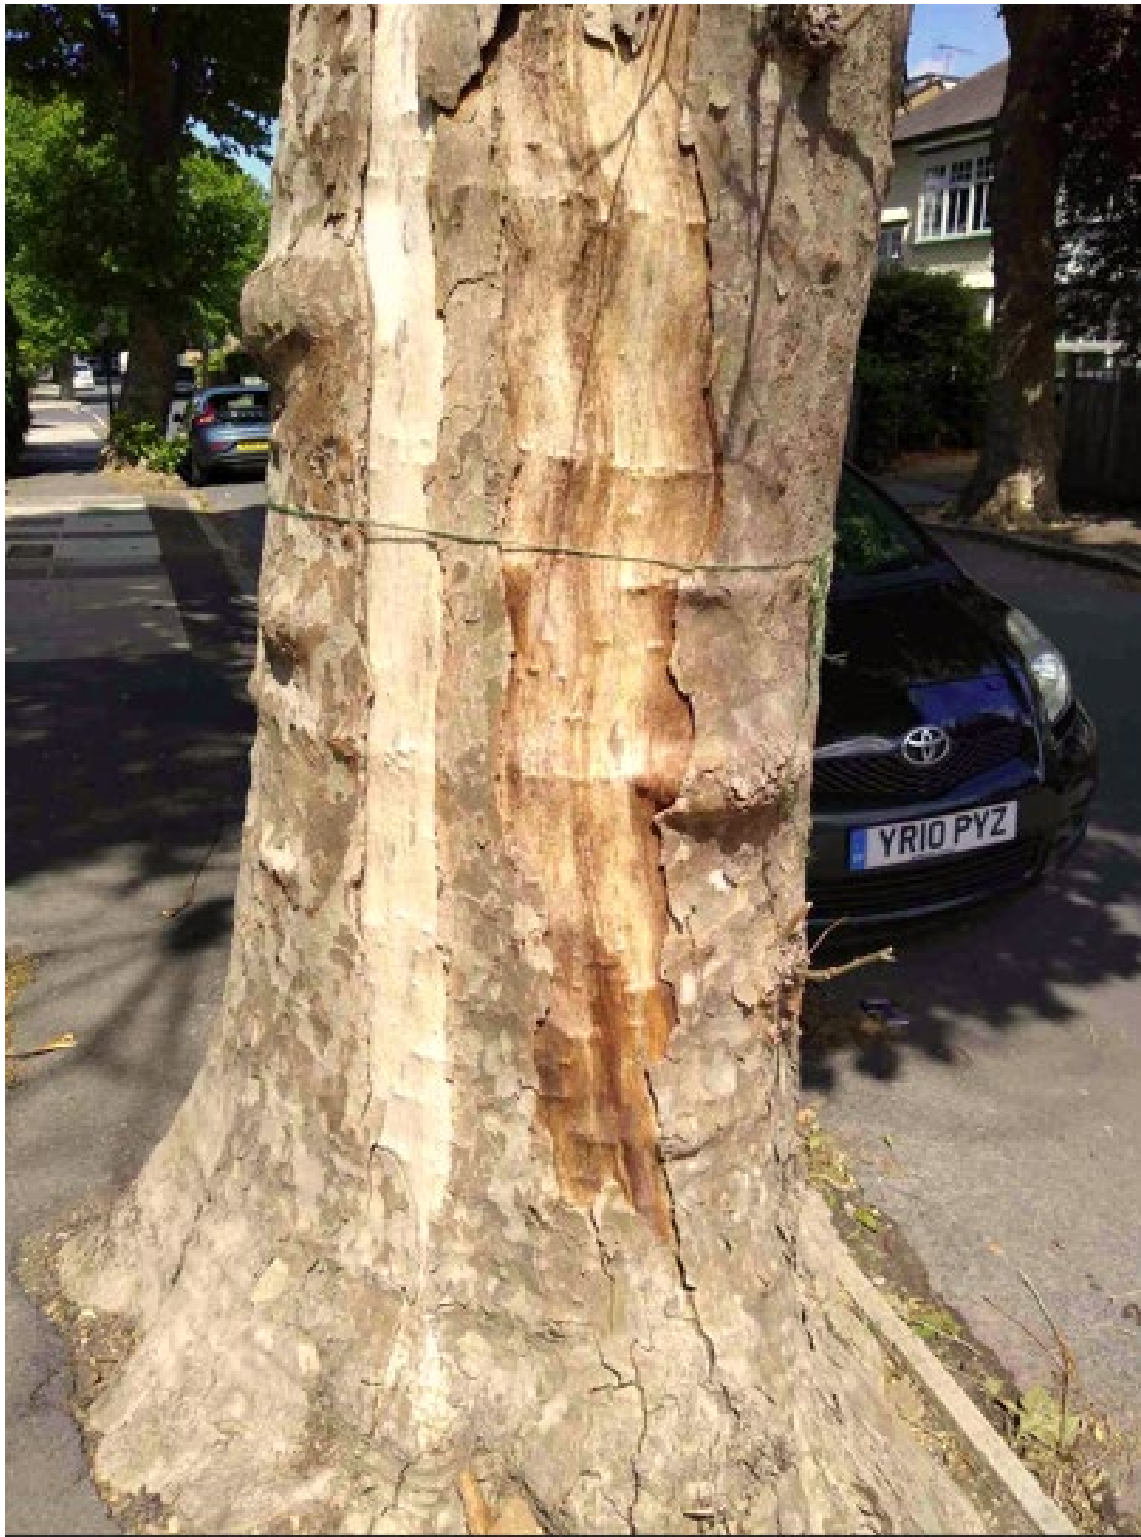
Image shows necrosis on stem.

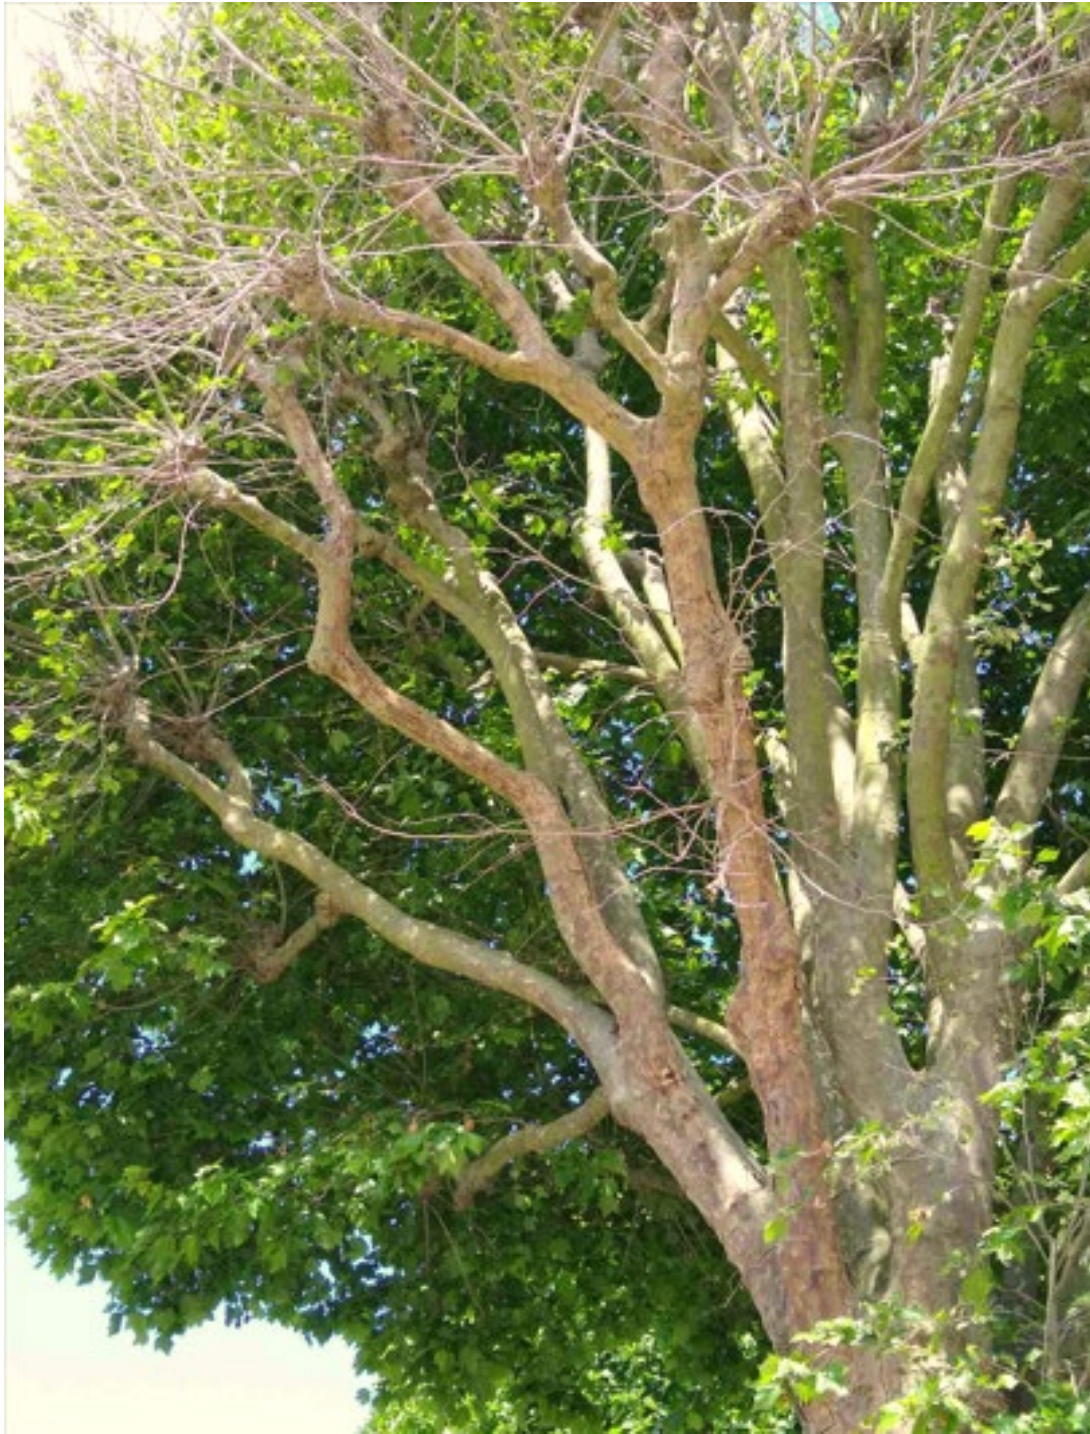
Image shows crown die back.

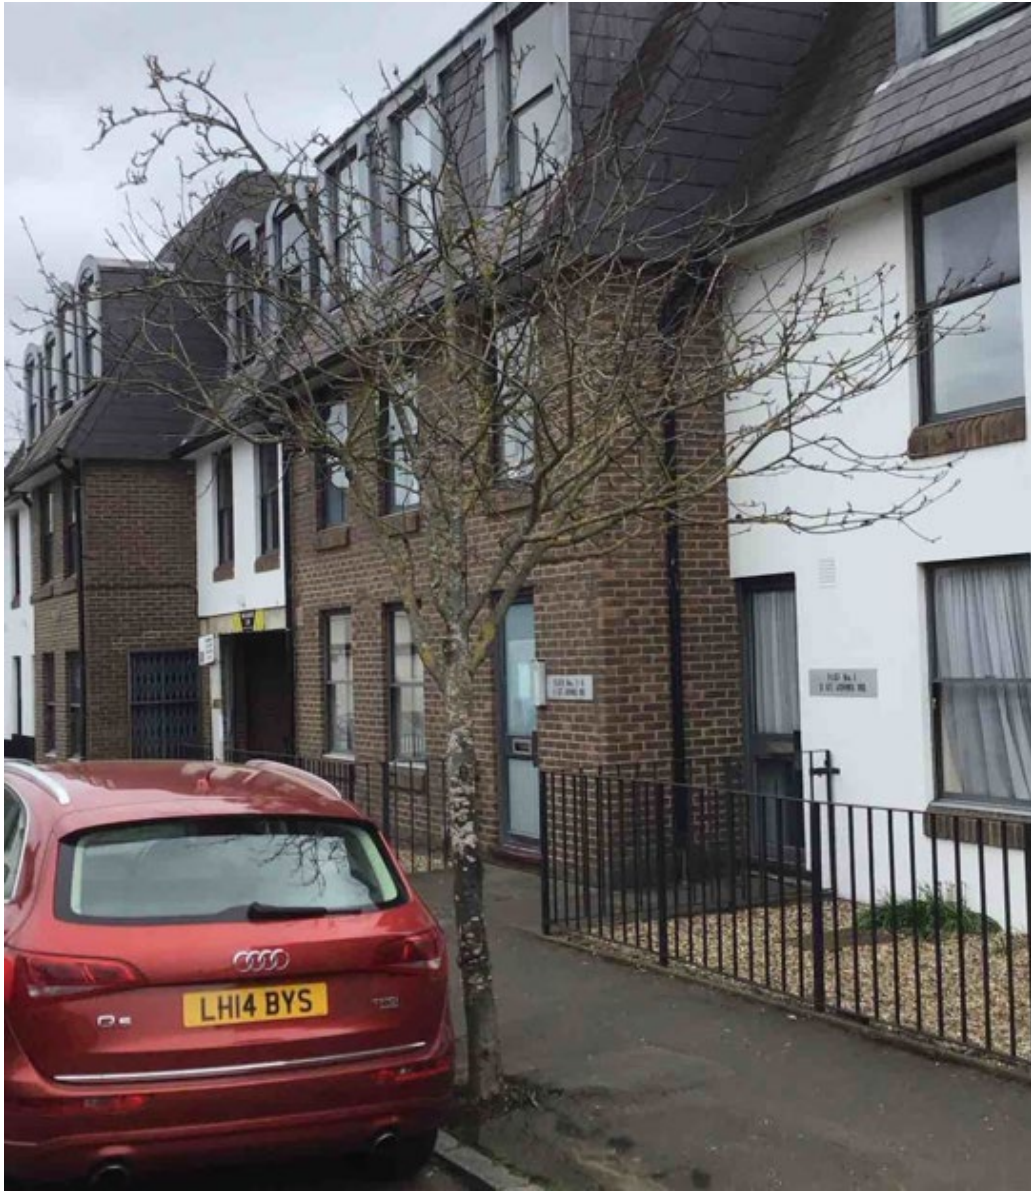
Ward	Hampton Wick and South Teddington
Road	St Johns Road
Location	Opposite 6
Species	Rowan (<i>Sorbus aucuparia</i>)
Height	6.0m
Physiological Condition	Dead
Structural Condition	Dead
Inspection findings	This tree is dead. Removal is required to prevent natural failure, manage risk, and facilitate replanting.

Image shows dead tree in street scene.

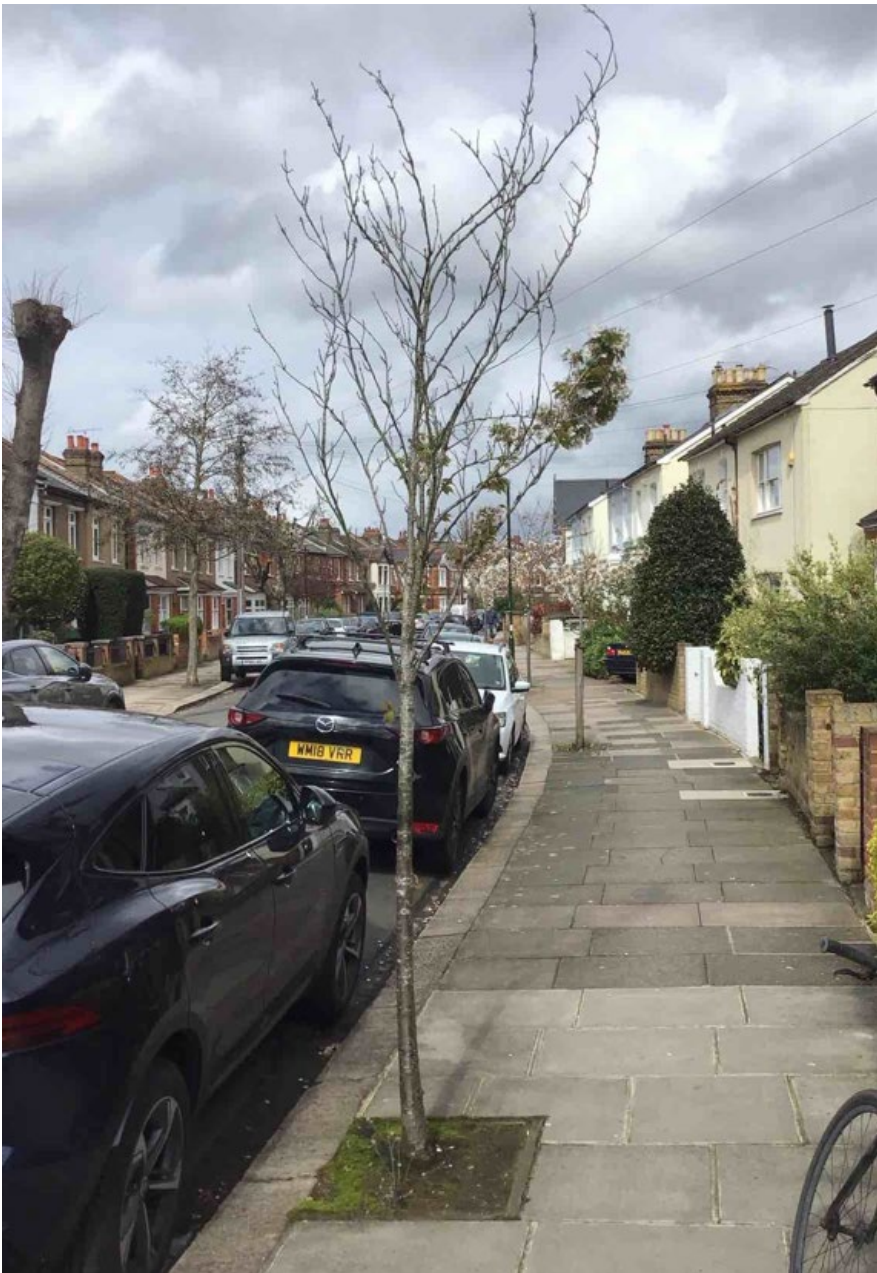
Ward	Hampton Wick and South Teddington
Road	Bushy Park Road
Location	Outside 61
Species	Cherry (<i>Prunus sp.</i>)
Height	4.0m
Physiological Condition	Poor
Structural Condition	Poor
Inspection findings	This tree is moribund with over 85 percent of the crown dead. Removal is required to prevent natural failure, manage risk, and facilitate replanting.

Image shows moribund tree in street scene.

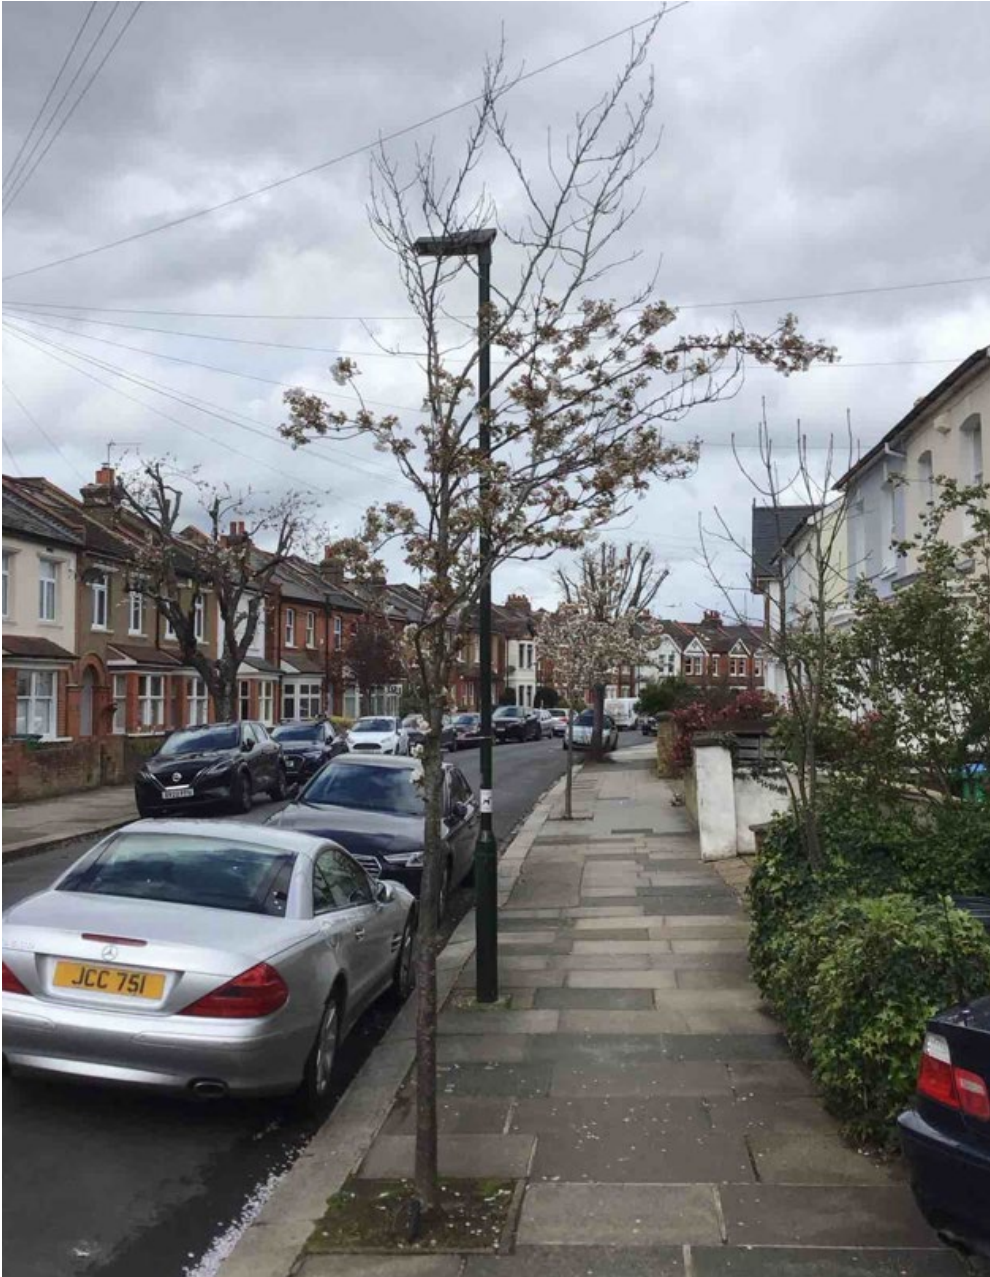
Ward	Hampton Wick and South Teddington
Road	Bushy Park Road
Location	Outside 53
Species	Cherry (<i>Prunus sp.</i>)
Height	4.0m
Physiological Condition	Poor
Structural Condition	Poor
Inspection findings	This tree is moribund with over 60 percent of the crown dead. Removal is required to prevent natural failure, manage risk, and facilitate replanting.

Image shows moribund tree in street scene.

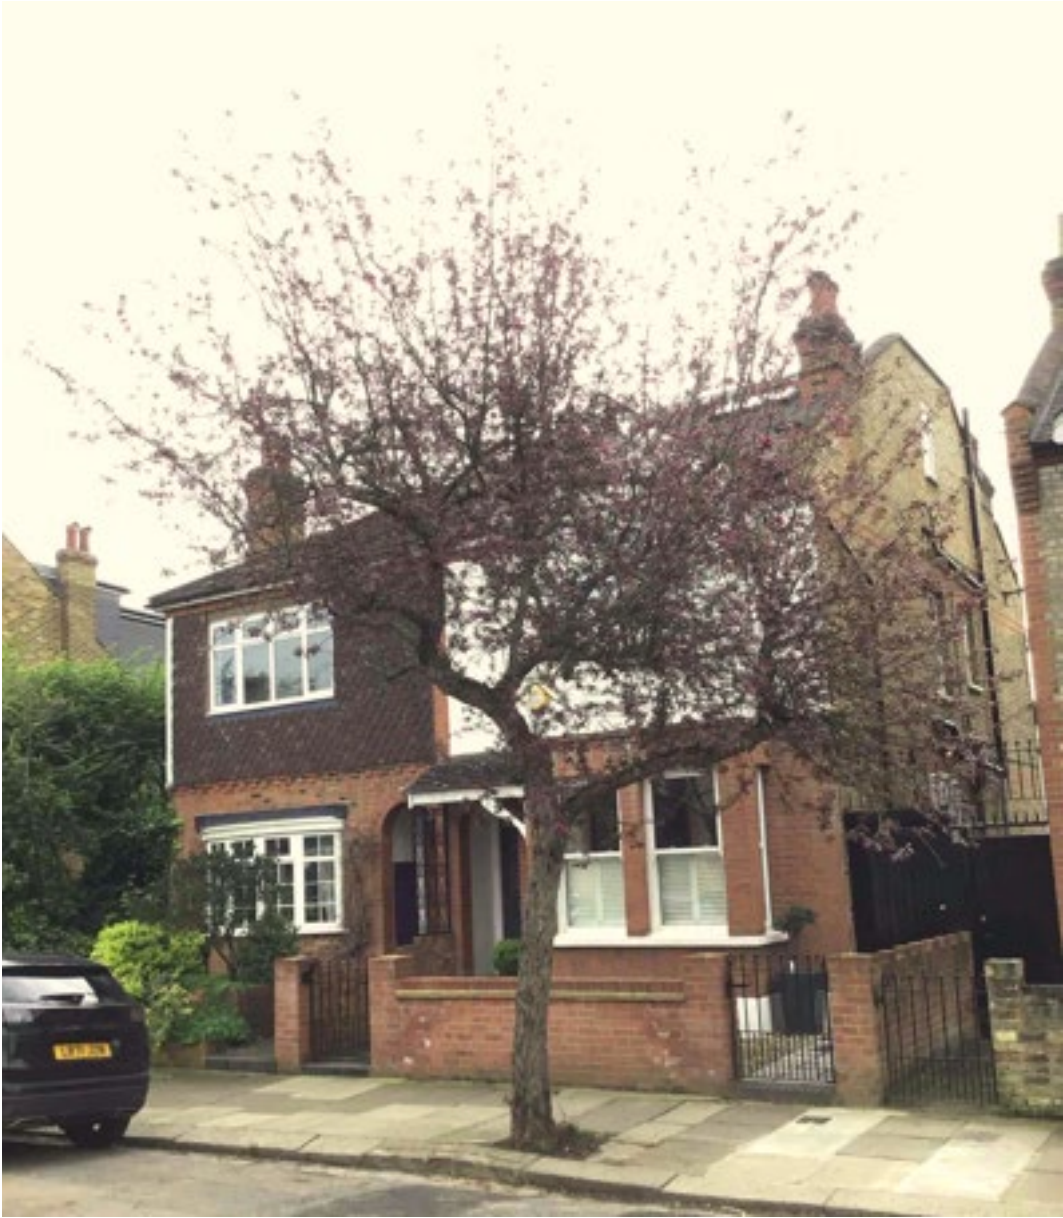
Ward	Hampton Wick and South Teddington
Road	Atbara Road
Location	Outside 55
Species	Apple (<i>Malus sp.</i>)
Height	7.5m
Physiological Condition	Poor
Structural Condition	Poor
Inspection findings	This tree is moribund. Cavities indicating an unacceptable amount of decay is present in the trunk of this tree. Crown dieback could correlate with the degradation of the trees structural. Removal is required to prevent natural failure, manage risk, and facilitate replanting

Image shows moribund tree in street scene.

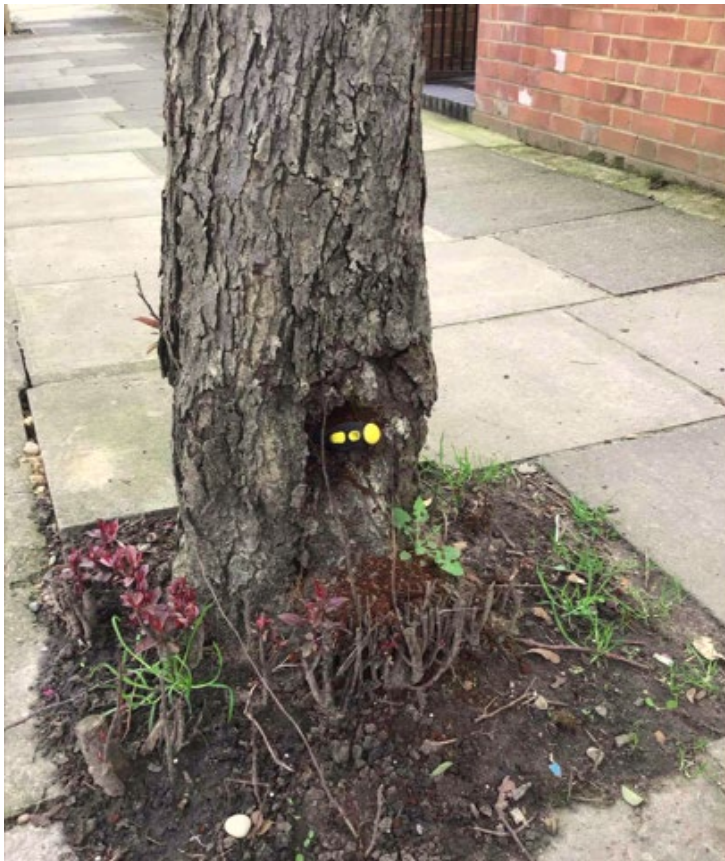
Image shows probe in cavity with decay in stem.

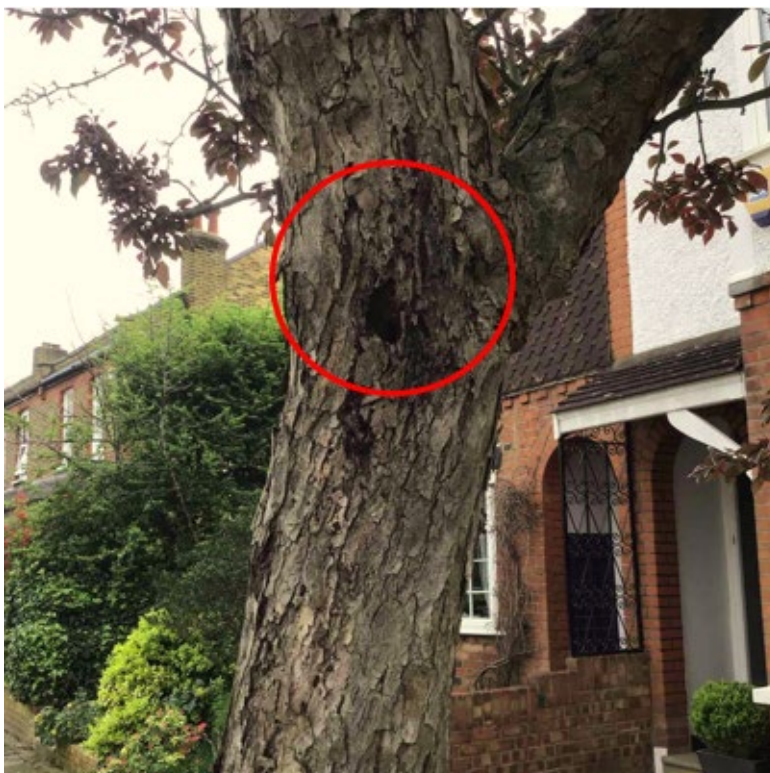
Image shows cavity with decay in stem circled.

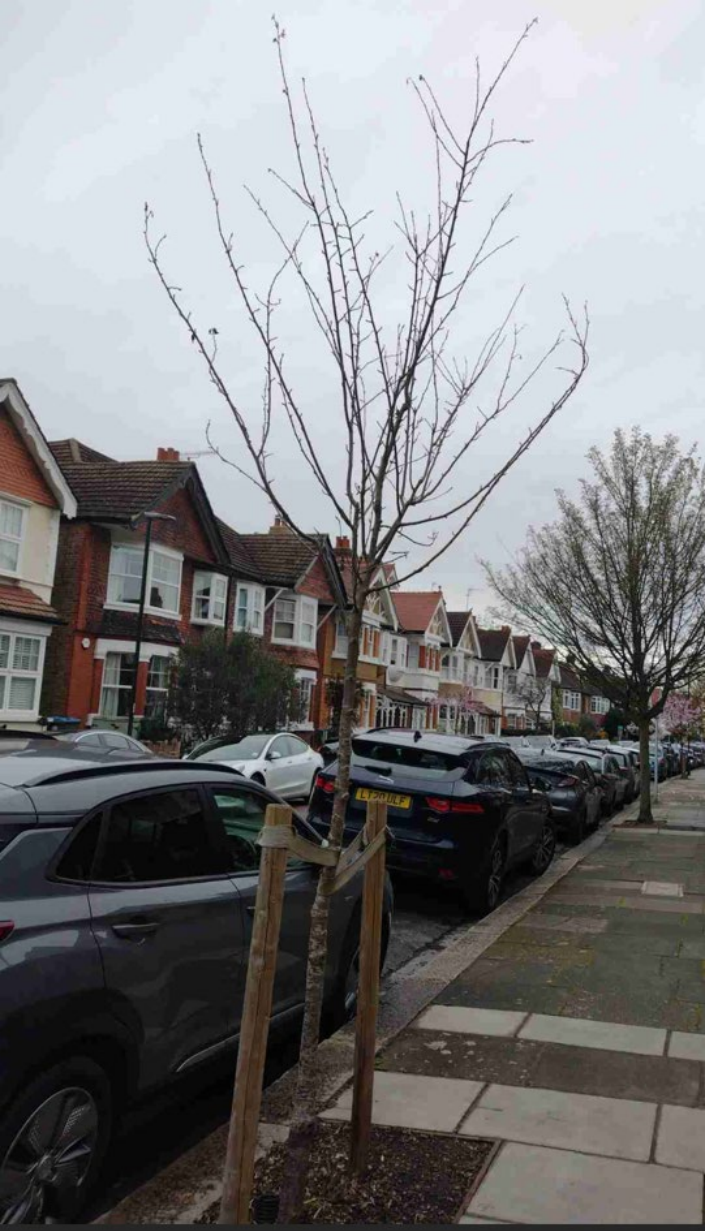
Ward	Kew
Road	Beechwood Avenue
Location	Outside 39/41
Species	Wild Cherry (<i>Prunus avium</i>)
Height	4.0m
Physiological Condition	Dead
Structural Condition	Dead
Inspection findings	This tree is dead. Removal is required to prevent natural failure, manage risk, and facilitate replanting.

Image shows dead tree in street scene.

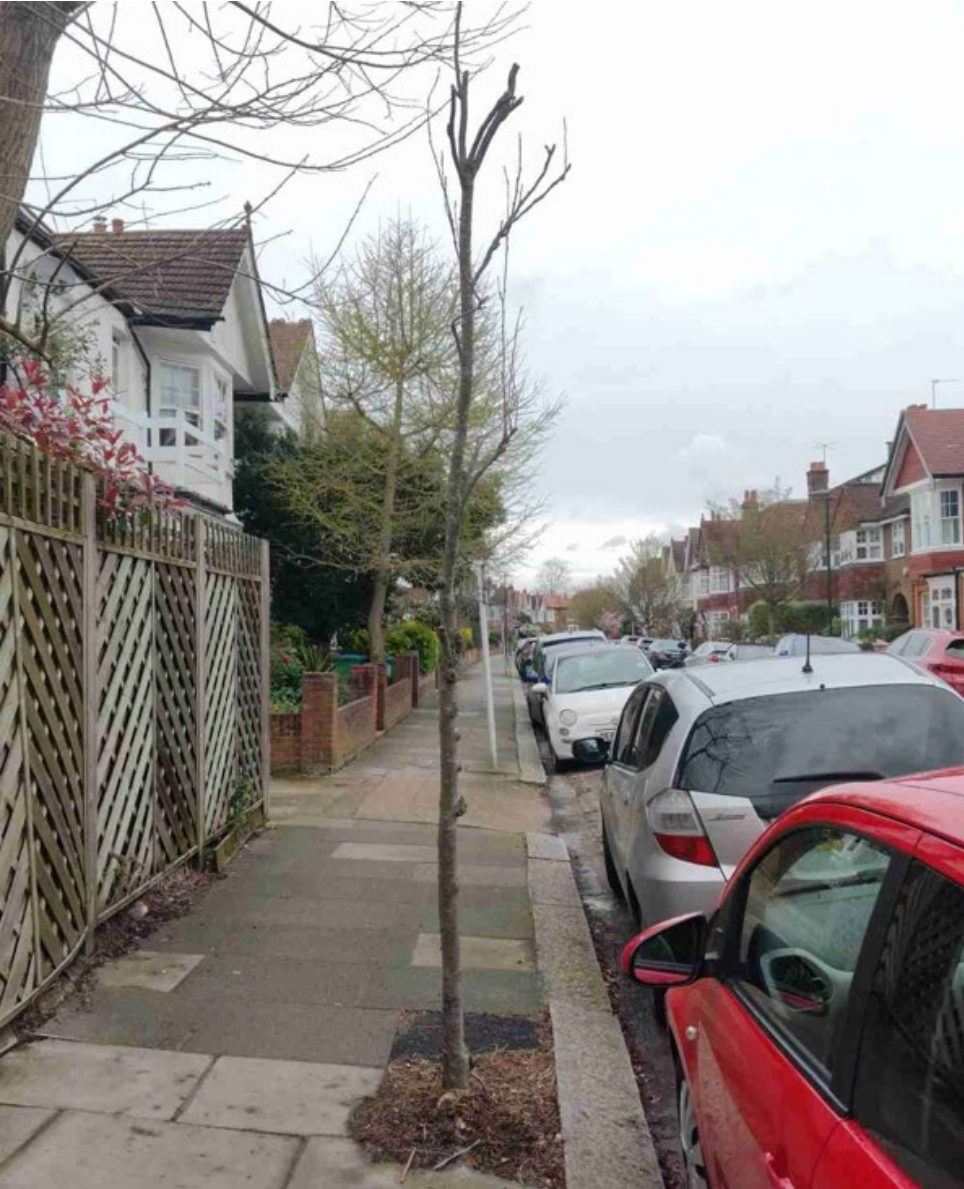
Ward	Kew
Road	Beechwood Avenue
Location	Adjacent to 13 West Park Road rear garden
Species	Cherry (<i>Prunus sp.</i>)
Height	4.0m
Physiological Condition	Dead
Structural Condition	Dead
Inspection findings	This tree is dead. Removal is required to prevent natural failure, manage risk, and facilitate replanting.

Image shows dead tree in street scene.

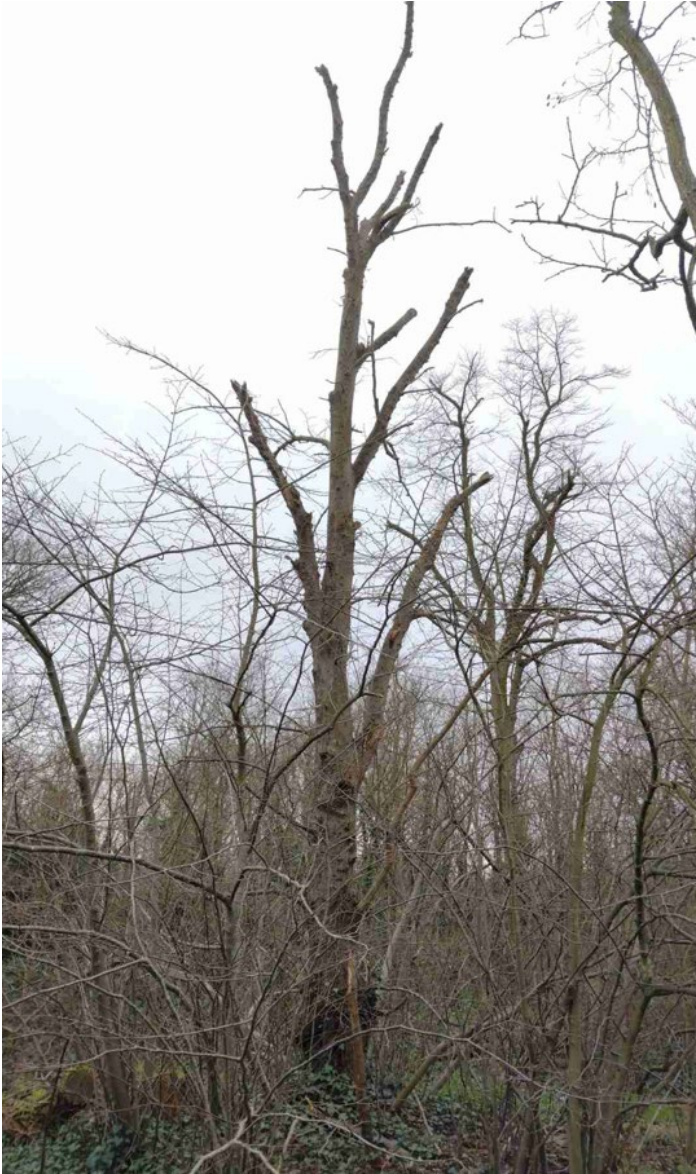
Ward	Mortlake and Barnes Common
Road	Mill Hill Road
Location	Barnes Common What3Words-///pretty.torn.circle
Species	Lime (<i>Tilia sp.</i>)
Height	12.0m
Physiological Condition	Dead
Structural Condition	Dead
Inspection findings	This tree is dead. Removal is required to prevent natural failure and manage risk. The trunk will be left as a 5m high monolith for habitat purposes.

Image shows dead tree in park scene.
