April 2024 - Reactive Tree Works Programme

Dated 22.04.2024

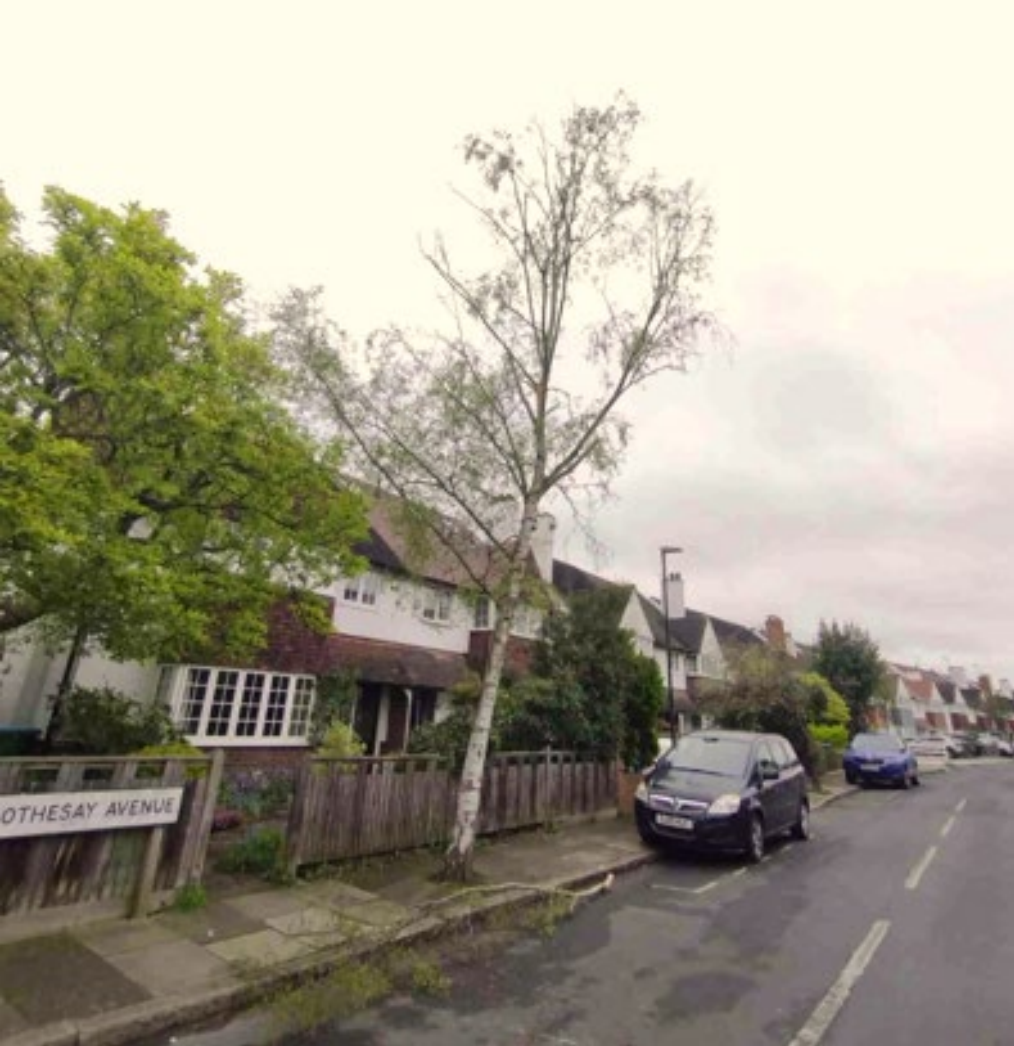
Ward	North Richmond
Road	Rothesay Avenue
Location	Outside 40
Species	Silver Birch (<i>Betula pendula</i>)
Height	12.0m
Physiological Condition	Poor
Structural Condition	Poor
Inspection findings	Fungal fruiting bodies fungus <i>Fomitopsis betulina</i> are present on the trunk of this tree. This fungus causes a brown rot which can rapidly reduce wood strength and cause branch or whole tree failure through brittle fracture. Crown dieback could correlate with the pathogen present. Removal is required to prevent natural failure, manage risk, and facilitate replanting.

Image shows tree in a moribund state.

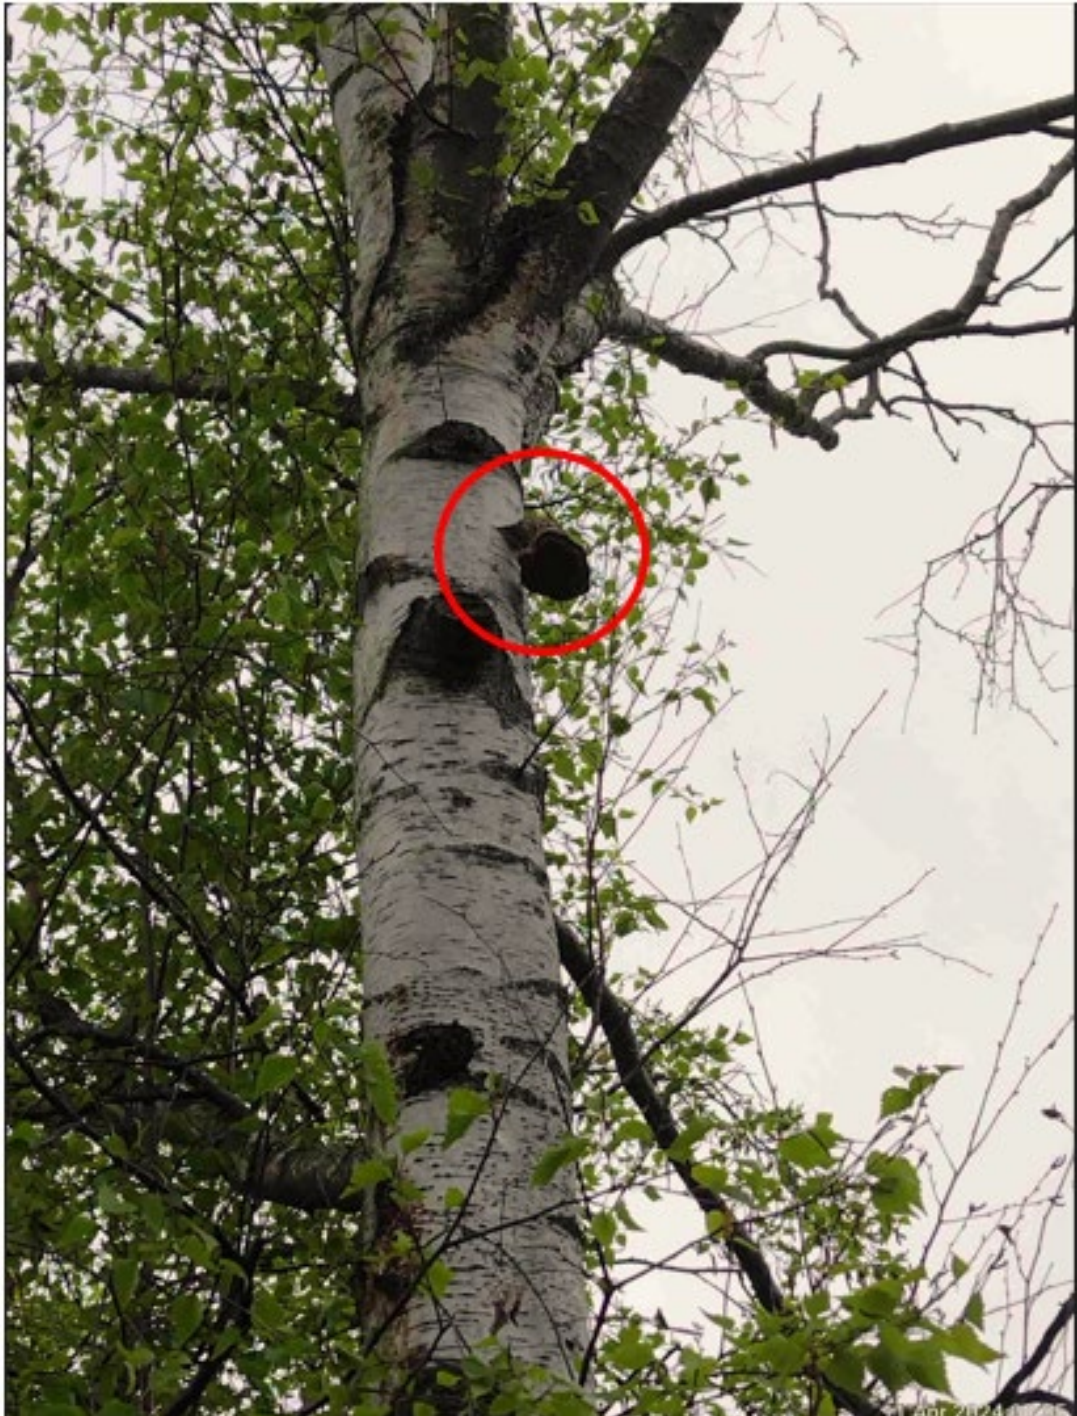
Image shows tree with location of fungal fruiting body circled.

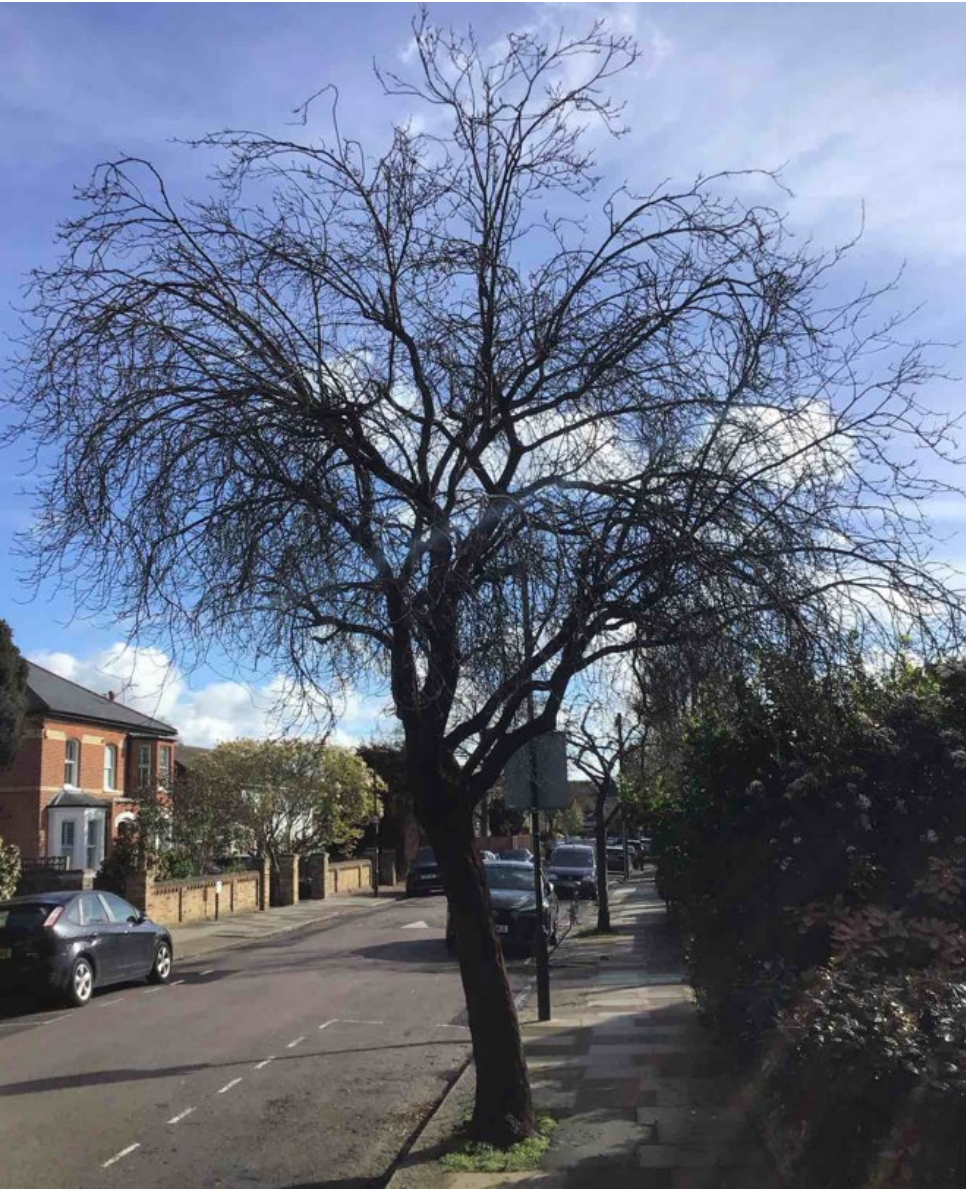
Ward	Teddington
Road	Teddington Park Road
Location	Outside 86/88
Species	Cherry Plum (<i>Prunus cerasifera</i>)
Height	8.0m
Physiological Condition	Dead
Structural Condition	Dead
Inspection findings	This tree is dead. Removal is required to prevent natural failure, manage risk, and facilitate replanting.

Image shows dead tree in street scene.

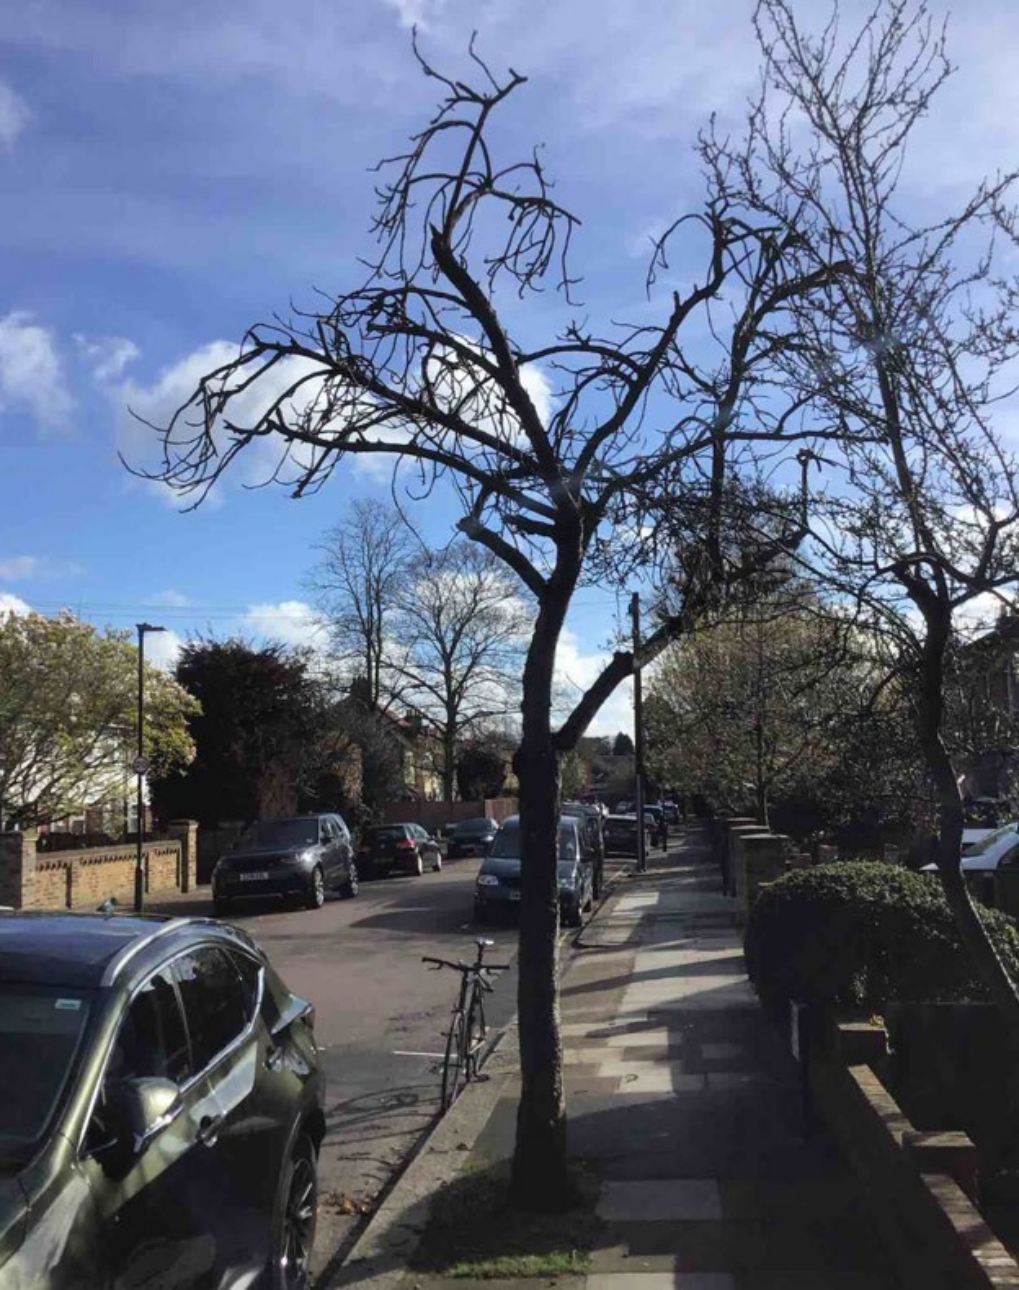
Ward	Teddington
Road	Teddington Park Road
Location	Outside 90/92
Species	Cherry (<i>Prunus sp.</i>)
Height	5.5m
Physiological Condition	Dead
Structural Condition	Dead
Inspection findings	This tree is dead. Removal is required to prevent natural failure, manage risk, and facilitate replanting.

Image shows dead tree in street scene.
