Site Details Hammersmith Temporary Bridge, Hammersmith, London, W6 9PF

Appendix B UXO Report

Site Address	Hammersmith Bridge, London, W6 9DA
National Grid Reference Centre Point	TQ 22971 78089
Site Description	The site is centred on Hammersmith Bridge, encompassing the entire River Thames crossing area, as well as both embankments and the wider area surrounding the bridge. This area includes several commercial buildings, areas of hardstanding and a large area of open ground in the south-west.
Proposed Works	Proposed works include piling and foundation installation in the River Thames, on the riverbanks and either side of Hammersmith Bridge.
Maximum Depth of Ground Works	30m bgl.

Hammersmith Bridge Refurbishment Pell Frischmann 8307 RA

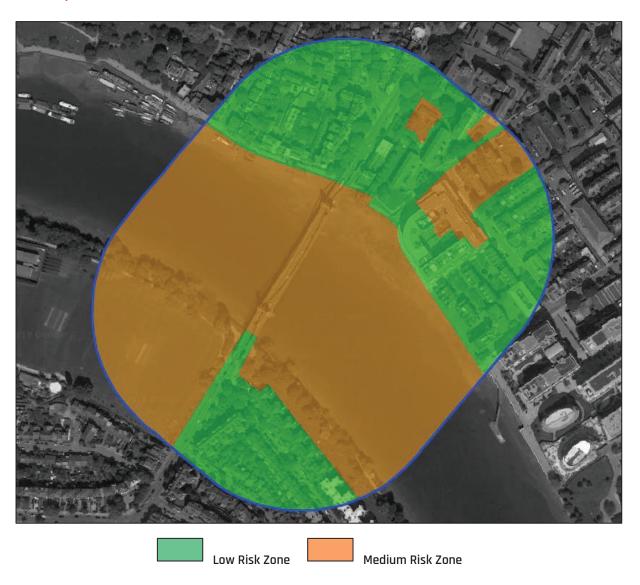
Risk Map – Annex R

RECOMMENDED RISK MITIGATION MEASURES:	Low Risk Zone	Medium Risk Zone
Site Specific Explosive Ordnance Safety and Awareness Briefings to all personnel conducting intrusive works	✓	✓
The Provision of Unexploded Ordnance Site Safety Instructions	✓	√
Explosive Ordnance Disposal (EOD) Engineer presence on site to support shallow intrusive works	×	✓
Handheld Intrusive Magnetometer Survey of all borehole locations down to the maximum bomb penetration depth	×	×
Non-Intrusive Magnetometer Survey and Target Investigation (greenfield land only)	×	×
Intrusive Magnetometer Survey of all pile locations down to the maximum bomb penetration depth	×	✓
MARINE ONLY		
Non-Intrusive Magnetometer and Side Scan UXO Survey (Marine)	×	✓
Intrusive Magnetometer Survey - Down-hole Vallon Probing ahead of Marine Boreholes	×	×
Barge-Mounted Intrusive Magnetometer Survey	×	×
Seismic Investigation: Further Non-Intrusive Survey over exact locations to identify and mitigate risk.	×	✓

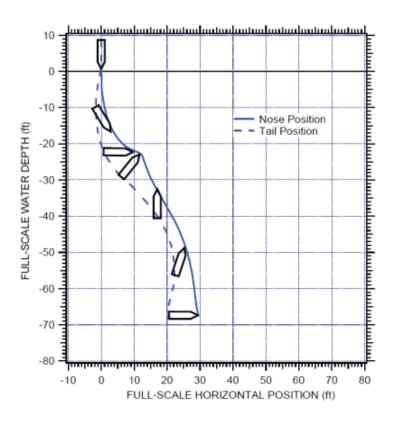
For any part of the site located below the water mark of the lowest water level, calculating a maximum bomb penetration assessment is more problematic as the water column produces a decelerating effect that is not easily calculated.

Penetration into riverbed by bombs with a standard tangent Ogive nosecone is not well predicted as the bomb will deviate from its original path. The velocity at which a bomb is travelling becomes irrelevant in water deeper than several metres because the water has such a decelerating effect that a bomb will essentially "float" down to the seabed, however not necessarily in a vertical orientation; see graph (left) - plotting the trajectory of an American MK-84 (925kg) HE bomb with no tail section into water at an entry velocity of 296m/s.4

Taking into account the above-mentioned factors it has been assessed that a 500kg bomb would have had an approximate maximum bomb penetration depth of between **10-12m** below WWII ground level. Penetration depth could potentially have been greater if the UXB was larger (though only 4% of German bombs used in WWII over Britain were of that size). Note that UXBs may be found at any depth between just below the WWII ground level and the maximum penetration depth.

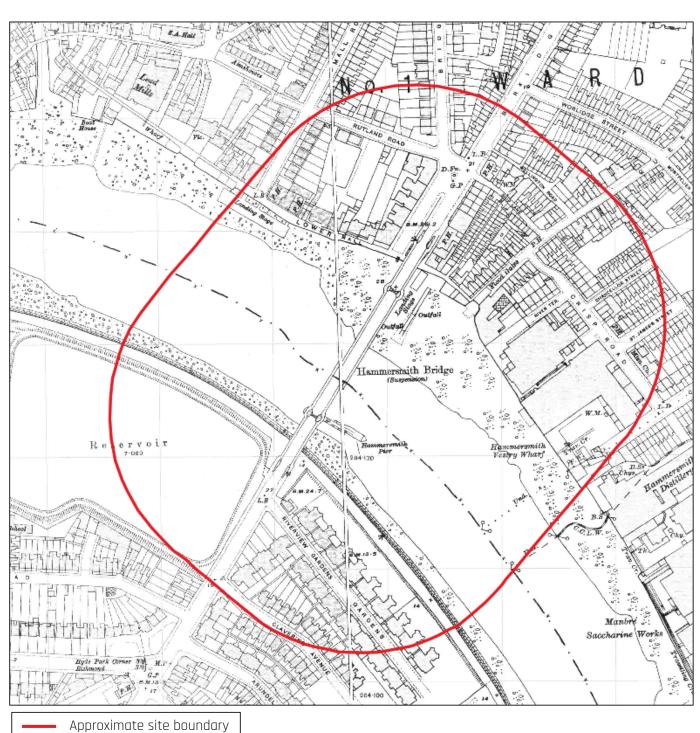
1951 OS Map

Date	1951		Scale	1:2,500	Source	Groundsure Ltd
The following are indicative of serious bomb damage on early post-WWII OS mapping:						
Ruins	One <i>Ruin</i> is located in the north of the site, with three more <i>Ruins</i> to the west of the site.			Ruins to the north-		
Clearance	✓	Several areas of clearance are located both on site and the surrounding area, predominantly north of the embankment, including commercial buildings and the clearance of the Landing Stage.

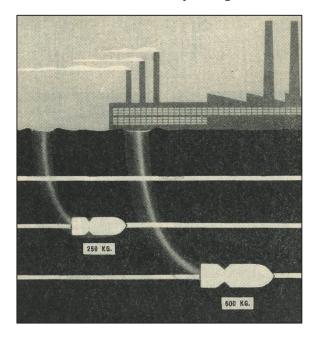
- **1. Ricochet resulting from low level attack:** UXB stays perpendicular to ground and rests at surface.
- **2. Buried UXB with J-Curve:** Bomb curves horizontally and rests perpendicular to surface.
- 3. UXB returning to surface due to J-Curve: Bomb points towards surface but may remain partially or completely below ground level.
- **4. UXB deflected by buried objects:** Results in unpredictable path and unusual shaft.

Below: UXB can come to rest beneath undamaged buildings due to the J-Curve effect if it lands in nearby soft ground.

The location of the bomb is thus "offset" from the hole of entry. This "offset" from vertical is generally understood to be about one third of the penetration depth but can reach up to (and have been found at) 15m/50 ft from point of entry, dependent on ground conditions and the bomb's angle of impact.

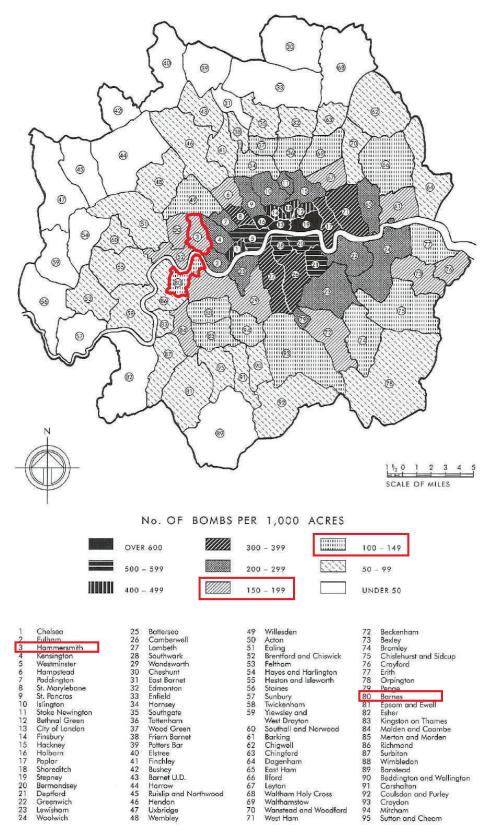
WWII London Bomb Density Map

The density of bombing across the London Region from 1939 to 1945 produced by the Research and Experiments Dept of the Ministry of Home Security. The site is located within the WWII-era London Boroughs of both Hammersmith and Barnes which sustained 150 - 199 bombs and 100 - 149 bombs respectively per 1,000 acres.

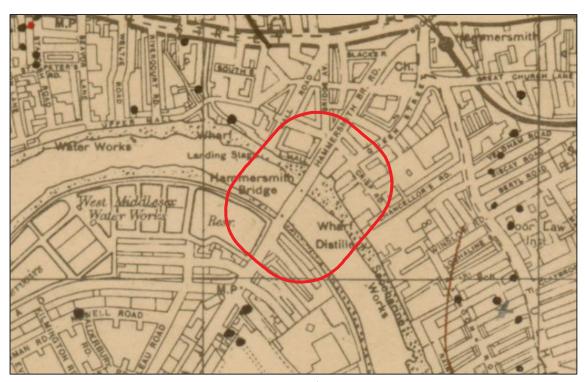
Night bombing up to 7th October 1940

- This is confirmed by original bomb census maps which plot at least eight HE bomb strikes on site, with a further 96 within a 300m radius.
- A consolidation of historical sources shows that buildings on site and in the surrounding area suffered
 varying degrees of bomb damage, many of these buildings were subsequently either redeveloped or
 cleared.

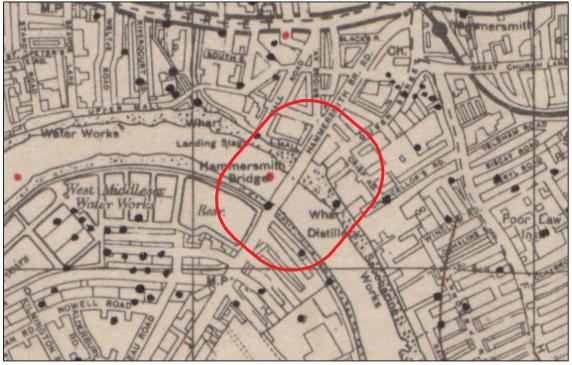
Night bombing between 7^{th} October 1940 and 28^{th} July 1941
