Hammersmith Temporary Ferry

Detailed UXO Risk Assessment

Report Ref: 102963-PEL-GEN-ZZZ-SUR-RM-00002

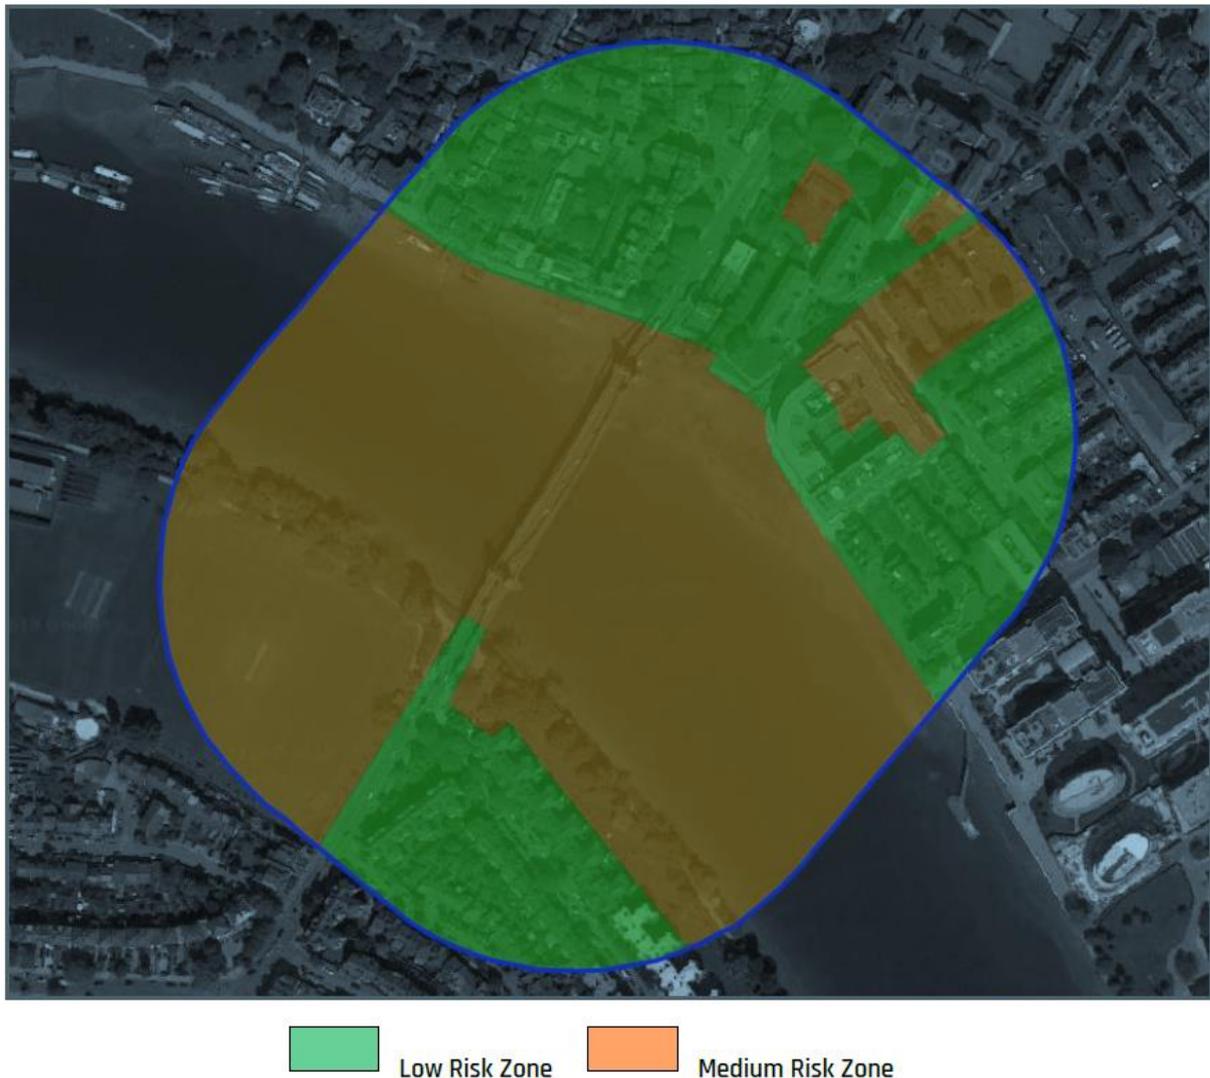
Figure 1 - Risk Map

The Detailed Assessment for the Hammersmith Temporary Ferry and the surrounding area has resulted in an overall Low to Medium risk of unexploded ordnance (UXO) as shown in the following figure. The recommendations for low and medium risk sites are detailed in Appendix A.

The River Thames itself is classified as a medium risk zone. To further mitigate the associated risks, an on-site UXO survey will be carried out prior to construction of the Temporary Ferry structures.

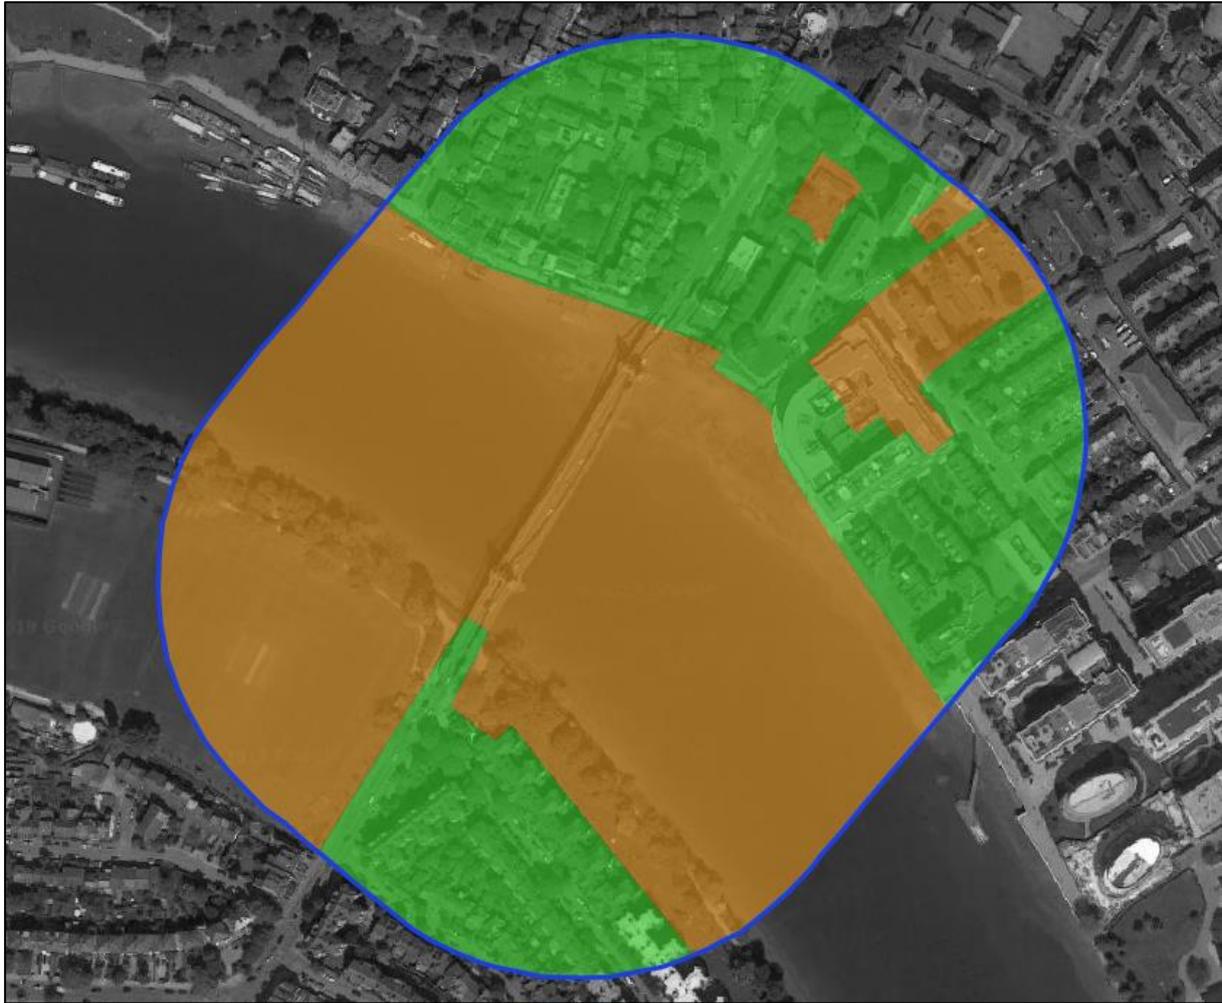
Risk Map - Annex R

Low Risk Zone

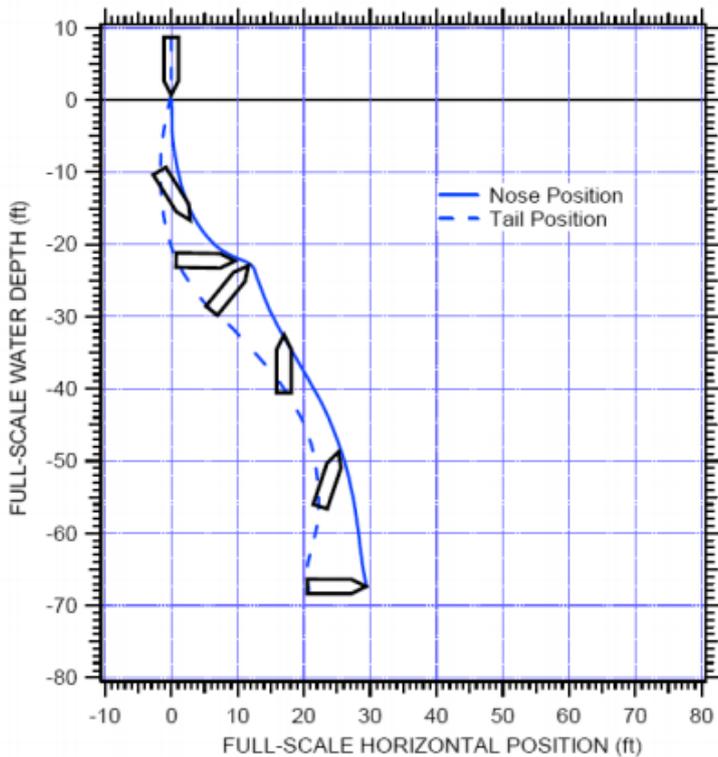
Within the section of the site occupied by river, the lowest possible water depth above the locations of the proposed works during WWII will also be considered.

For any part of the site located below the water mark of the lowest water level, calculating a maximum bomb penetration assessment is more problematic as the water column produces a decelerating effect that is not easily calculated.

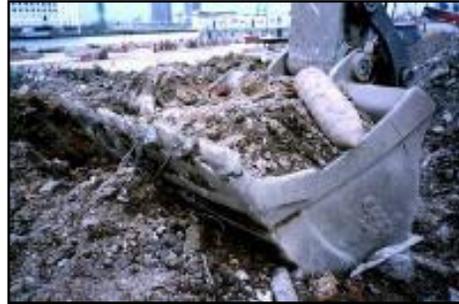
50kg bomb, London Docklands

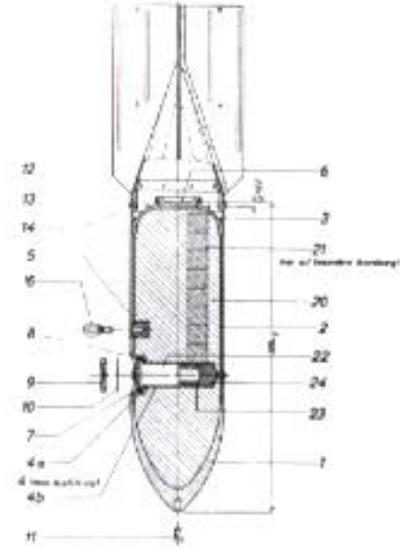
SC-50 JA (Güteklasse 1)

Use: Against lightly damageable materials, hangars, railway rolling stock, ammunition depots, light bridges and buildings up to three stories.

Remarks: The smallest and most common conventional German bomb. Nearly 70% of bombs dropped on the UK were 50kg.

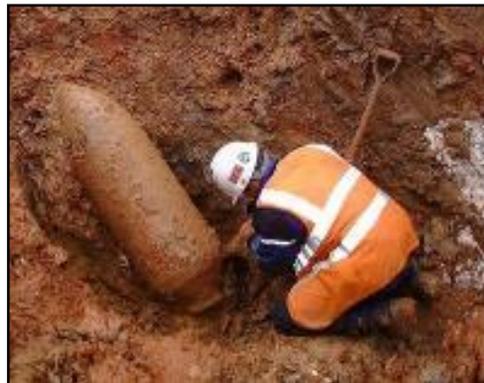
250kg bomb, Hawkinge

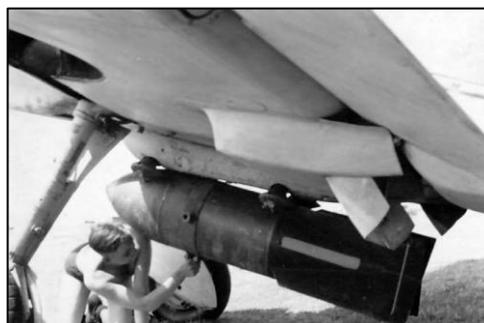
SC250 attached to undercarriage of Messerschmitt Bf109

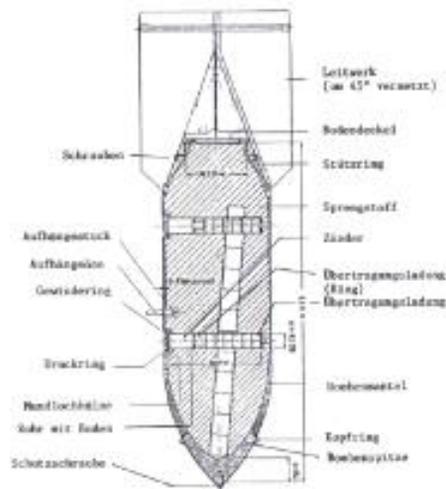
SC-250 JA (Güteklasse I)

Body diameter: 368mm (14.5in)

Use: Against railway installations, embankments, flyovers, underpasses, large buildings and below-ground installations.

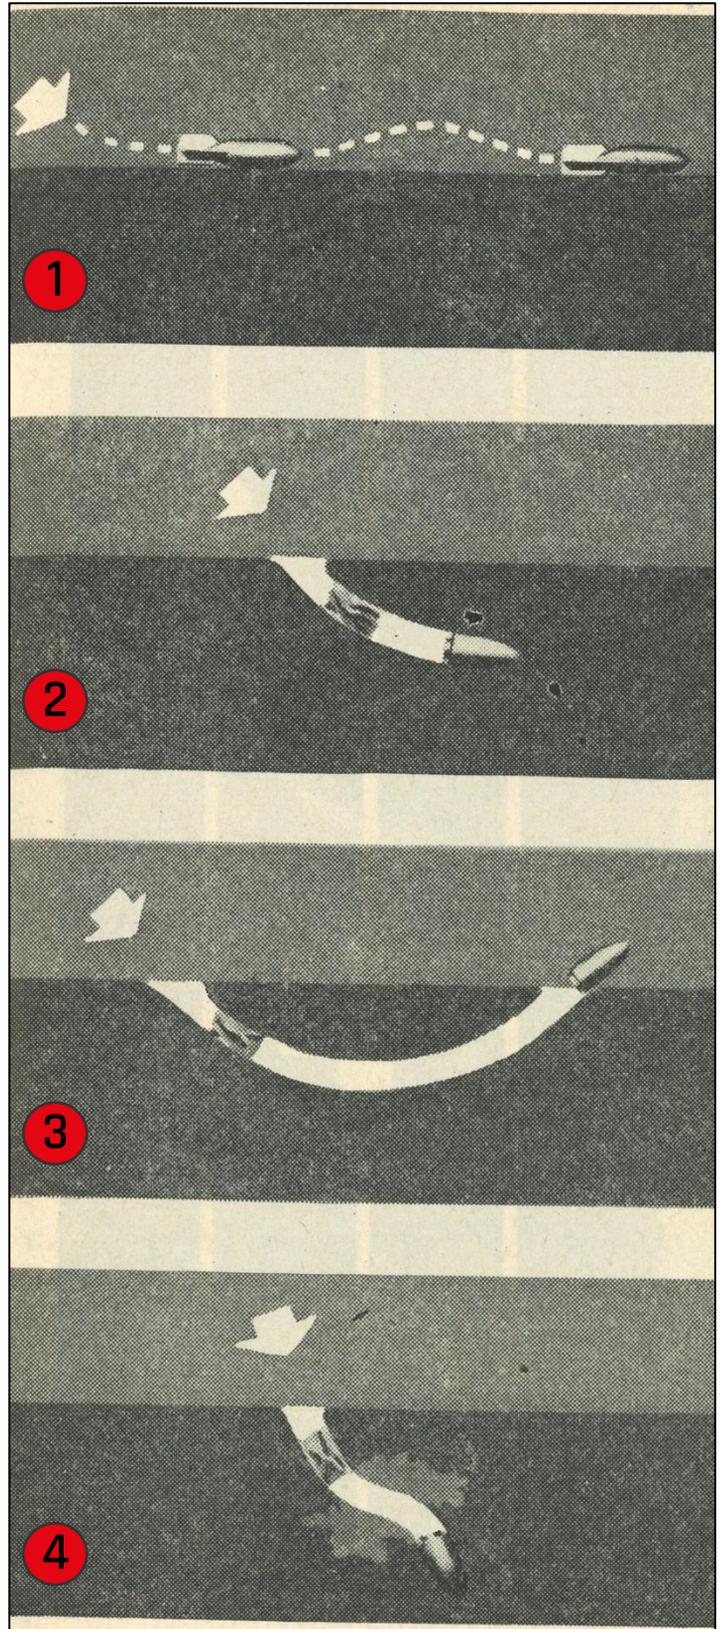
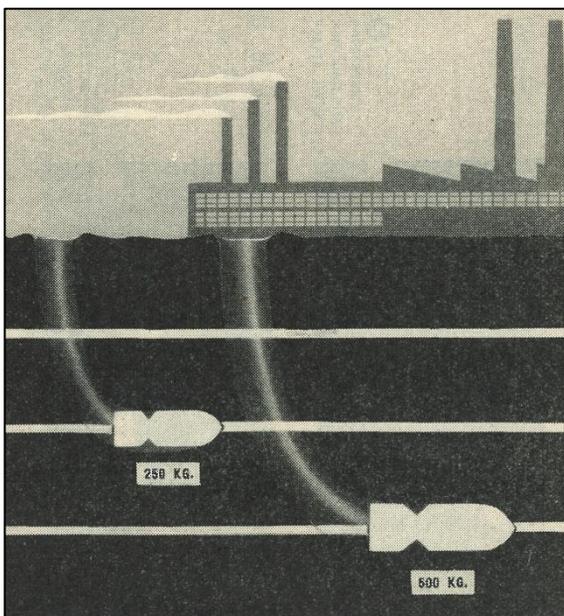
Path of UXB in soft ground

1. **Ricochet resulting from low level attack:** UXB stays perpendicular to ground and rests at surface.
2. **Buried UXB with J-Curve:** Bomb curves horizontally and rests perpendicular to surface.
3. **UXB returning to surface due to J-Curve:** Bomb points towards surface but may remain partially or completely below ground level.
4. **UXB deflected by buried objects:** Results in unpredictable path and unusual shaft.

Below: UXB can come to rest beneath undamaged buildings due to the J-Curve effect if it lands in nearby soft ground.

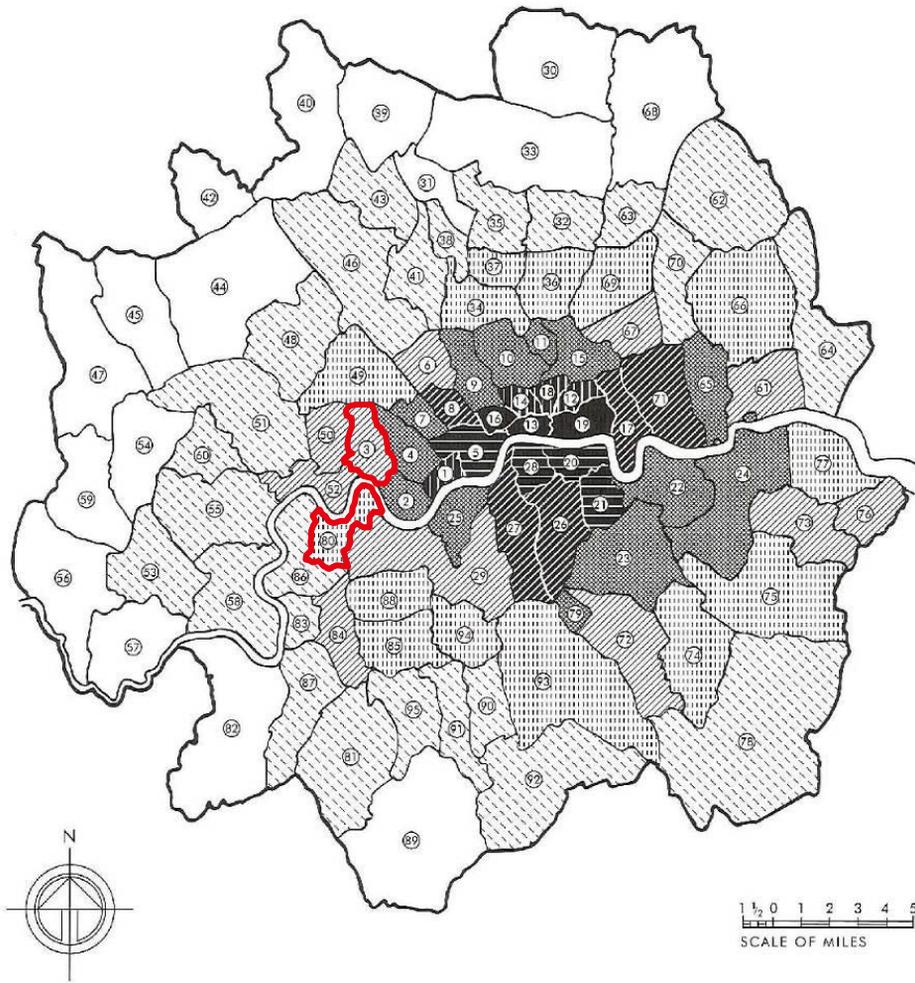
No. OF BOMBS PER 1,000 ACRES

The density of bombing across the London Region from 1939 to 1945 produced by the Research and Experiments Dept of the Ministry of Home Security. The site is located within the WWII-era London Boroughs of both Hammersmith and Barnes which sustained 150 - 199 bombs and 100 - 149 bombs respectively per 1,000 acres.

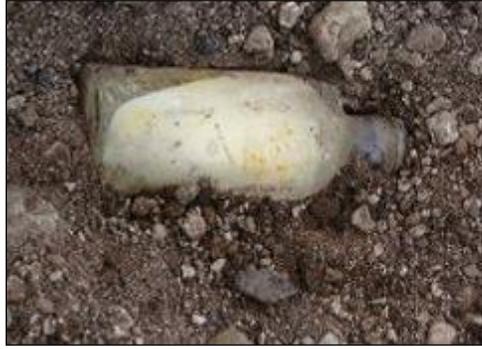
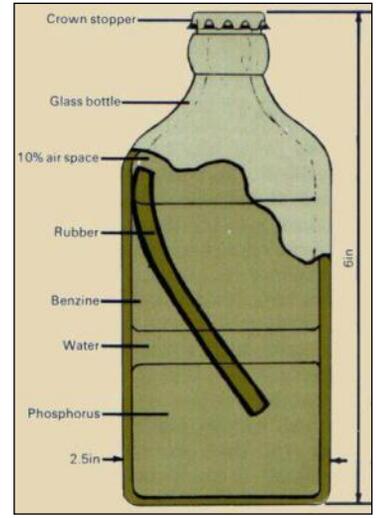
Self Igniting Phosphorous (SIP) Grenades

The grenade comprised a glass bottle with a total volume of approximately one pint. It was filled with White Phosphorus, benzene, a piece of rubber and water. Over time the rubber dissolved to create a sticky fluid which would self ignite when the bottle broke. Fired by hand or Northover Projector. Sometimes called the "A & W" (Albright & Wilson) grenade.

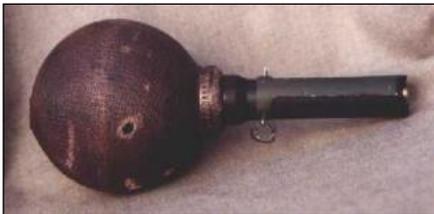
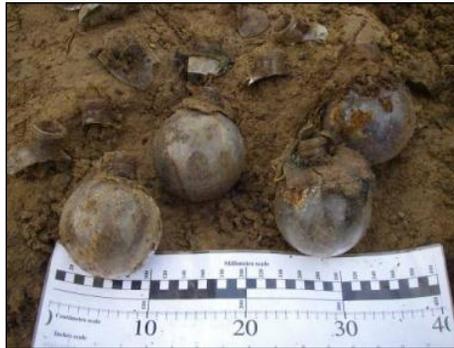
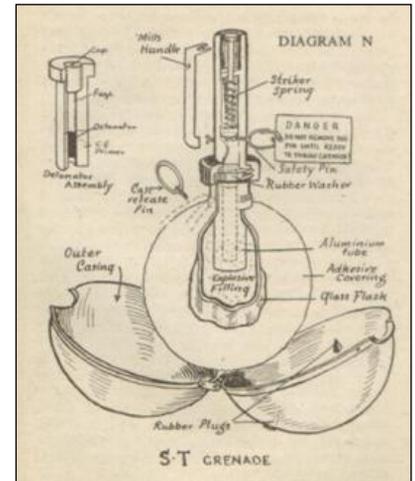
No 74 Grenade (Sticky Bomb)

Designed as an anti-tank grenade and used by the Home Guard. The grenade consisted of a glass ball on the end of a Bakelite (plastic) handle. Inside the glass ball was an explosive filling whilst on the outside was a very sticky adhesive covering. Until used, this adhesive covering was encased in a metal outer casing.

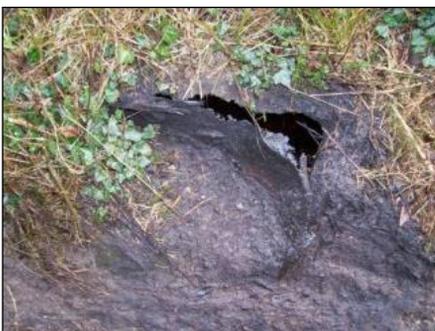
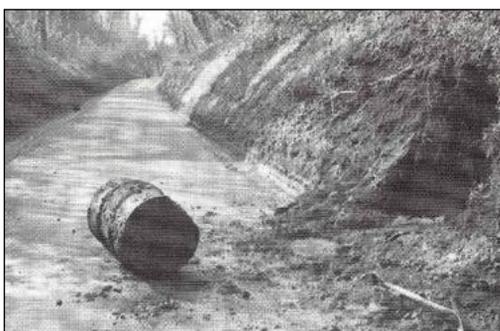
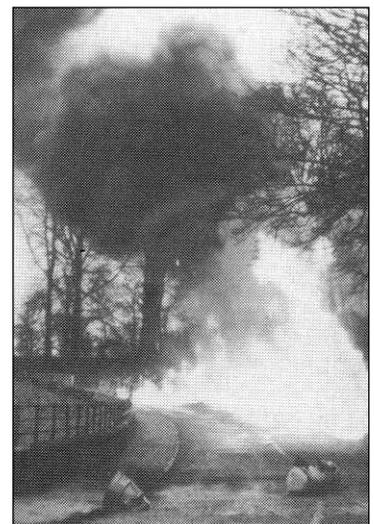
Flame Fougasse Bomb

A Flame Fougasse was a weapon in which the projectile was a flammable liquid, typically a mixture of petrol and oil. It was usually constructed from a 40-gallon drum dug into the roadside and camouflaged. Ammonal provided the propellant charge which, when triggered, caused the weapon to shoot a flame 3m (10ft) wide and 27m (30 yards) long. Initially a mixture of 40% petrol and 60% gas oil was used, this was later replaced by an adhesive gel of tar, lime and petrol known as 5B.

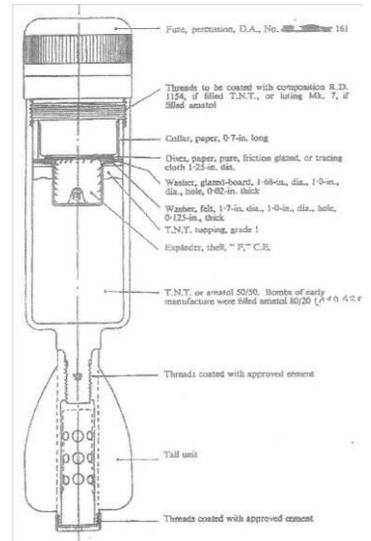
Typical 2 inch High Explosive Mortar

- Bomb Weight: 1.02kg (2.25lb)
- Type: High Explosive
- Dimensions: 51 x 290mm (2in x 11.4in)
- Filling: 200g RDX/TNT
- Maximum Range: 457m (500yds)
- Remarks: Fitted with an impact fuze which detonates the fuze booster charge (exploder) and, in turn, the high explosive charge. The main charge shatters the mortar bomb body, producing near optimum fragmentation and blast effect at the target.

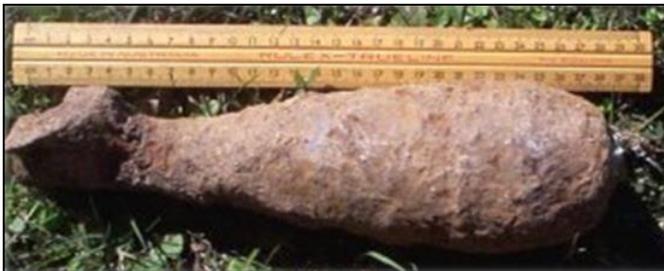
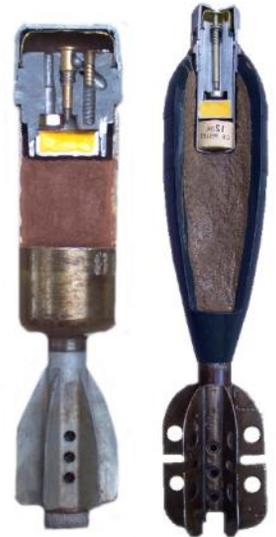
Typical 3 inch Smoke Mortar

- Type: Smoke
- Dimensions: c490 x 76mm (19.3in x 3in)
- Filling: Typically white phosphorous
- Maximum Range: 2515m (2,750yds)
- Remarks: On impact, the fuze functions and initiates the bursting charge. The bursting charge ruptures the mortar bomb body and disperses the white phosphorous filler. The white phosphorous produces smoke upon exposure to the air.

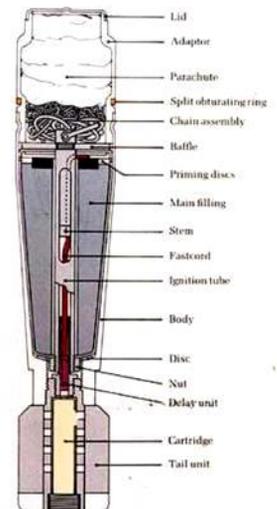
Typical 2 inch Illuminating Mortar

- Type: Illum.
- Dimensions: 51 x 290mm
- Filling: Various
- Remarks: The expulsion charge ignites and ejects the candle assembly. A spring ejects the parachute from the tail cone. The parachute opens, slowing the descent of the burning candle which illuminates the target.

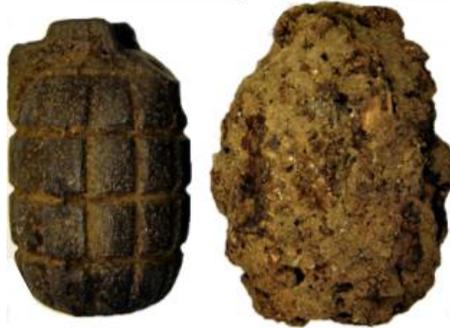
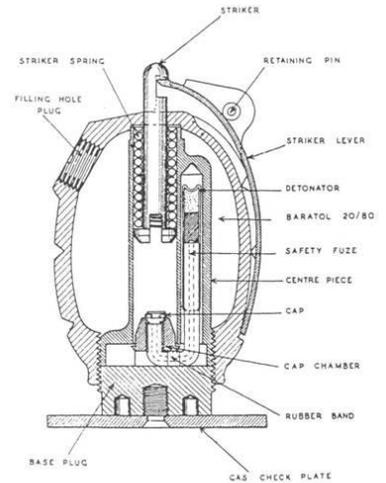
No. 36 'Mills' Grenade

Weight: 0.7kg filled (1lb 6oz)
Type: Hand or discharger, fragmentation
Dimensions: 95 x 61mm (3.7 x 2.4in)
Filling: Alumaton, Amatol 2 or TNT
Remarks: 4 second hand-throwing fuse with approximate 30m range. First introduced May 1918.

Grenade, .303 inch rifle, No. 36M, Mark I.

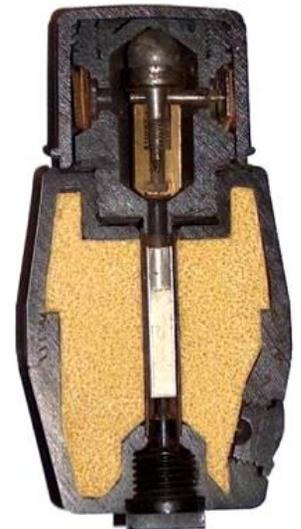
No. 69 Grenade

Weight: 0.38kg filled (0.8lb)
Type: Percussion/Blast
Date Introduced: December 1940
Remarks: Black Bakelite body. Blast rather than fragmentation type. After unscrewing the safety cap, a tape is held when throwing the grenade releasing the safety bolt in the throwing motion. Detection is problematic due to its very low metal content.

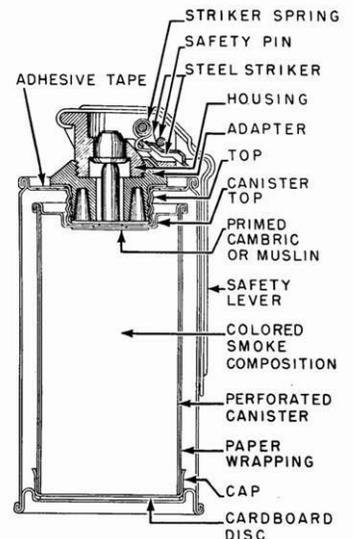
Typical Smoke Grenade

Dimensions: Approx. 65 x 115mm (2.5 x 4.5in)
Type: Smoke
Date Introduced: Current MoD issue
Remarks: Smoke grenades are used as ground-to-ground or ground-to-air signalling devices, or landing zone marking devices, and screening devices for unit movement.

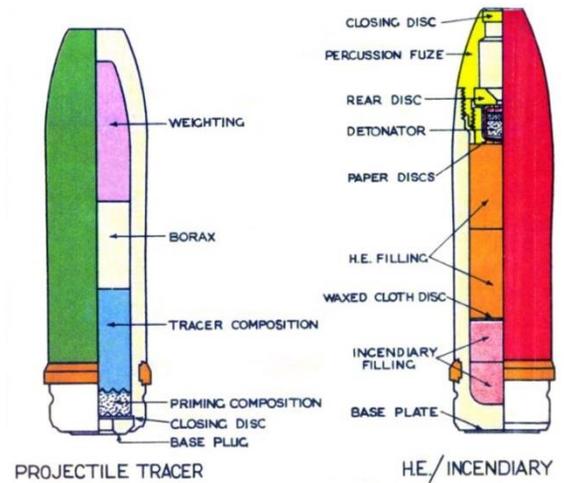
20mm Hispano HEI Ammunition

- Type: Live canon round
- Markings: Upper half of projectile pointed 'buff' colour, lower half is red.
- Cartridge Weight: 256 grams
- Dimensions: Total cartridge / projectile length - 182mm
- Fuzed: Contact fuze - No.253, No.254 or No.917
- Filling: 108 grains of contact explosive + 68 grains of SR.379 incendiary composition.
- Threat: Explosives within unspent cartridge as well as the projectile.
- Deployment: Royal Navy, RAF and British Army Light Anti- Aircraft guns. Also RAF aircraft canons.
- Remarks: Cartridges are belted or supplied lose in cartons.

COLOUR IDENTIFICATION		
BRITISH		
NATURE OF SHELL	H.E.FILLING	COLOUR
H.E. TRACER	T.N.T.	Blue
H.E.	T.N.T.	Orange
PROJ. PRACTICE		Purple
PROJ. TRACER		Green
H.E. INCENDIARY	T.N.T.	Red
H.E. INCENDIARY TRACER	T.N.T.	Green

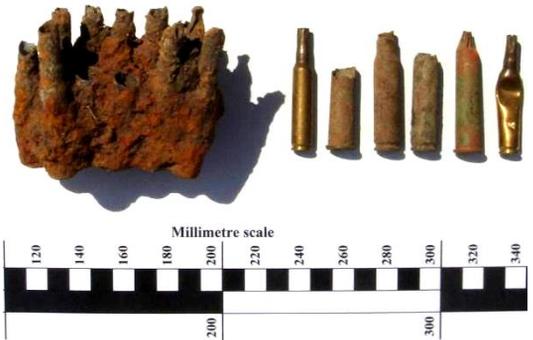
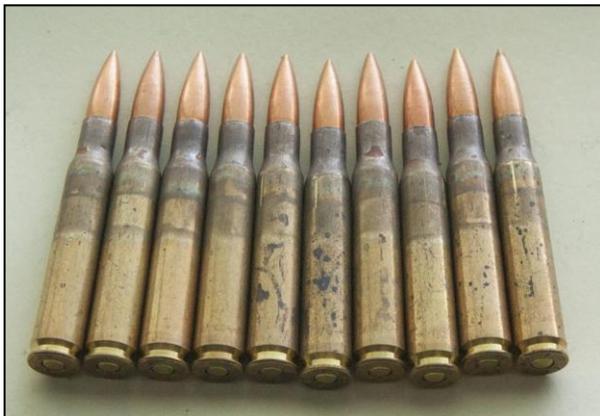
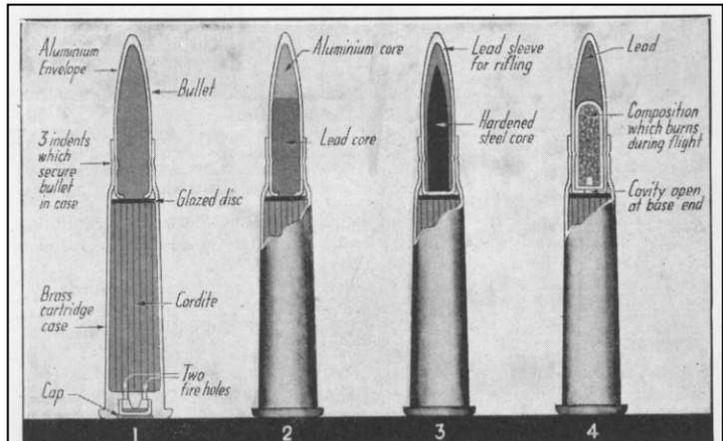
.303" Ammunition

- Type: Rifle / machine gun round
- Markings: Regular round - none. Tracer round - red Primer
- Bullet Weight: 150 - 180 grams
- Dimensions: Total cartridge /projectile length - 78mm
- Filling: Regular round - none. Tracer round - small incendiary fill
- Threat: Explosive cordite within unspent cartridge
- Deployment: Royal Navy, RAF and British Army Light Anti-Aircraft guns, machine guns and rifles. Standard British and Commonwealth military cartridge from 1889 until the 1950s.
- Remarks: Cartridges are belted or supplied lose in cartons.

Fig. 1. Four types of ammunition used by modern infantry. 1 and 2 are ball cartridges, 3 is an armour-piercing bullet, and 4 a tracer bullet which burns and makes its flight visible.

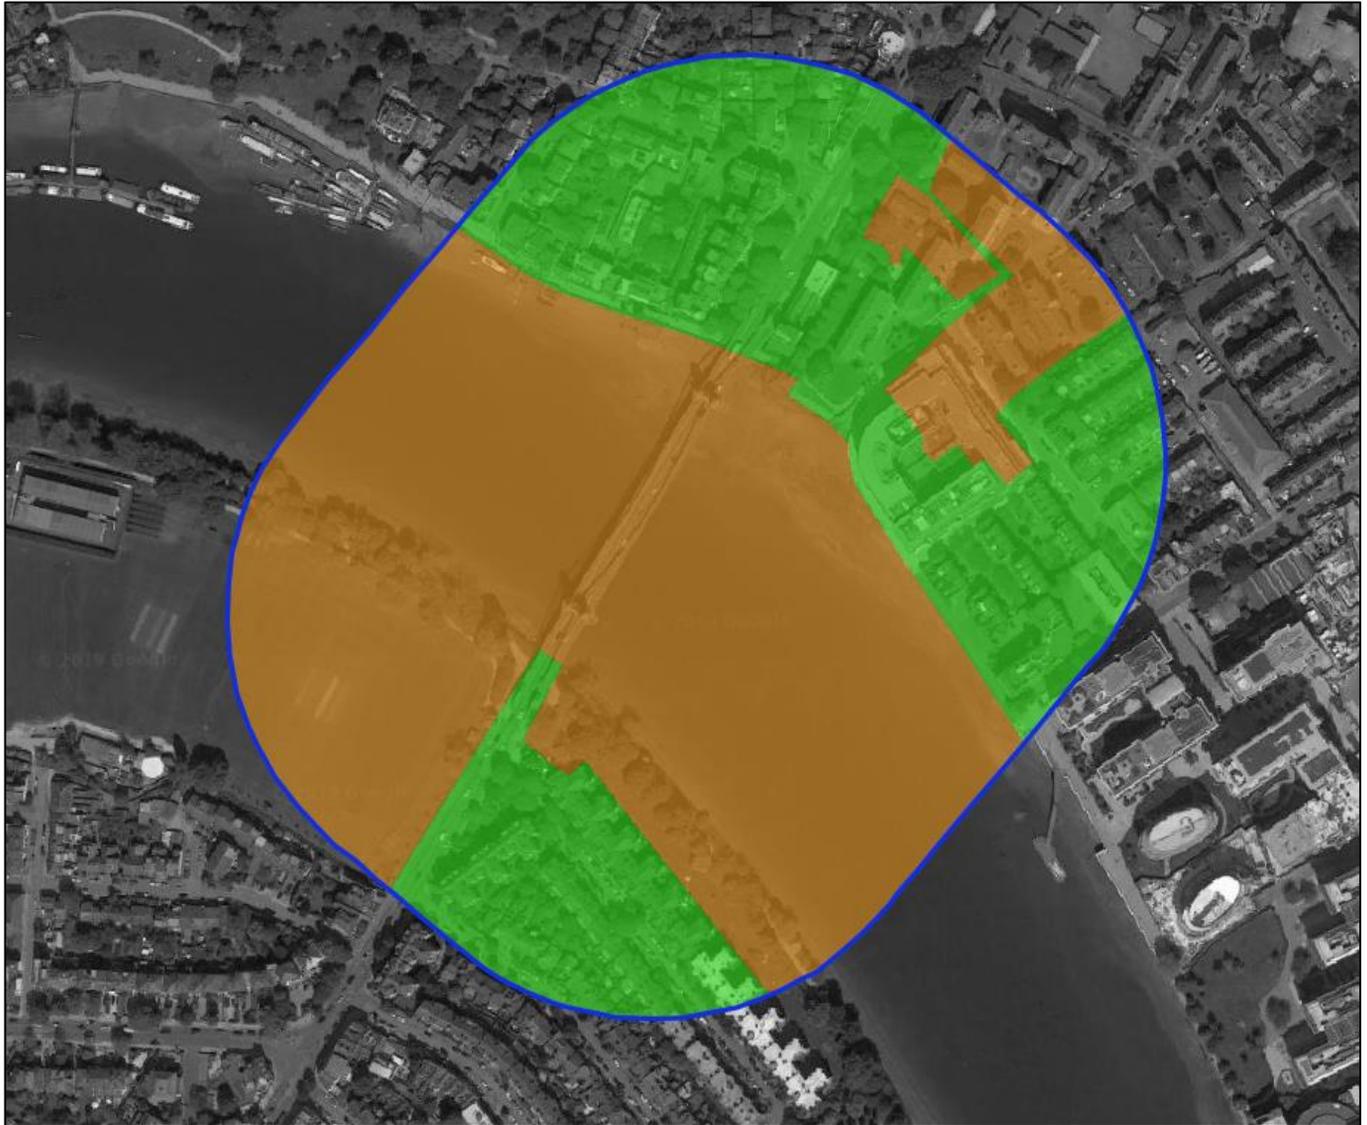
Low Risk Zone
